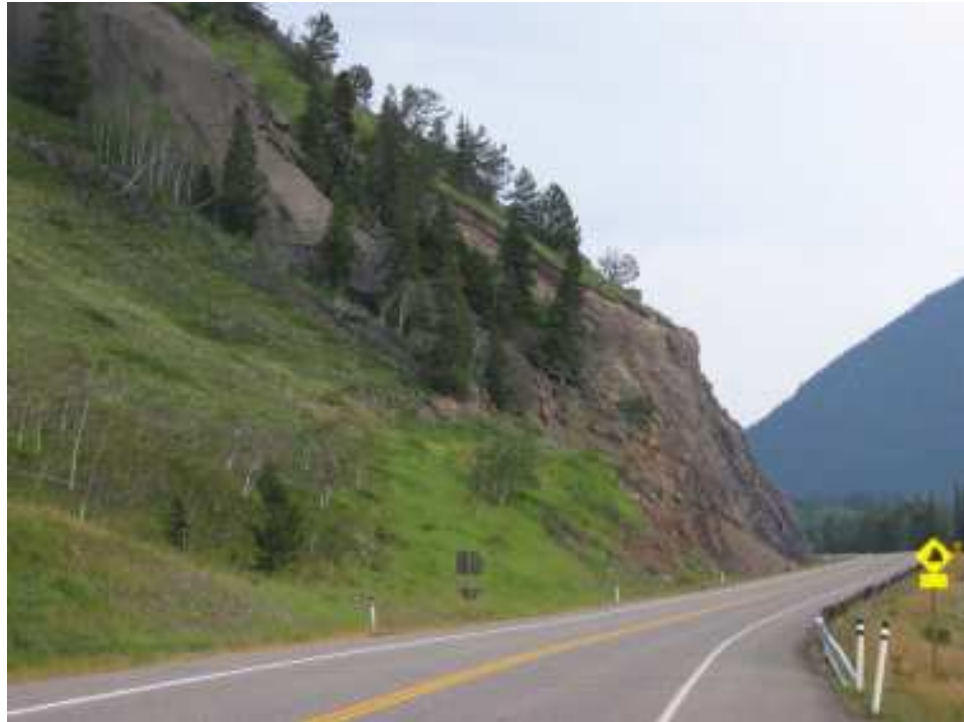
Photo S20-1 – August 2004 (upper left)

Facing eastbound along Highway 541 with the Highwood House Rock Cut visible on the left side of the road. This view illustrates the overall slope profile with the approximately 20 m high, near-vertical to vertical cut slope along the road and the natural slopes up to 35° inclination above the crest of the cut slope.

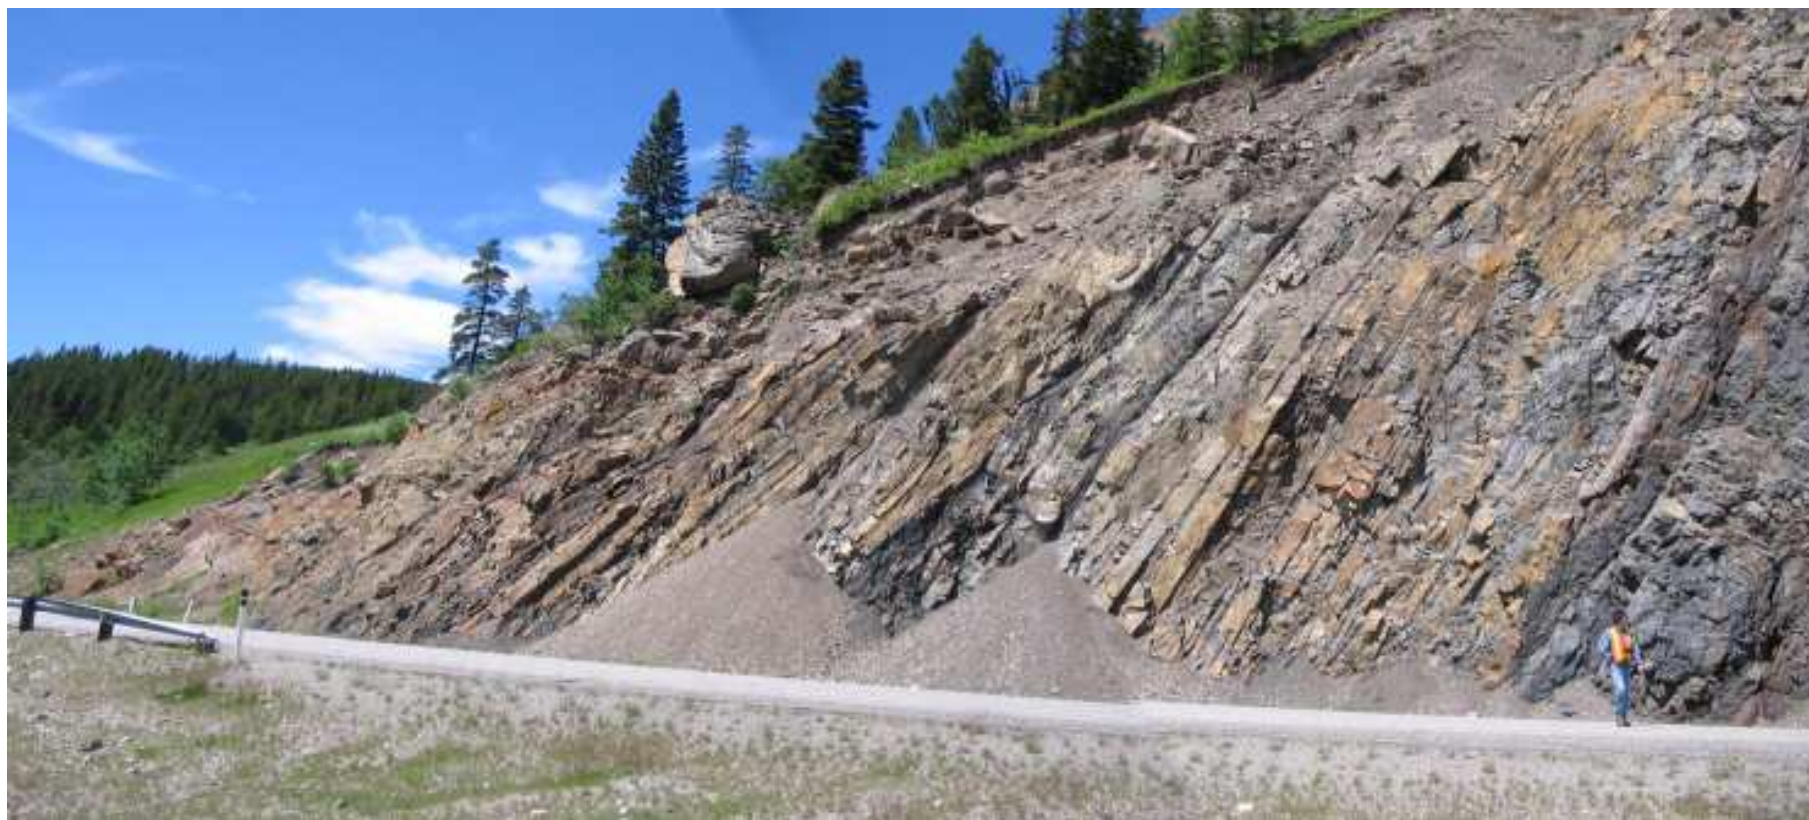
Photo S20-2 – June 2007 (bottom)

Facing north across Highway 541 with the central and western ends of the Highwood House Rock Cut visible. The exposed bedrock consists of steeply dipping beds of shale, coal and conglomerate with the dip direction roughly parallel to the highway alignment and down towards the west (left, as seen in this photo). Note the significant accumulation of rockfall debris in the talus cones in the road ditch.

The rockfalls are caused by weathering and erosion of the exposed rock in the cut slope as well as erosion of the rocky soil exposed along the crest of the cut slope that releases cobble to boulder sized rocks.

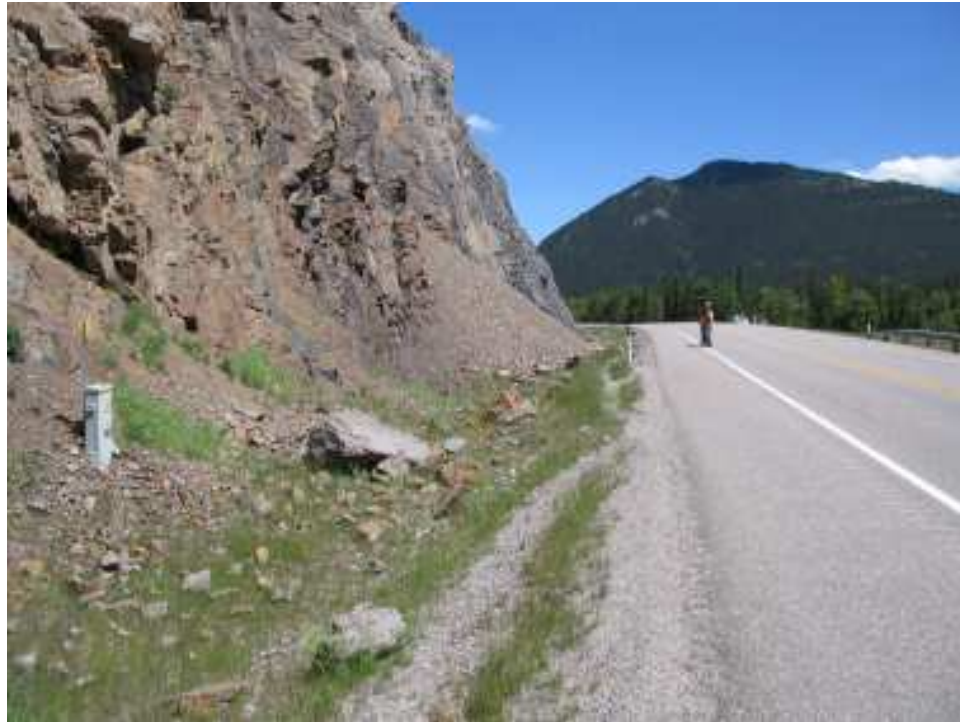
Photo S20-3 – June 2007 (upper left)
Facing eastbound along the north highway ditch at the toe of the cut slope. The boulder visible to the right of the Telus pedestal has a maximum dimension of approximately 2 m and was judged to have fallen during 2005 based on the site inspections at that time.

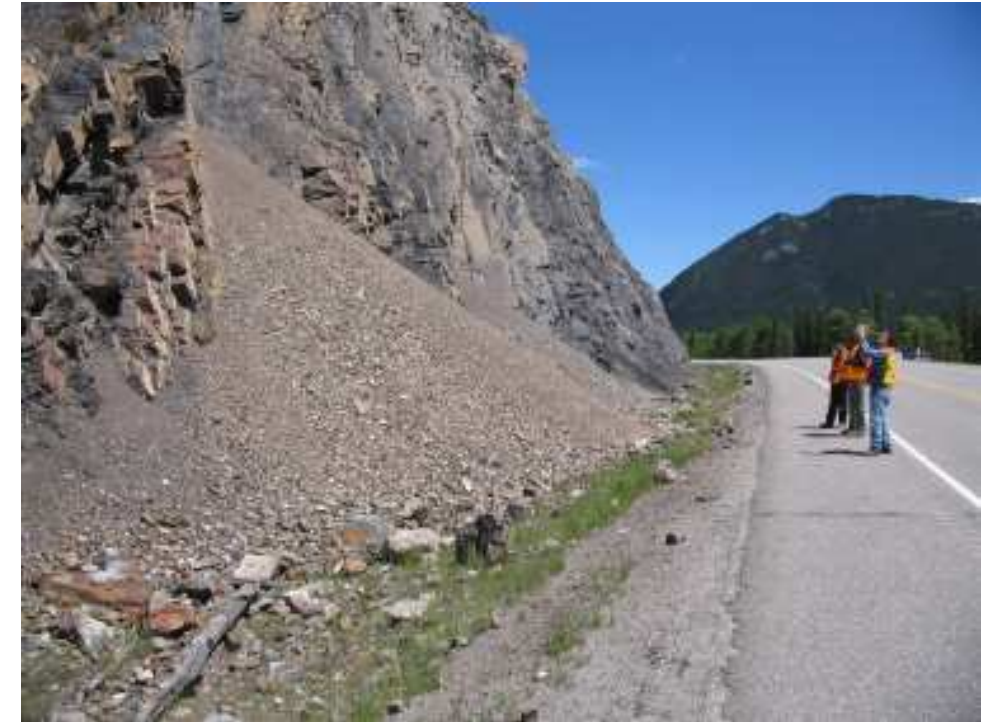
Photo S20-4 – June 2007 (upper right)
Closer view of the talus cones that were accumulated in the north ditch at the time of the June 2007 inspection. Note the proximity of cobble sized rocks to the north edge of the pavement.

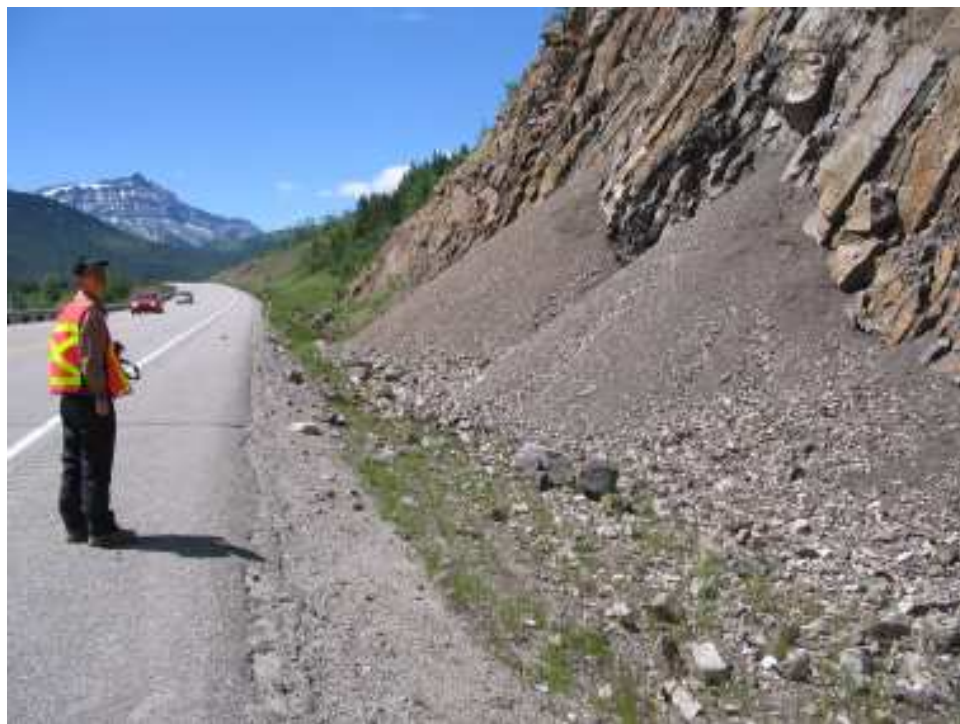
Photo S20-5 – June 2007 (lower left)
Facing westbound across the area shown in Photo S20-4.

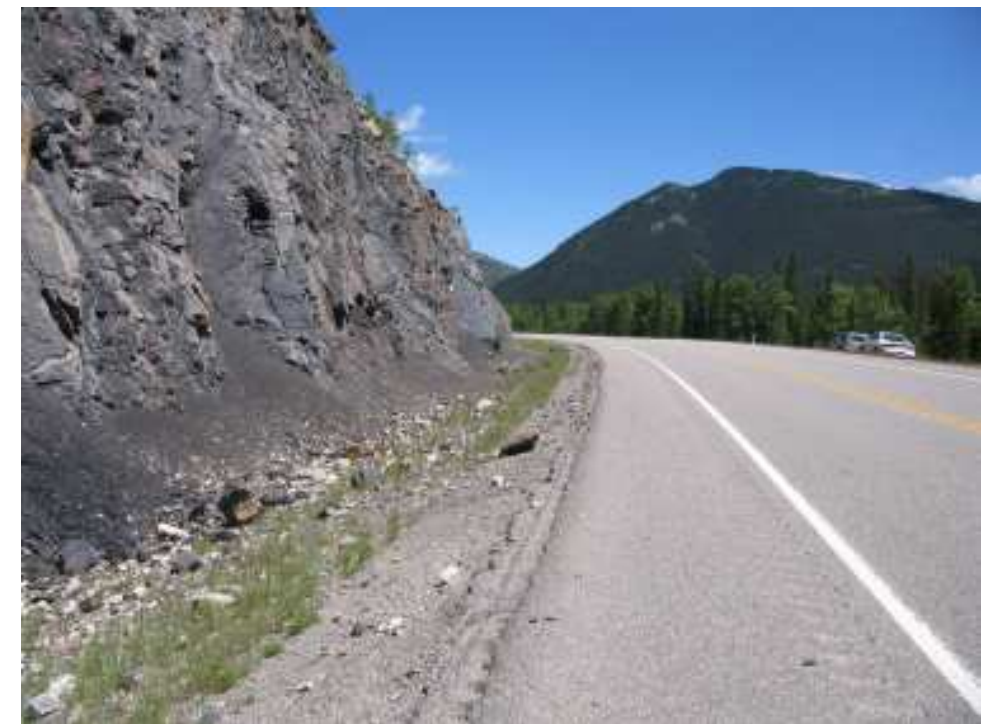
Photo S20-6 – June 2007 (lower right)
Facing eastbound across the north ditch at the east end of the cut slope. Relatively less rockfall debris was present in the ditch at this end of the site, however some cobble-sized rocks were still noted within 1 m of the edge of the pavement.

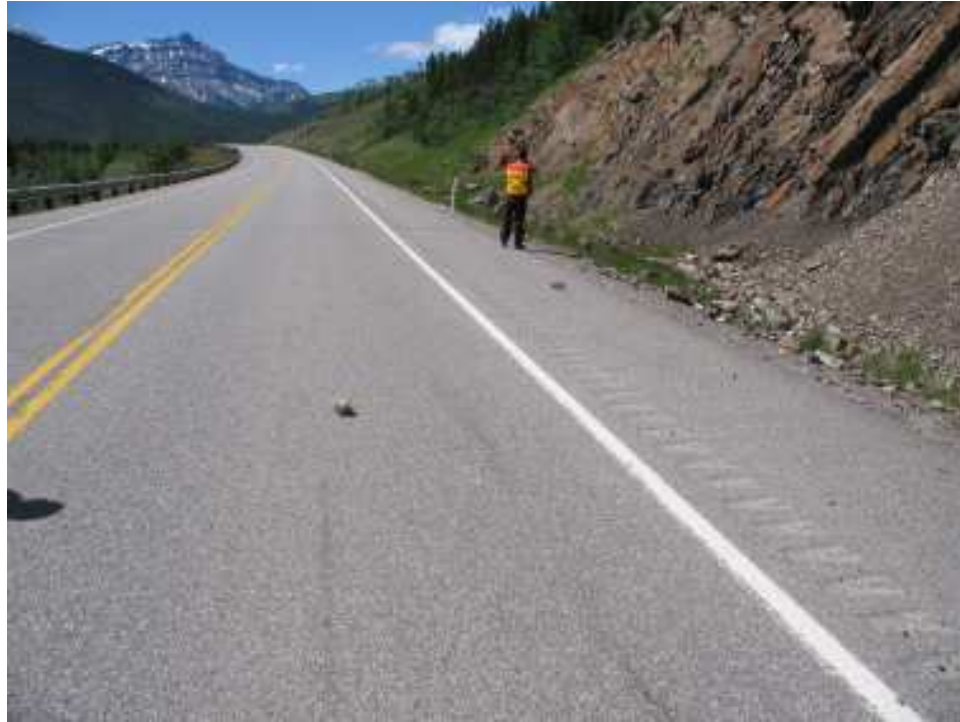
Photo S20-7 – June 2007 (upper left)
Baseball sized rock noted in the middle of the westbound lane at the time of the June 2007 site inspection.

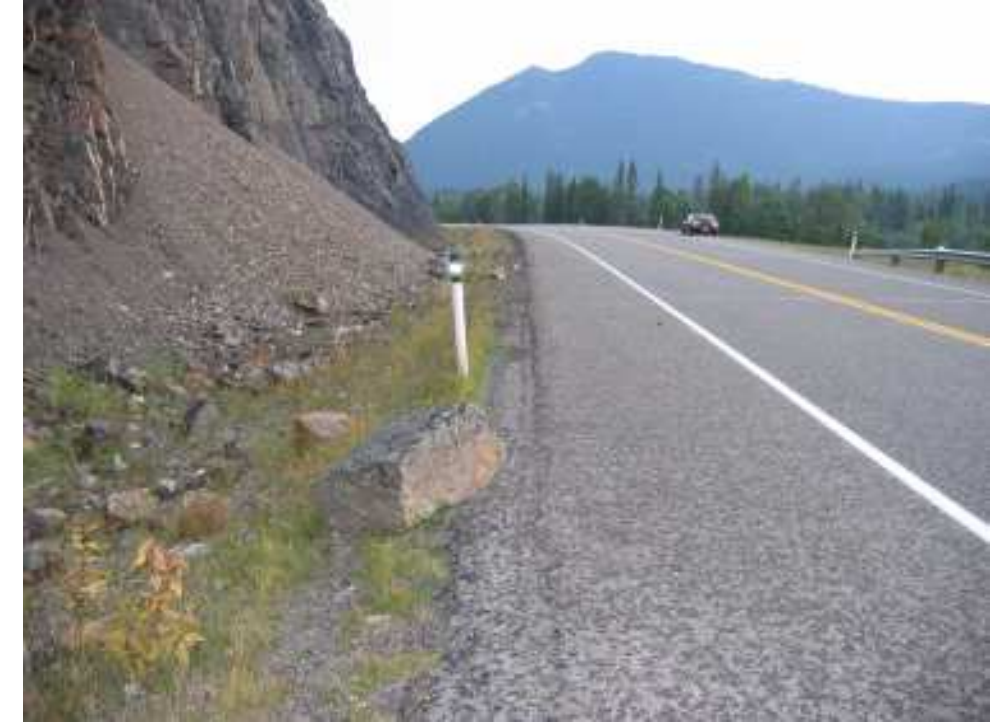
Photo S20-8 – August 2004 (upper right)
Boulder sized rockfall debris deposited along the north edge of the pavement in the central/west portion of the site.
