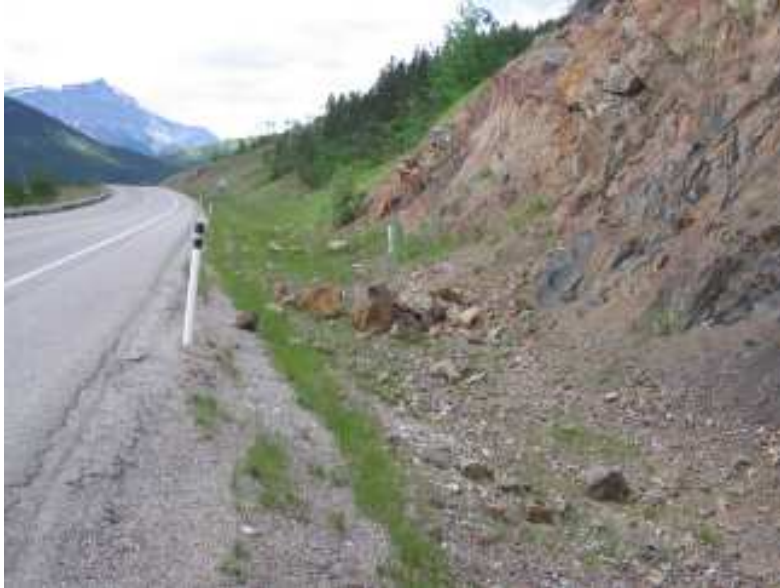
Photo S20-1 (top) – June 2008
Facing westbound across the far west end of the site. Note the boulder sized debris that has fallen into the ditch.

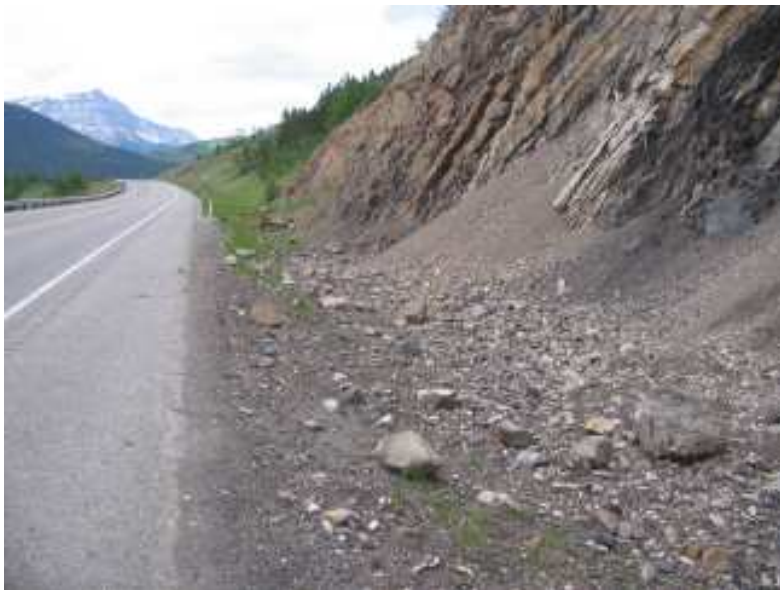
Photo S20-2 (bottom) – June 2008
Another view facing westbound from the west end of the site and from below the gully/chute in the slope above the crest of the cut. Note the accumulation of rockfall debris in the ditch, including cobble sized rocks near the edge of the pavement. Several gravel sized rocks were found on the pavement during the 2008 inspection, and during previous inspections up to cobble sized rocks were noted on the pavement.

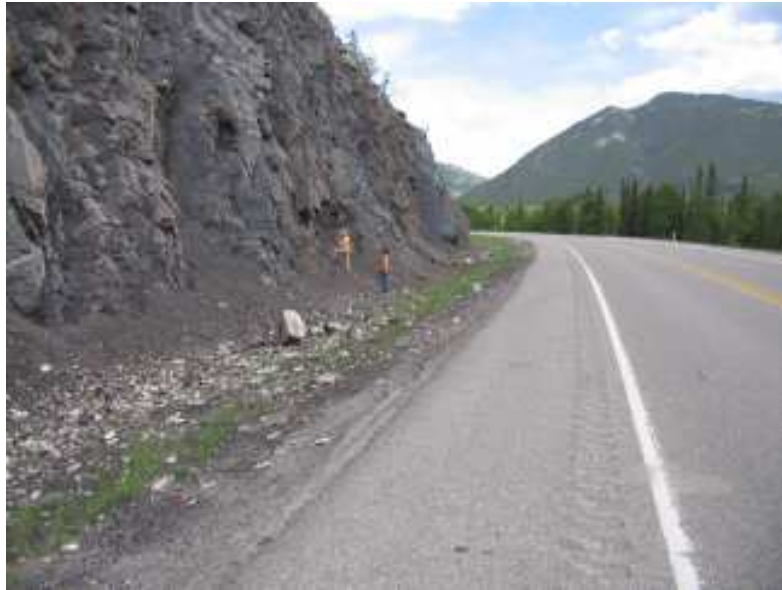
Photo S20-3 (top) – June 2008
Facing eastbound from the central portion of the site, showing the accumulation of rockfall debris in the ditch east of the area below the chute.

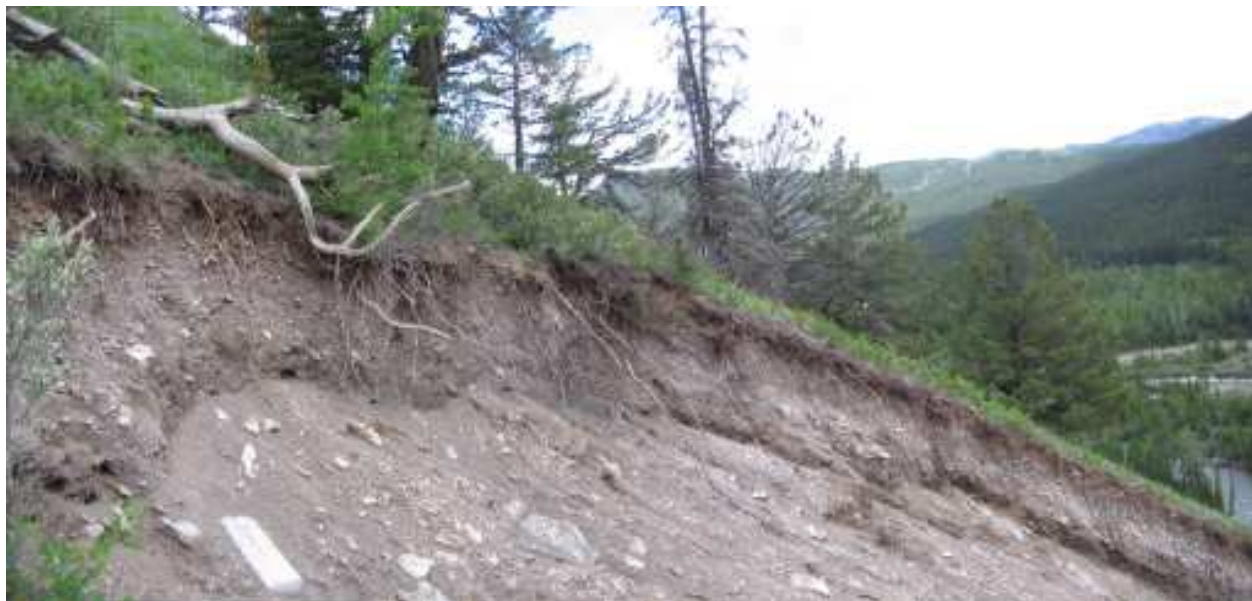
Photo S20-4 (bottom) – June 2008

This eroding soil face at the head of the chute/gully above the rock cut slope appears to be the source of some of the rockfall.

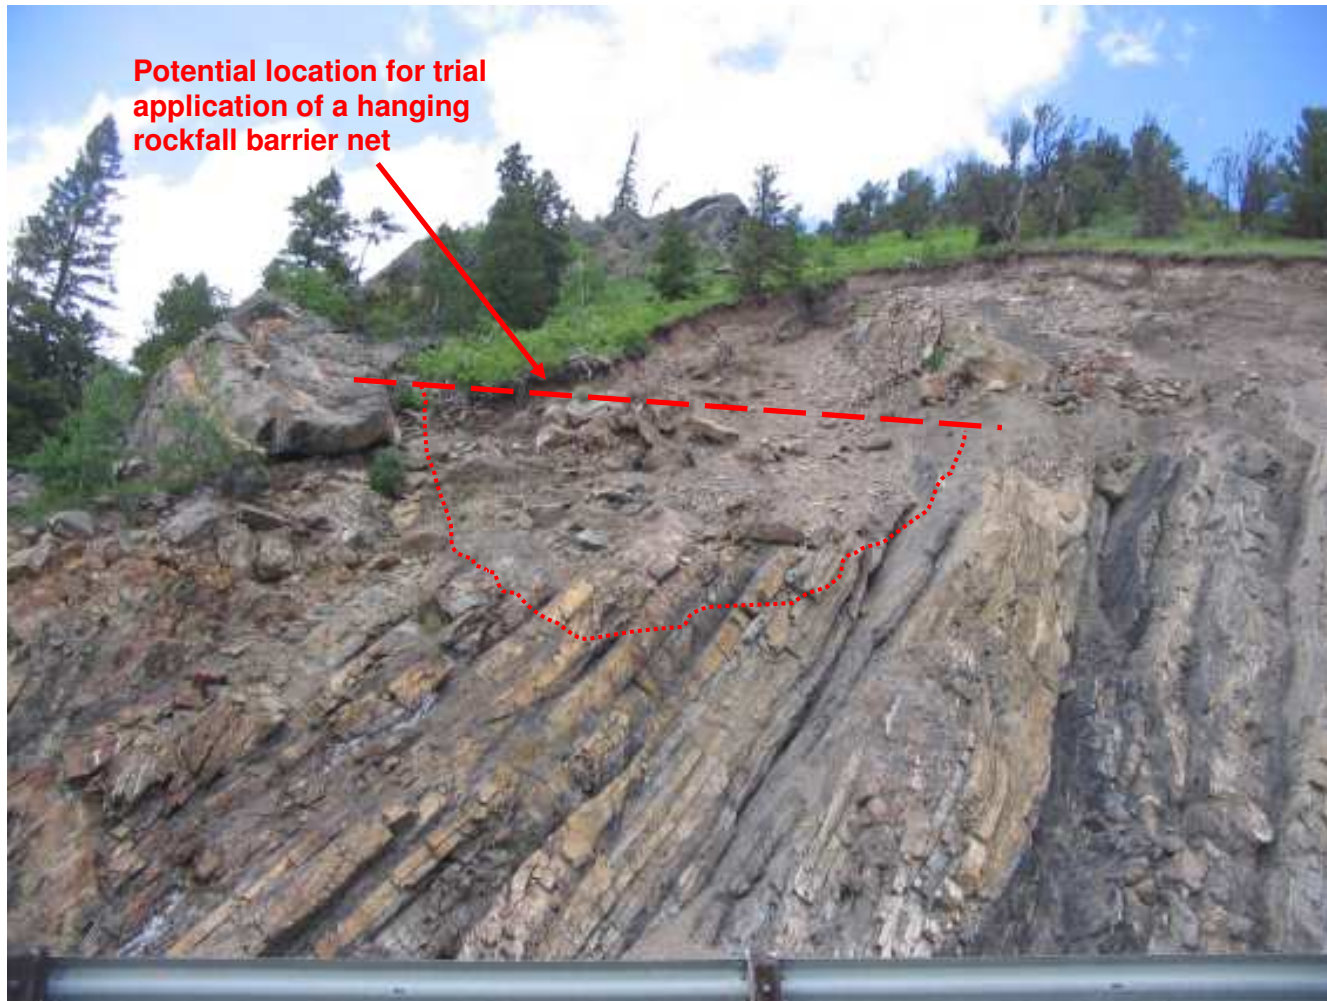
Photo S20-5 – June 2008

Facing the east/central portion of the cut slope, with the eroding gully/chute visible on the slope above. The approximate location for the trial application of a Trumer Schutzbauten brand hanging rockfall barrier net along the crest of the cut slope is shown.
