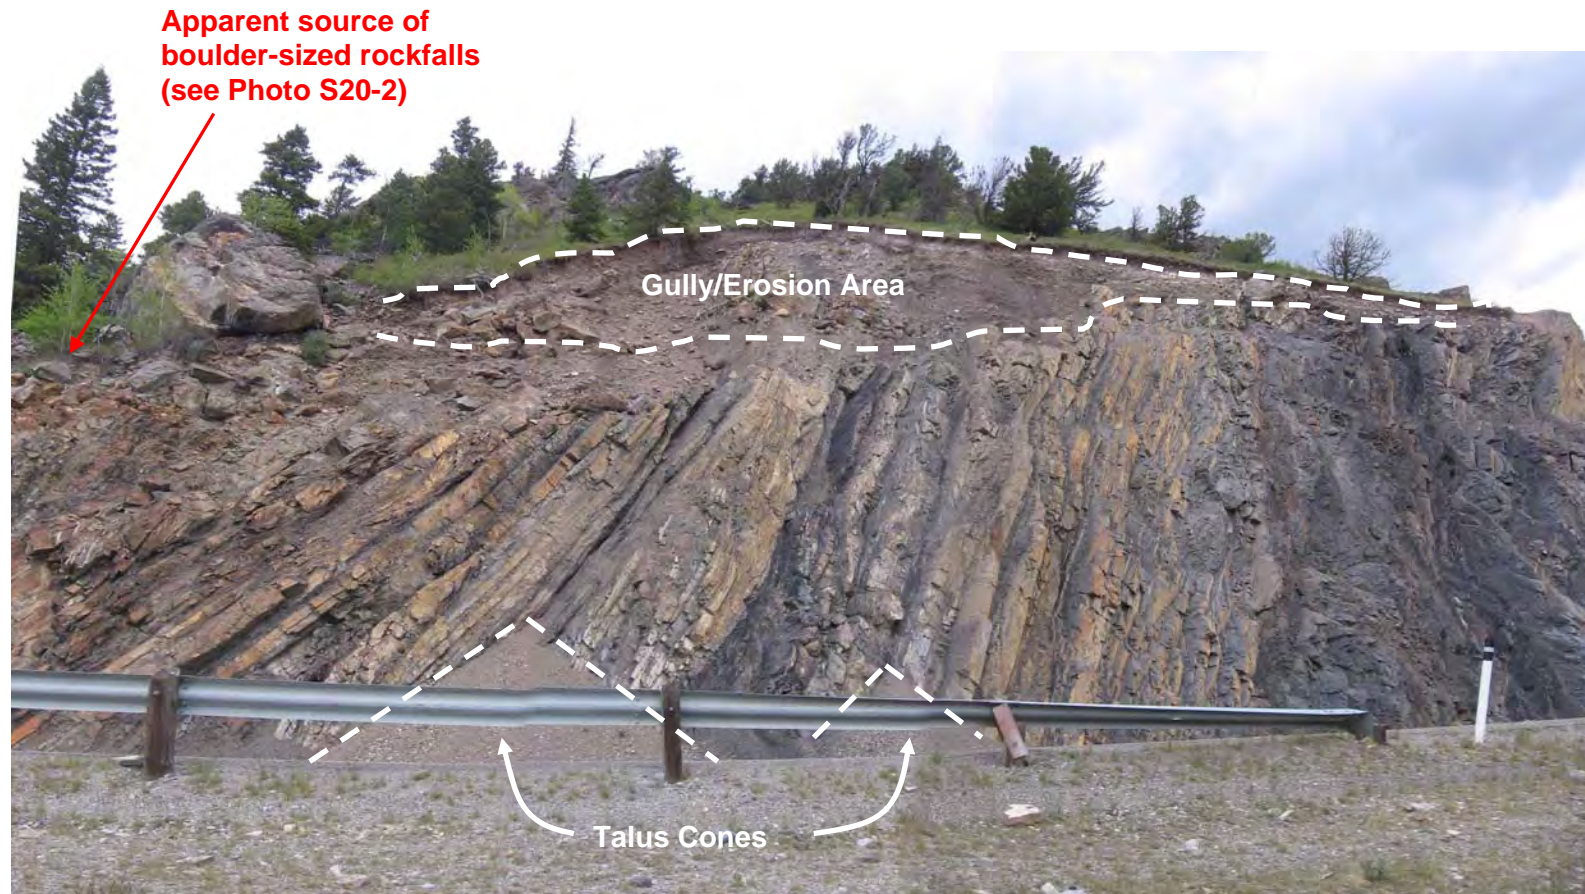
**Photo S20-1 – June 2009**

Facing the cut slope from the opposite side of the highway. Note the gully eroding into the rocky soil on the natural slope above the crest of the highway cut slope. Note also the talus cones that have accumulated in the upslope ditch below the gully.

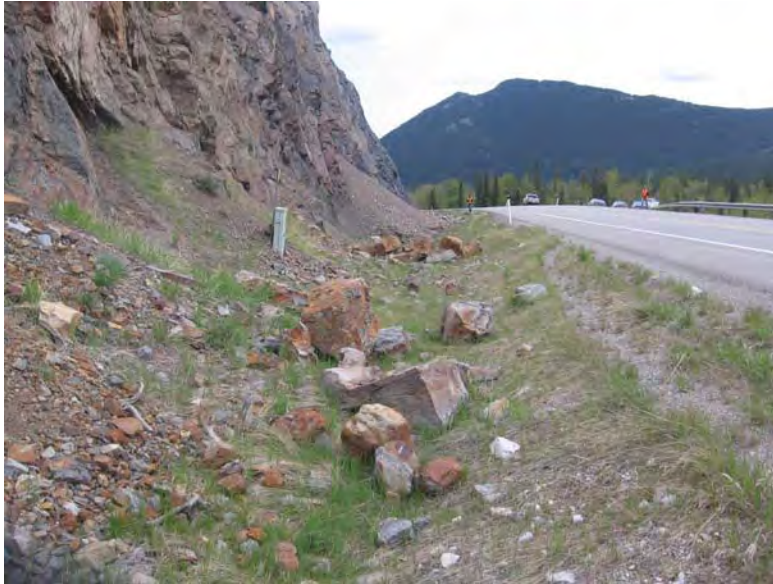
**Photo S20-2 (top) – June 2009**

Facing eastbound along the ditch at the far west end of the site. Note the boulder-sized rockfall debris that has accumulated in the ditch. At least some of these boulders appeared to have fallen since the June 2008 inspection (based on comparison of the June 2008 and June 2009 inspection photos).

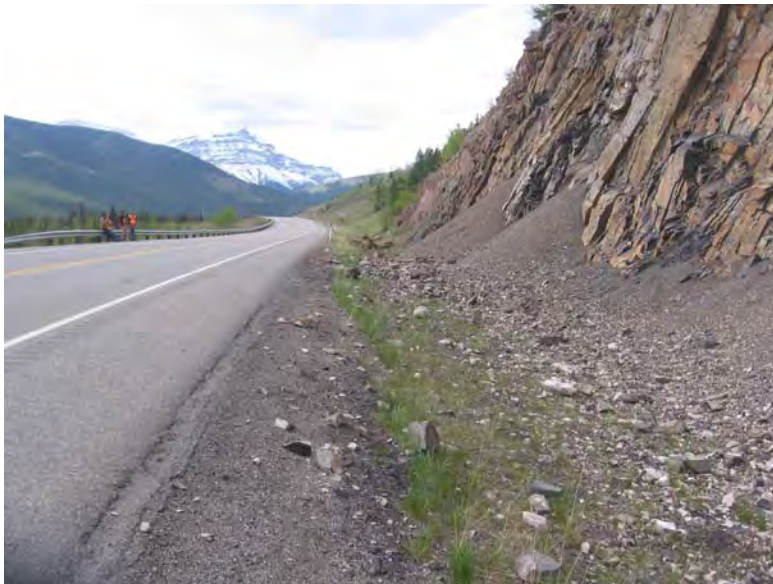
**Photo S20-3 (bottom) – June 2009**

Facing westbound across the central portion of the site, below the eroding gully in the natural slope above the crest of the cut slope (see Photo S20-1 for illustration). Note the large talus cones that have accumulated below the gully, indicating that the largest volumes of rockfall debris originate from the gully area.
