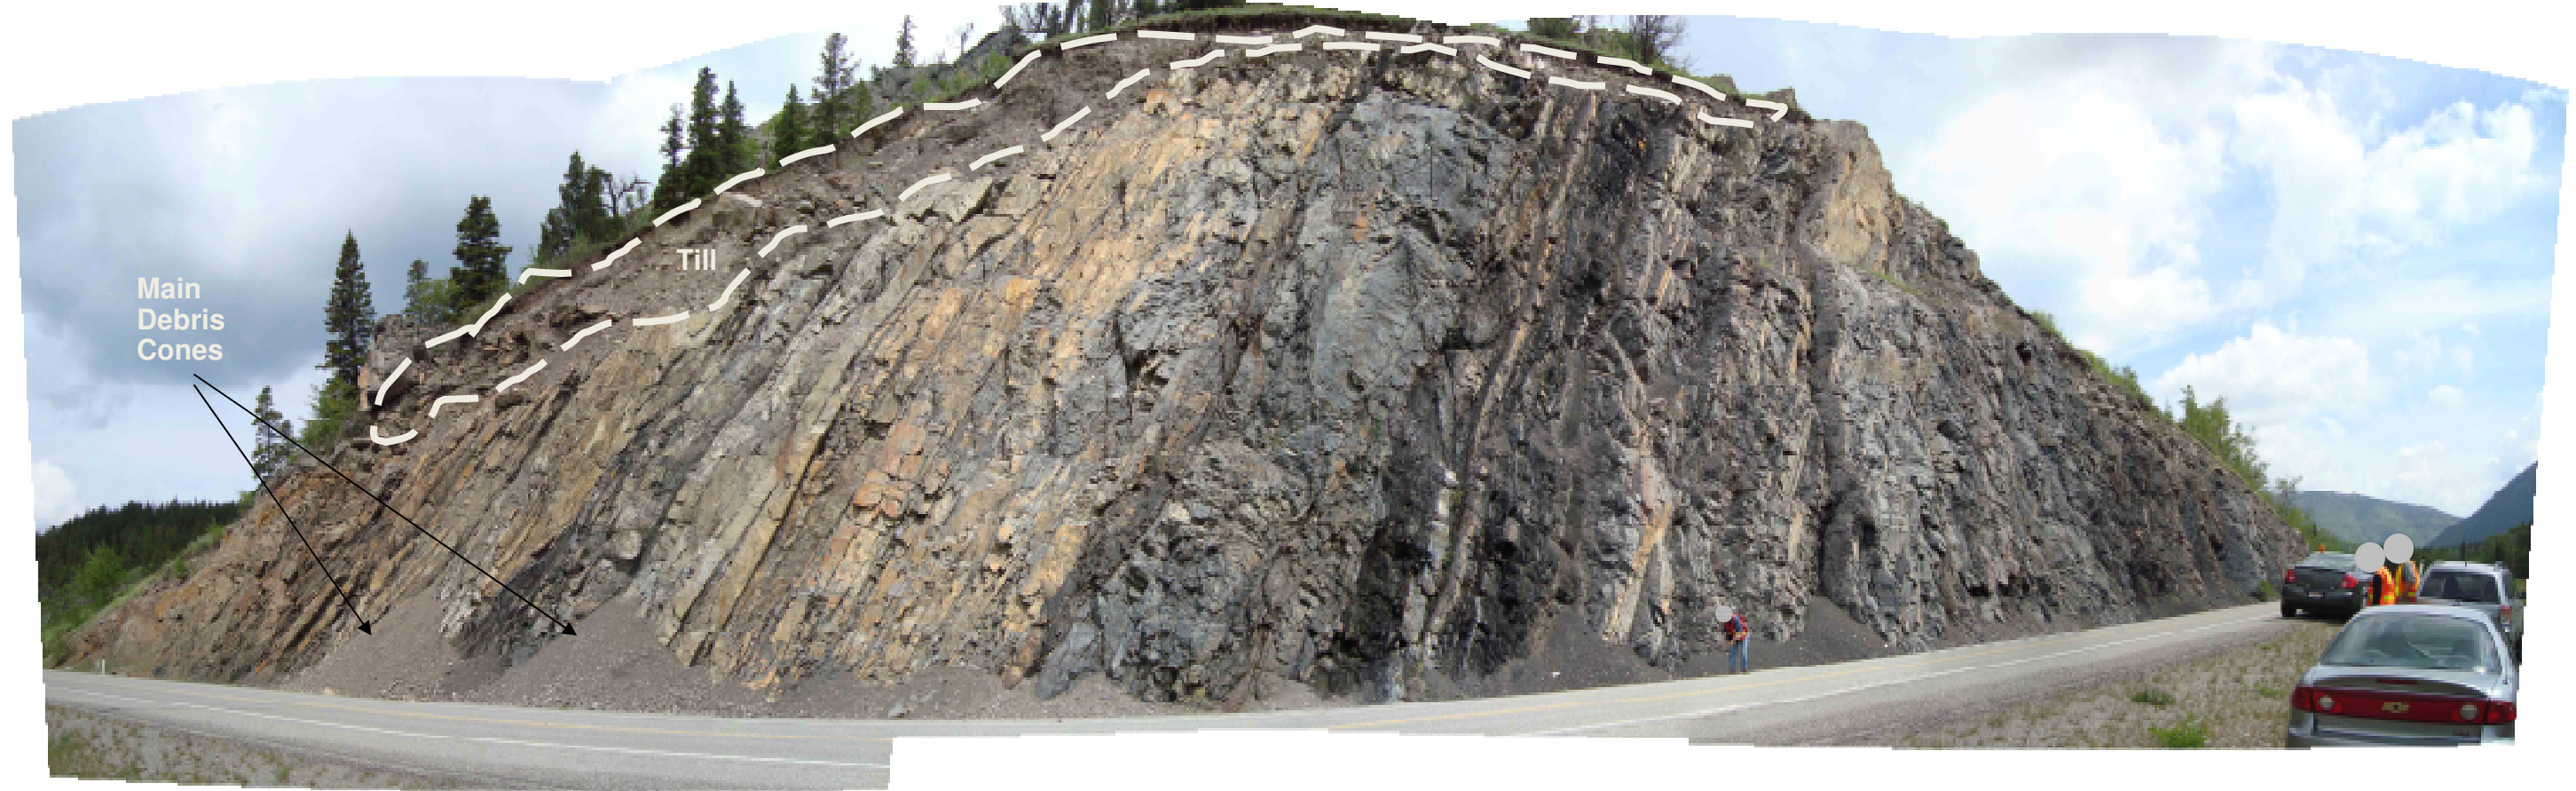
Photograph S20-1- Stitched photographs of cut slope taken from south side of the highway, with till soil layer and main debris cones marked.

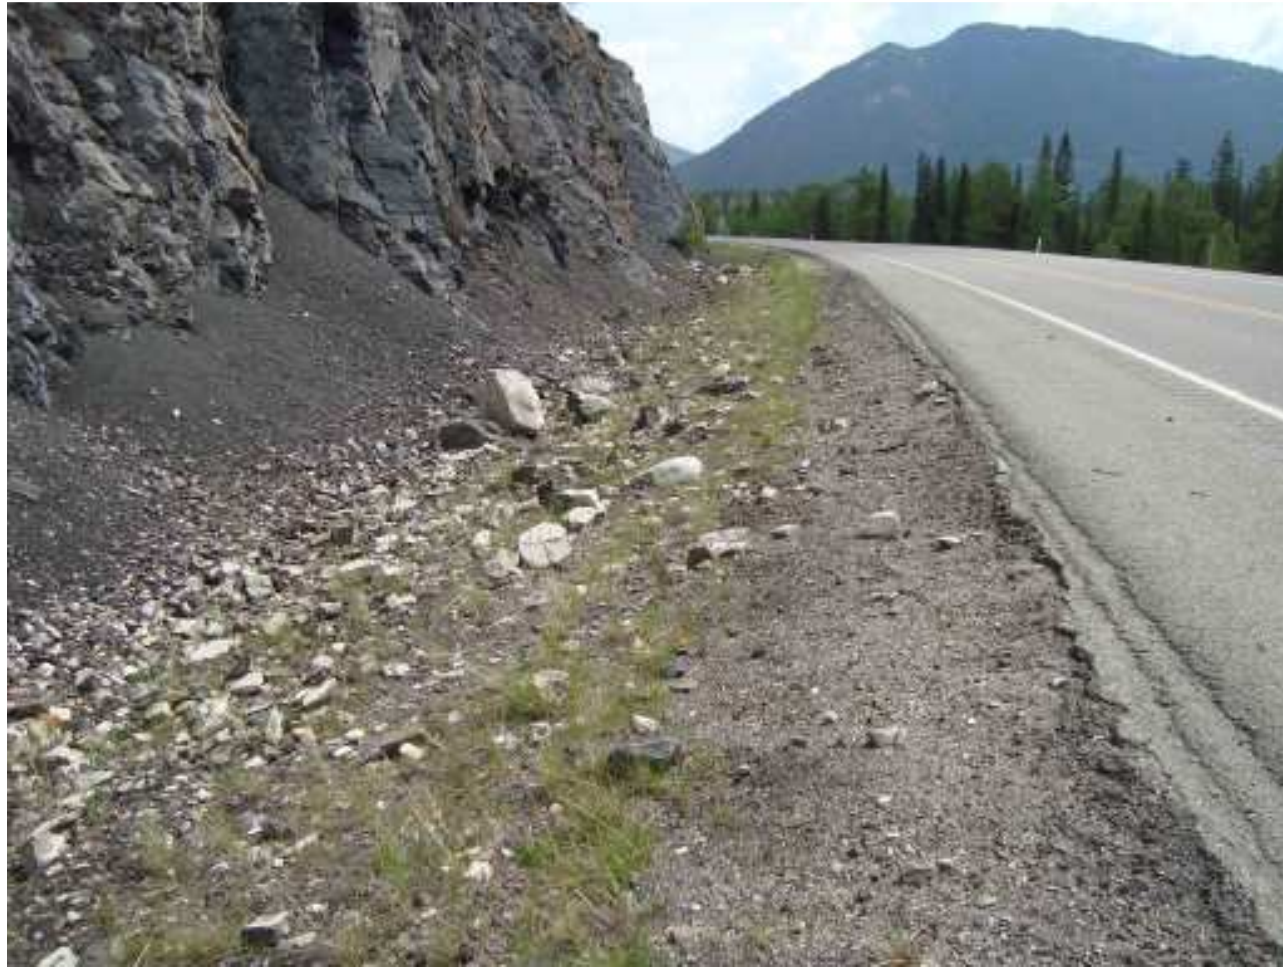
Photograph S20-2 – Looking eastbound along the north ditch. Rock fall includes gravel to cobble sized rocks, with gravel on the paved shoulder and cobbles immediately adjacent to the paved surface. Boulder sized rocks are also present in the ditch, and during past inspections have been noted at positions along the edge of the pavement.

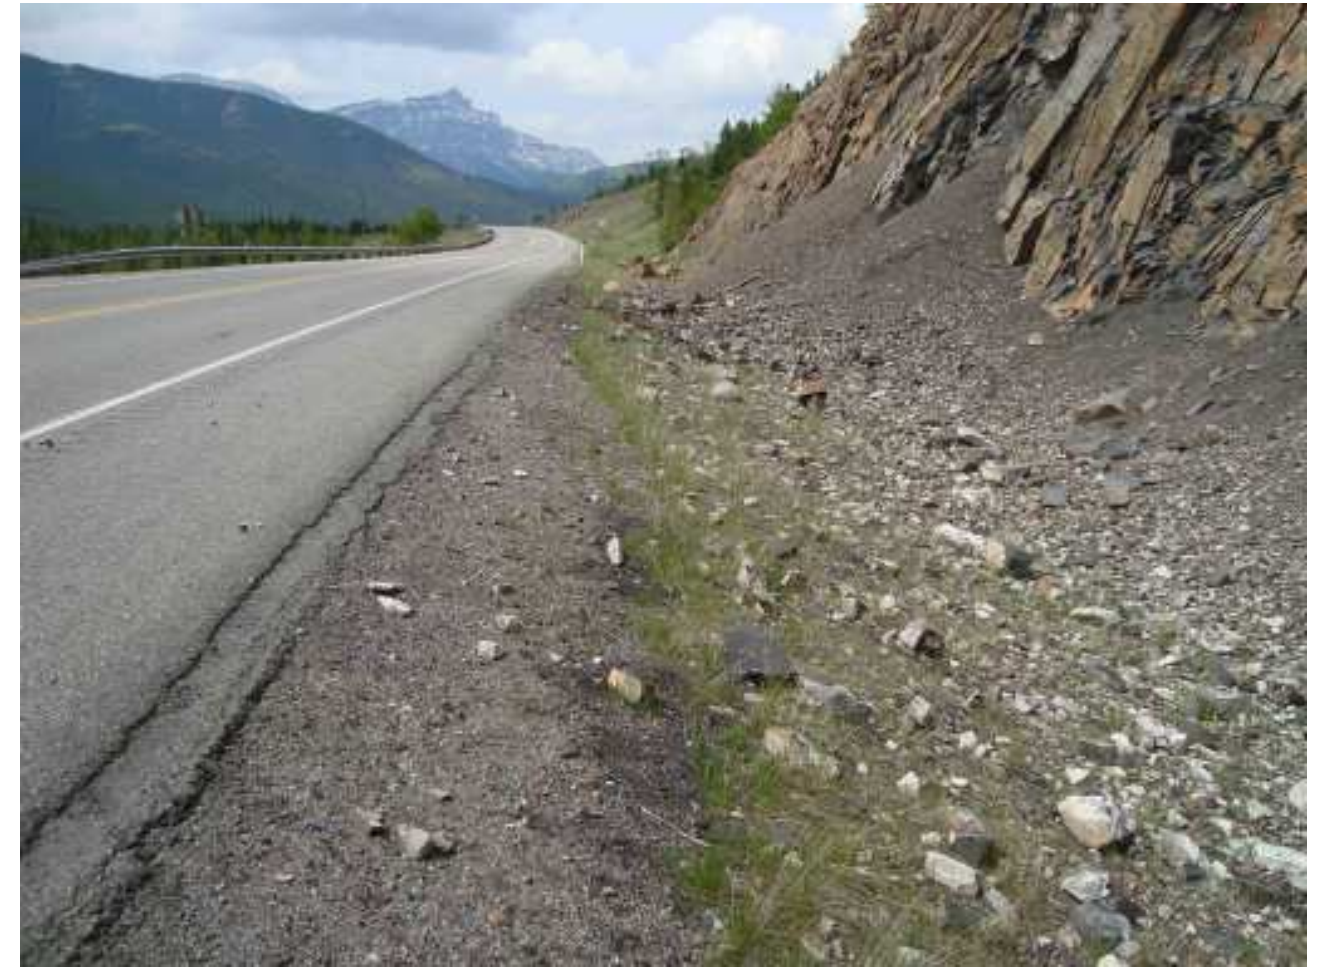
Photograph S20-3 – Looking westbound along the north ditch. Note the large boulders that have rolled down the main debris cones to within 2 m of the paved surface at the time of the June 2010 inspection.
