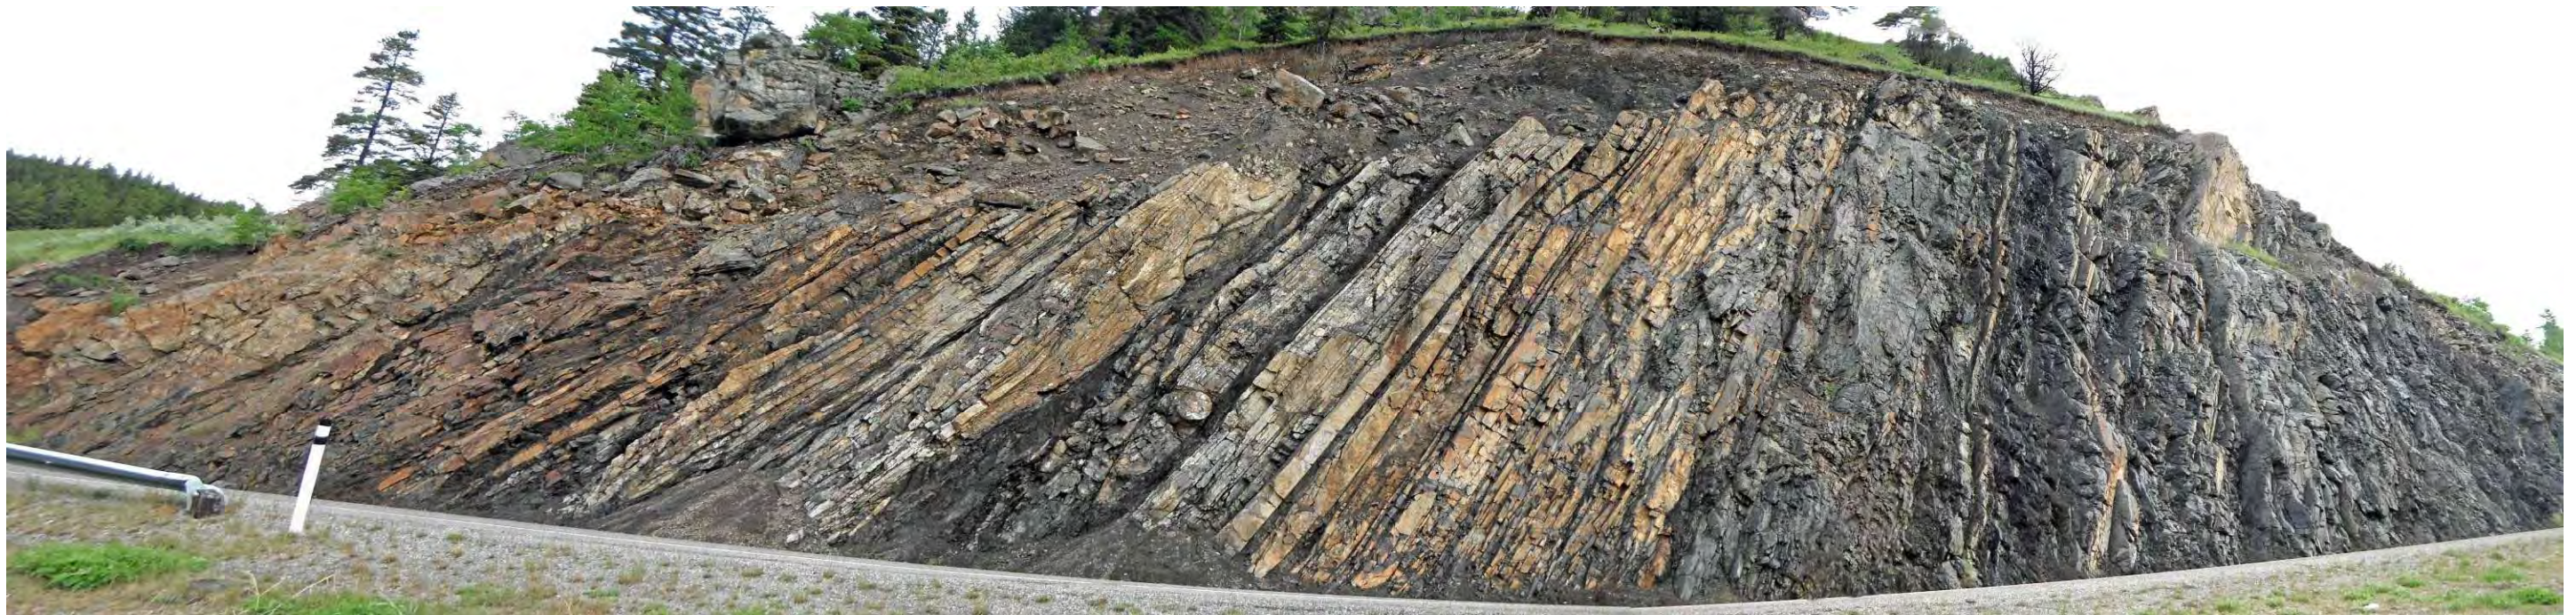
Photograph S20-1 – June 2012

Stitched photographs of cut slope taken from south side of the highway. Image is slightly distorted horizontally due to image processing.

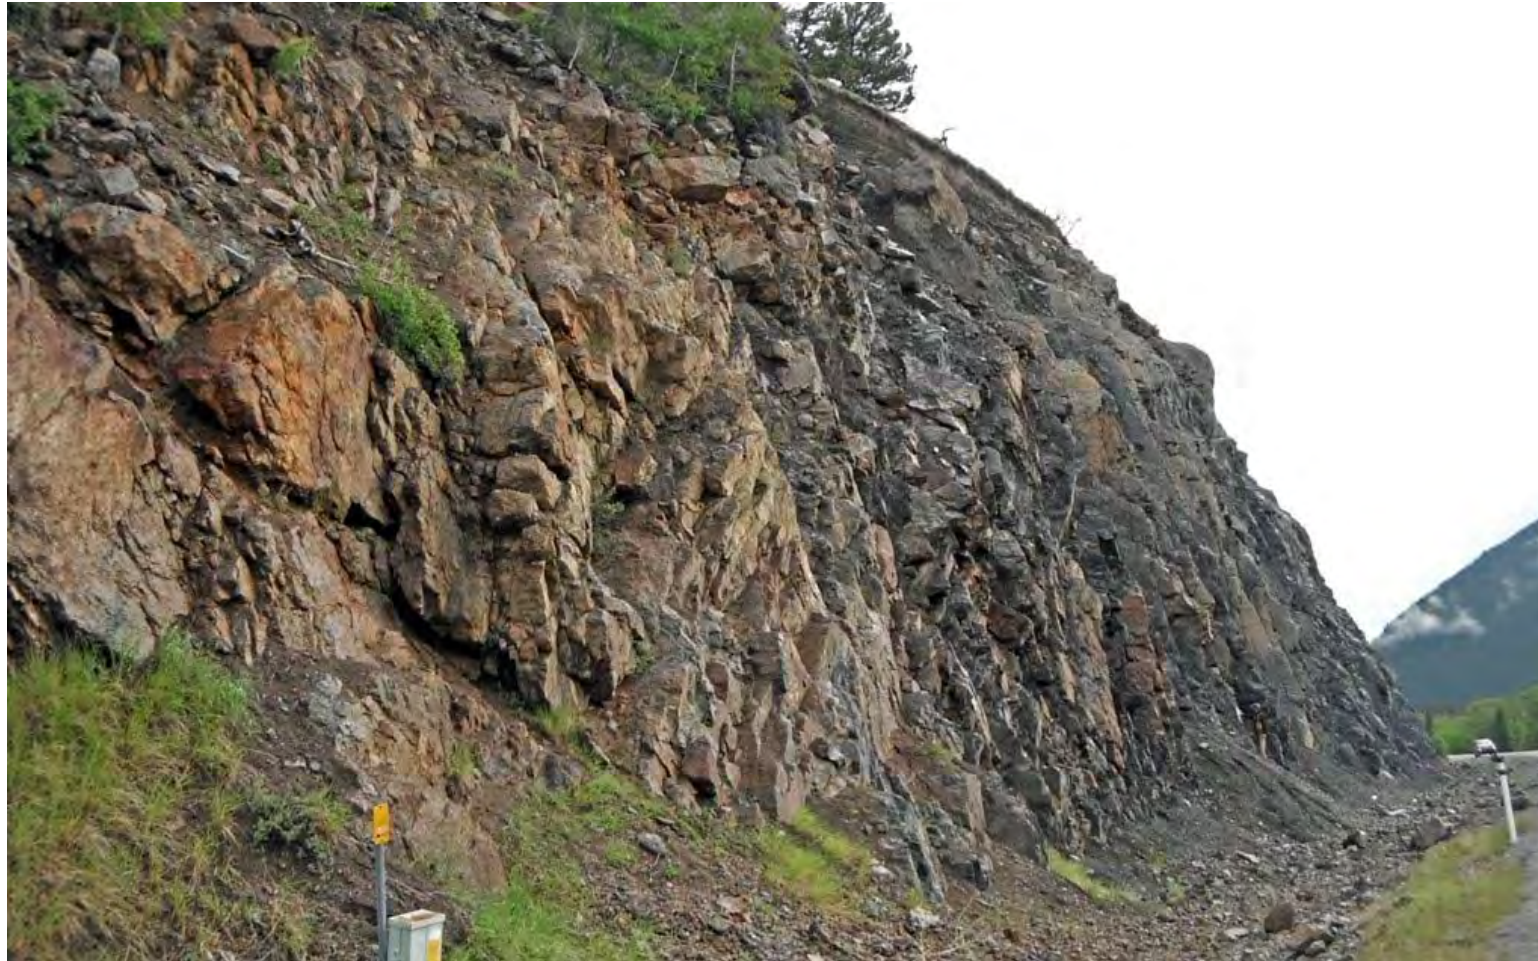
Photograph S20-2 – June 2012

Looking eastbound along the north ditch. Rock fall includes gravel to cobble sized rocks, with gravel on the paved shoulder and cobbles immediately adjacent to the paved surface. Boulder sized rocks are also present in the ditch.

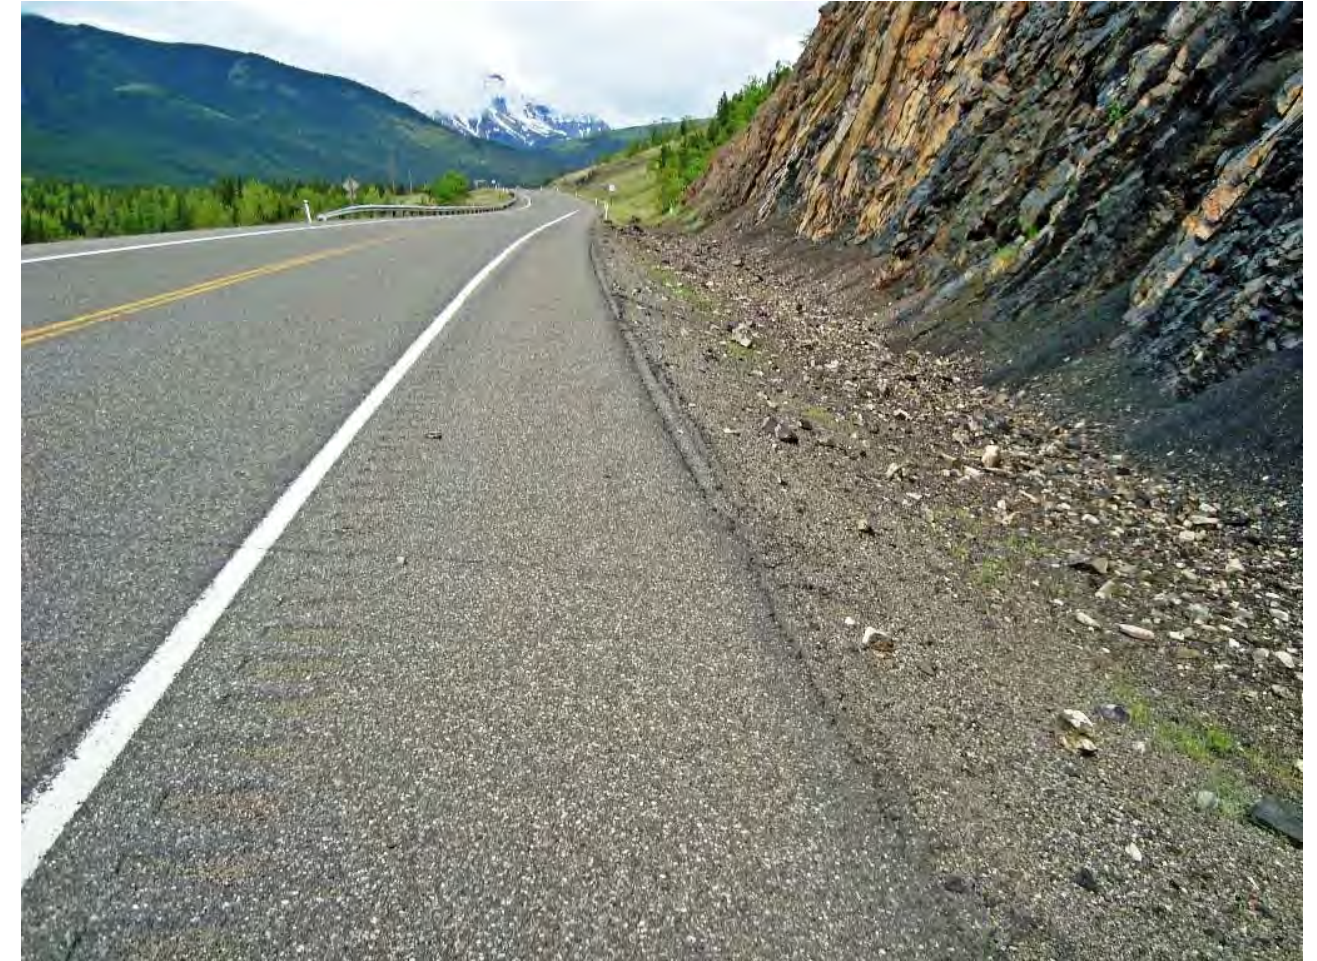
Photograph S20-3 – June 2012

Looking westbound along the north ditch. Ditch cleaning since the 2010 inspection has reduced the size of the debris cones.
