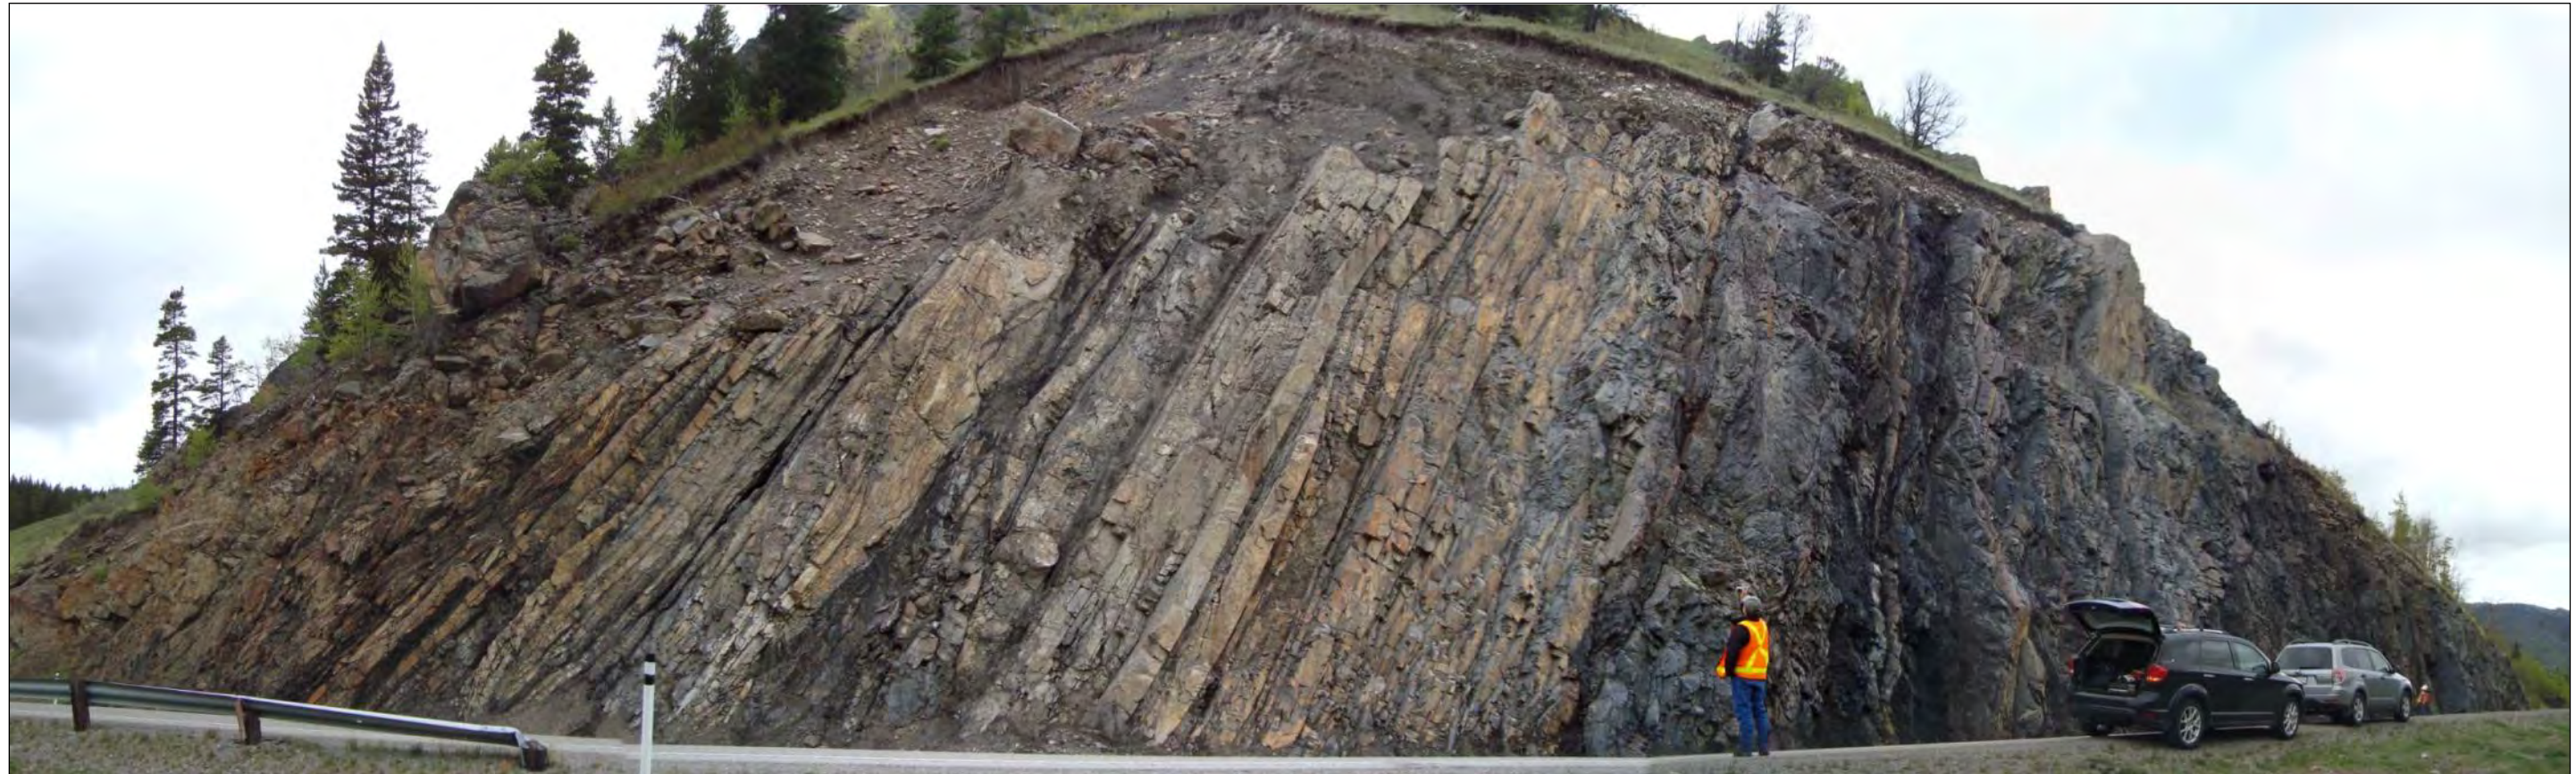
Photograph S20-1 – May 2013

Stitched photographs of cut slope taken from south side of the highway. Image is slightly distorted horizontally due to image processing.

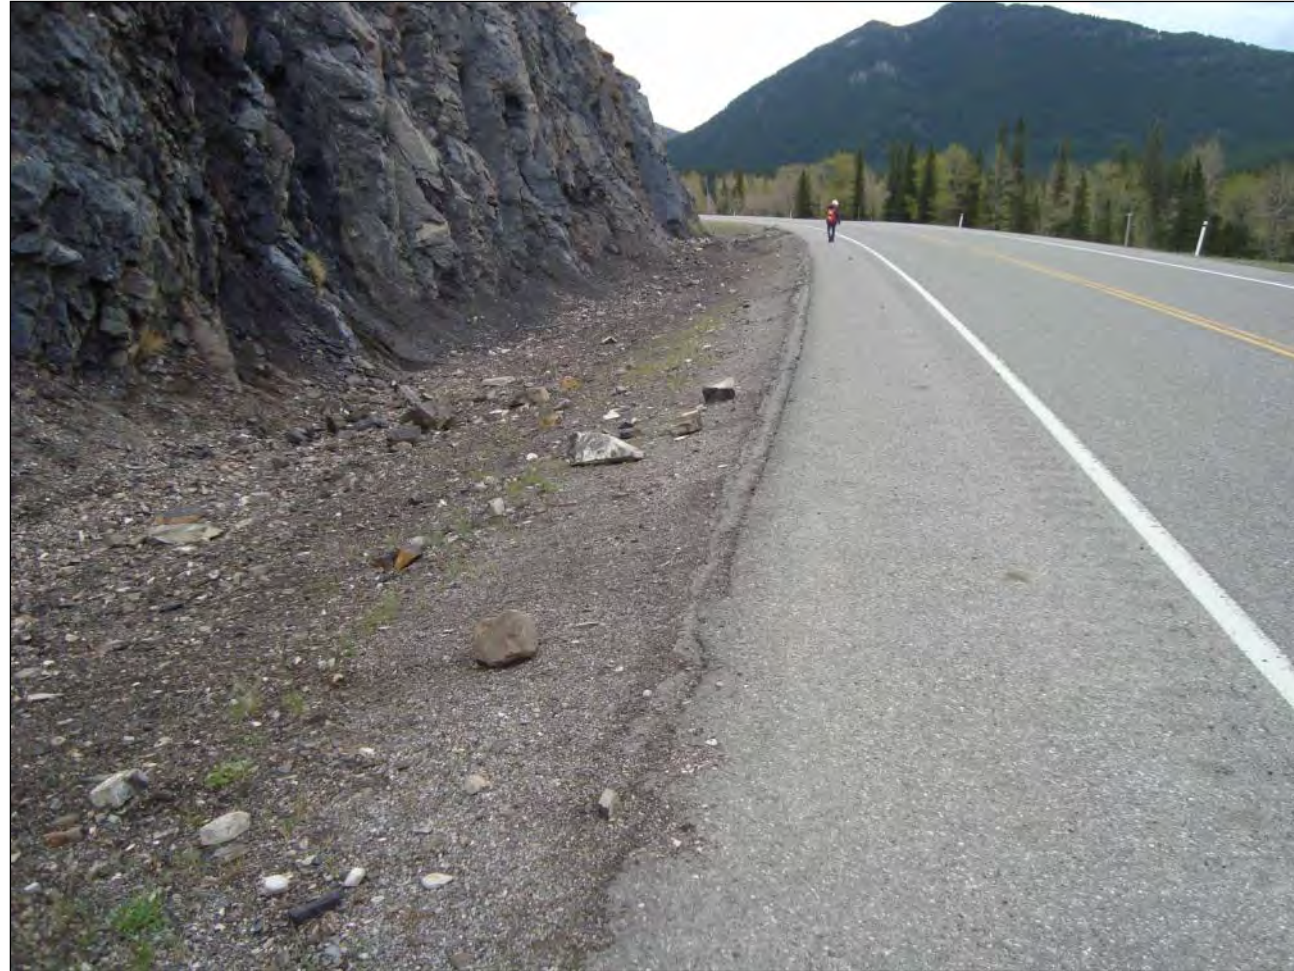
Photograph S20-2 – May 2013

Looking eastbound along the north ditch. Rock fall includes gravel to cobble sized rocks, with gravel on the paved shoulder and cobbles immediately adjacent to the paved surface. Boulder sized rocks are also present in the ditch.

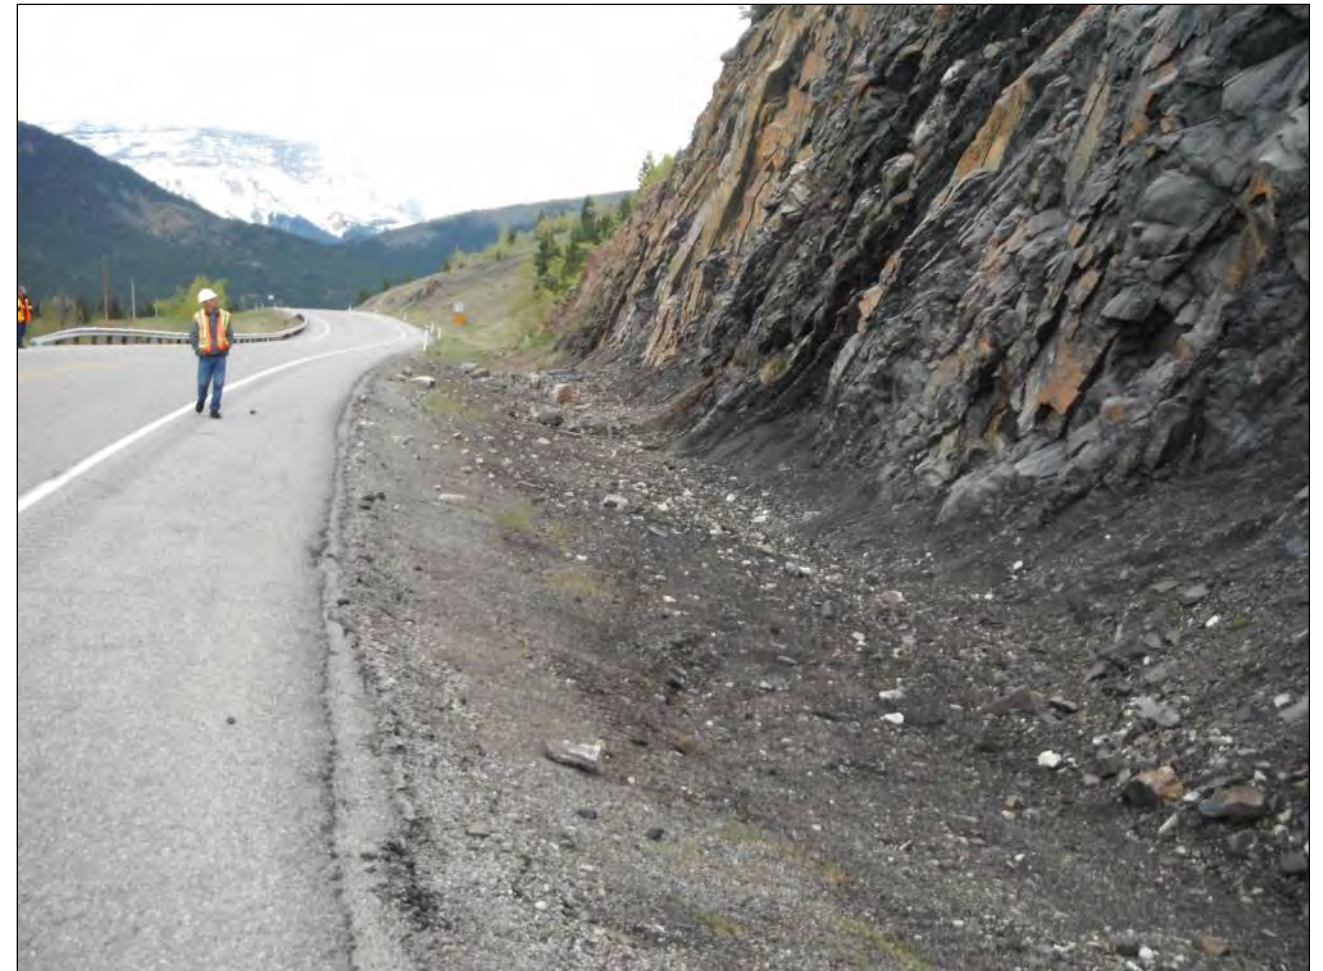
Photograph S20-3 – May 2013

Looking westbound along the north ditch. Ditch cleaning since the 2010 inspection has reduced the size of the debris cones.
