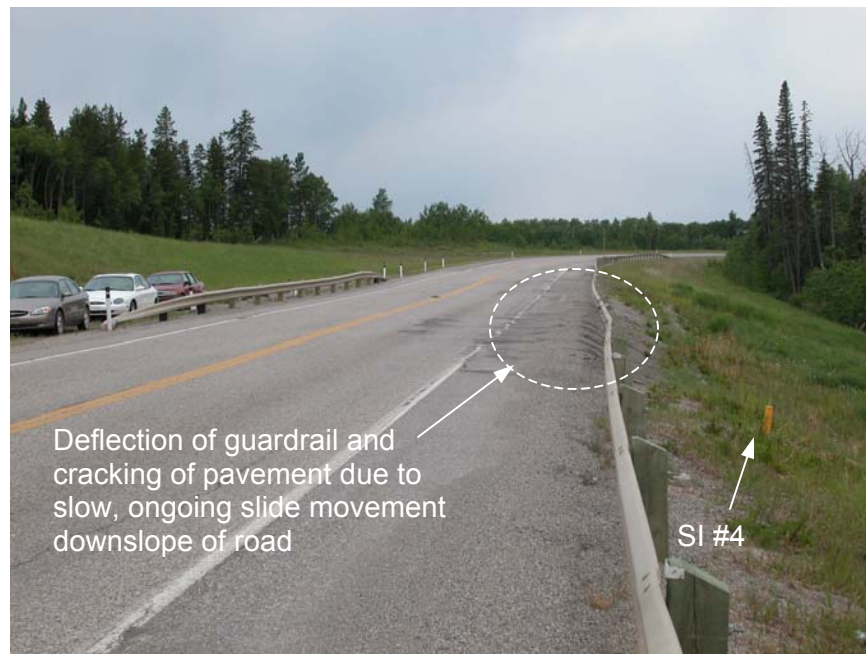
**Photo 1** (upper left) – July 2003  
Facing west along the downslope edge of the road through the slide area. The existing pile wall is located just to the left of the guardrail. Note the deflection of the guardrail and cracking of the road due to ongoing, slow movement of the landslide below the road – appears to be worse than noted in May 2002 (Photo 2). The north shoulder of the road (adjacent to the guardrail) required patching in the summer of 2002 and was scheduled for repaving again later in the day that this photo was taken (July 8, 2003).

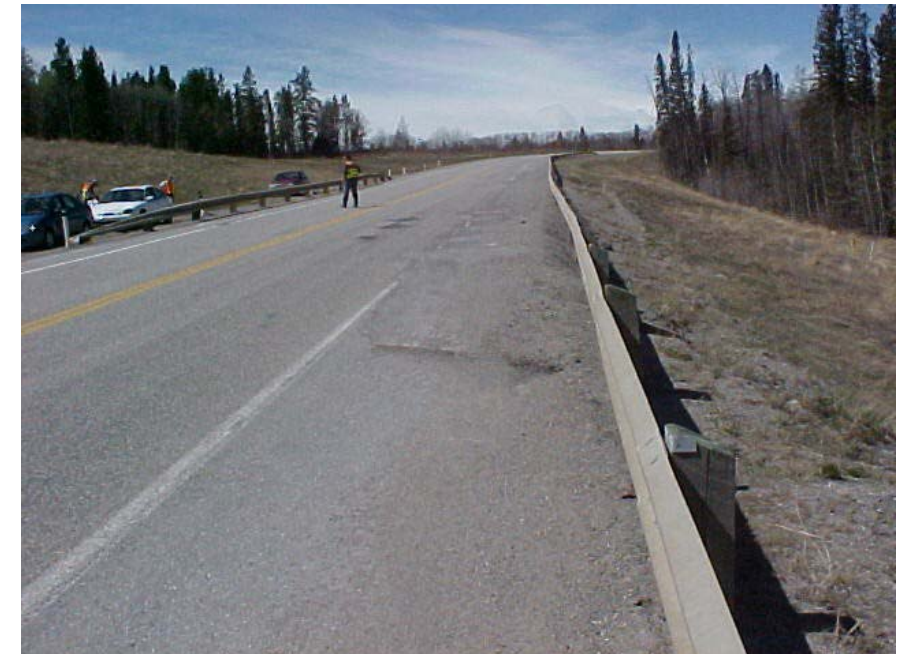
**Photo 2** (upper right) – May 2002  
Same area as Photo 1, as seen during the May 2002 inspection.

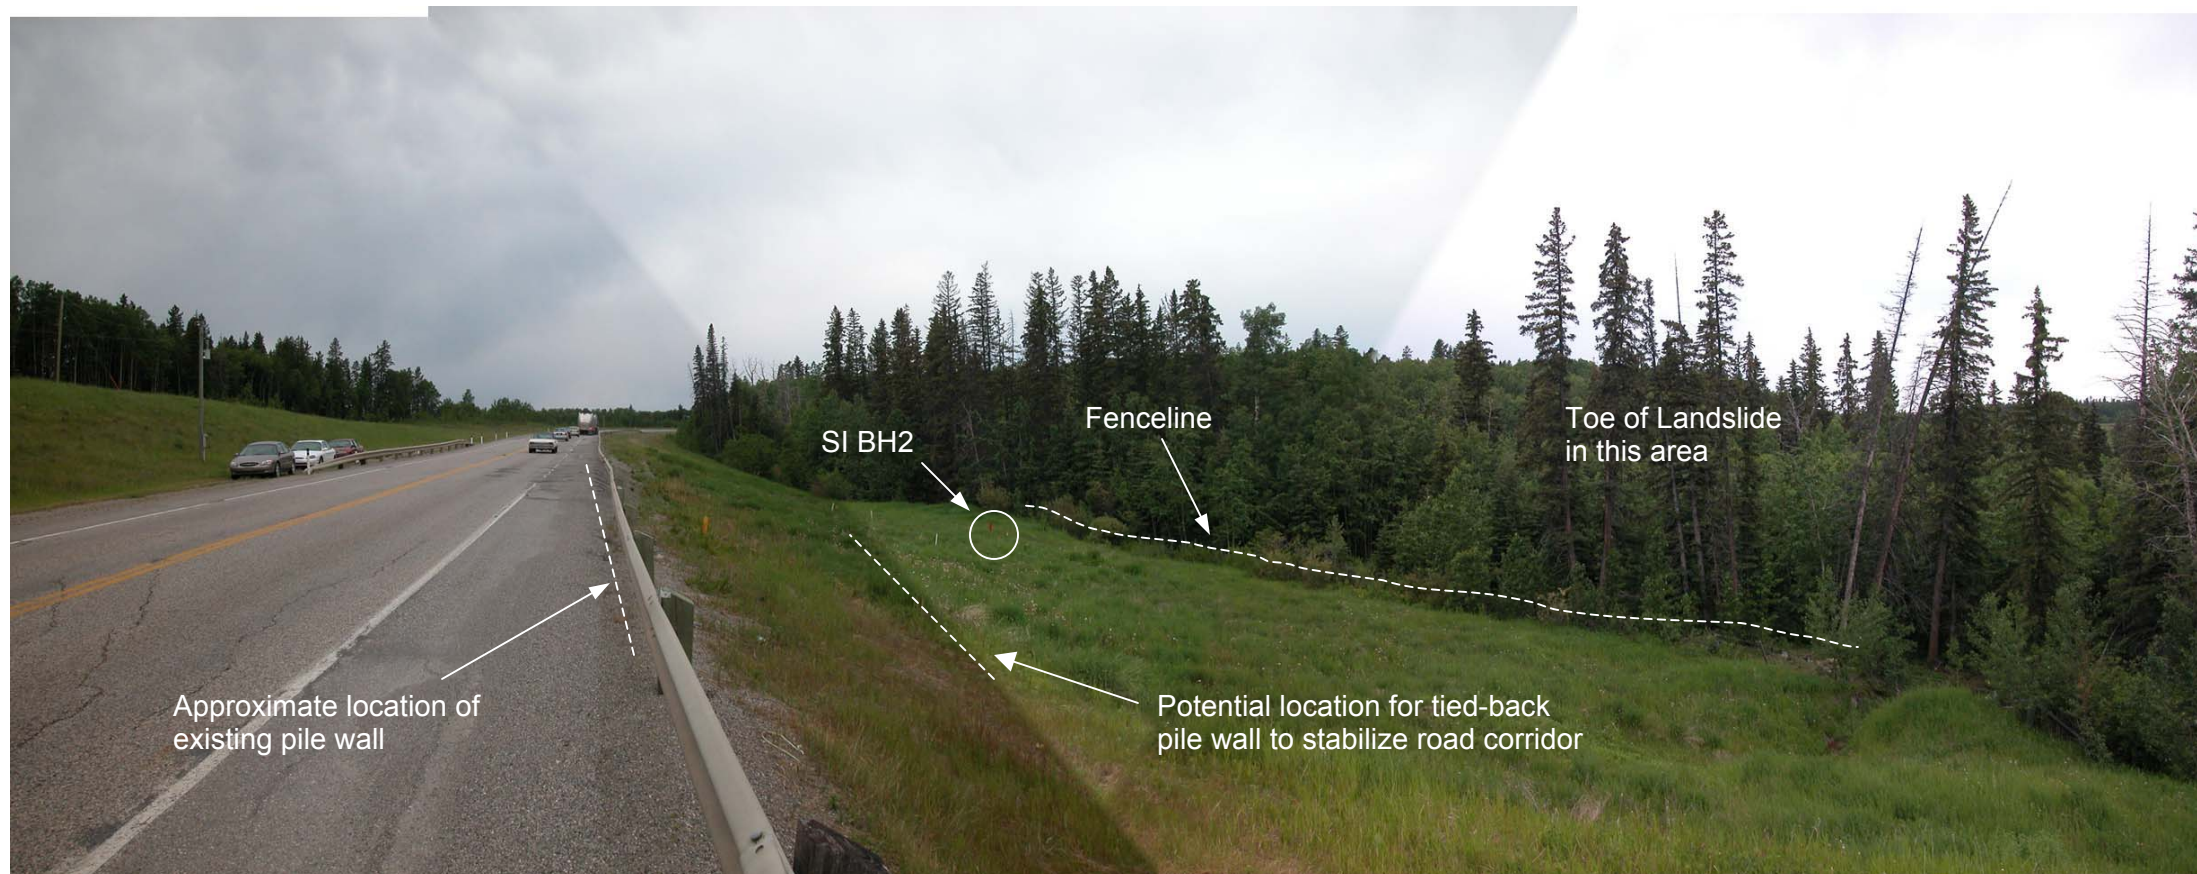
**Photo 3** (left) – July 2003  
Wide view of the site showing the landslide area below the road. The SI in BH2 near the fenceline is showing active slope movement at 5.75 m depth. This SI is the only remaining functioning SI in the lower portion of the slope. Additional SI's should be considered around the toe of the slope/fenceline to replace the other SI's in this area that have sheared off. The overall toe of the landslide is in the forested area north of the fenceline.

The 2001 site investigation and preliminary stability analysis indicated that a pile wall installed on the slope below the road and tied back into the bedrock underlying/upslope of the road would be the most effective mitigative

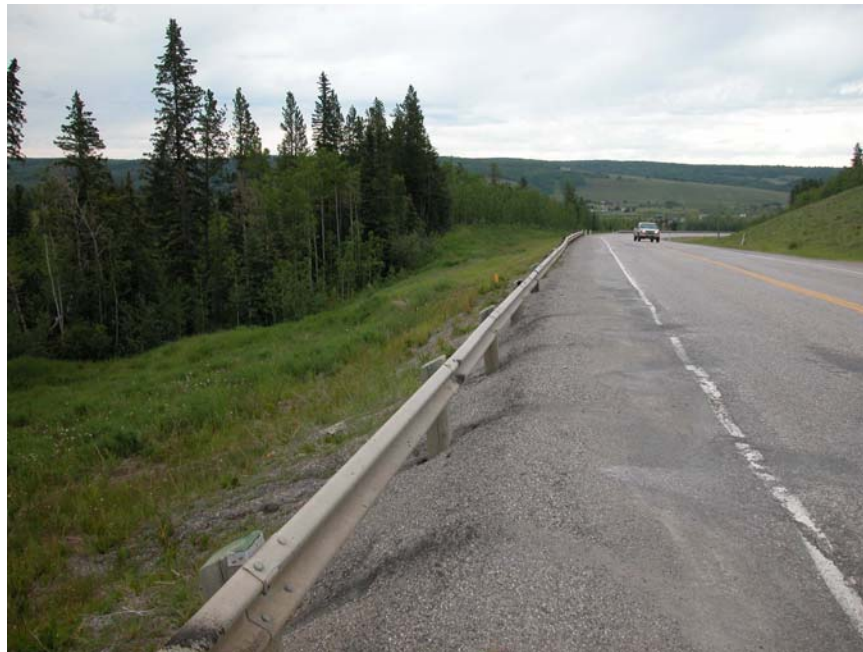
**Photo 4** (upper left) – July 2003  
Facing east along the north shoulder of the road through the slide area. Note the loss of ground immediately downslope of the guardrail. The existing pile wall along the north shoulder of the road remains partially effective in supporting the shoulder, however ongoing movement of the slide below the road has still resulted in continued settlement and cracking of the road surface and deformation of the guardrail, as shown in Photos 1, 2 and 3.

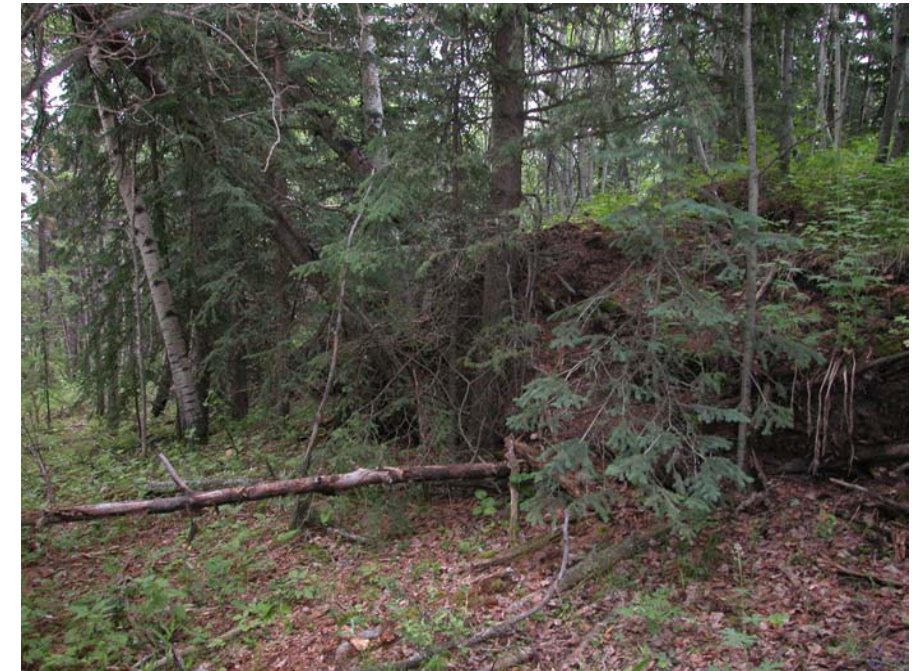
**Photo 5** (upper right) – July 2003  
Displaced and upthrust soil in the toe area of the landslide, in the forested area north of the fence line and approximately 150 m from the road.

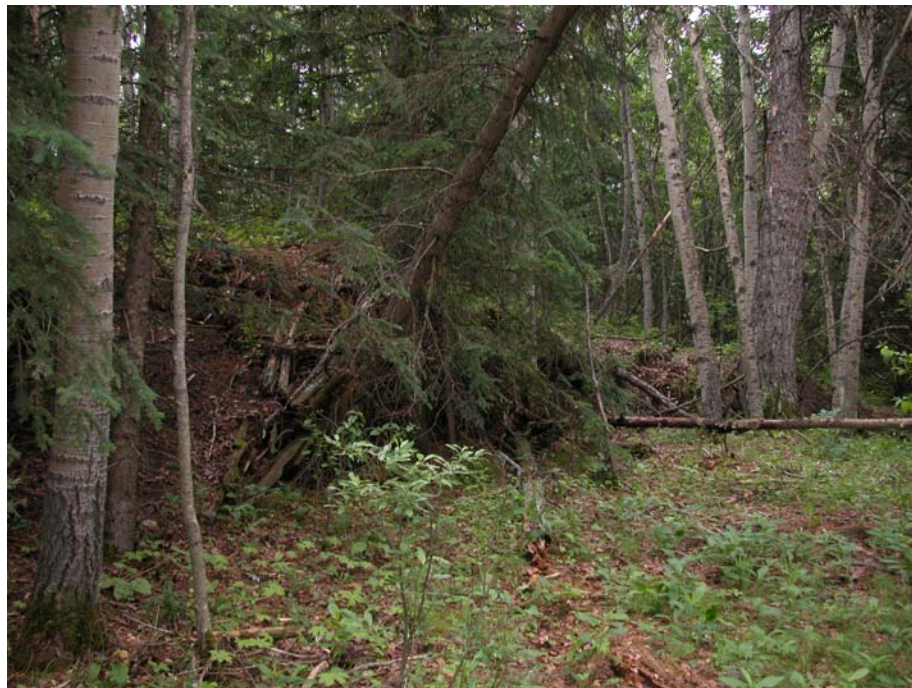
**Photo 6** (lower left) – July 2003  
Another view of the toe area of the landslide, as seen during the July 2003 inspection. Compare with Photo 7, taken in May 2002. It appears that additional movement of the toe lobe and tilting of the trees has occurred.

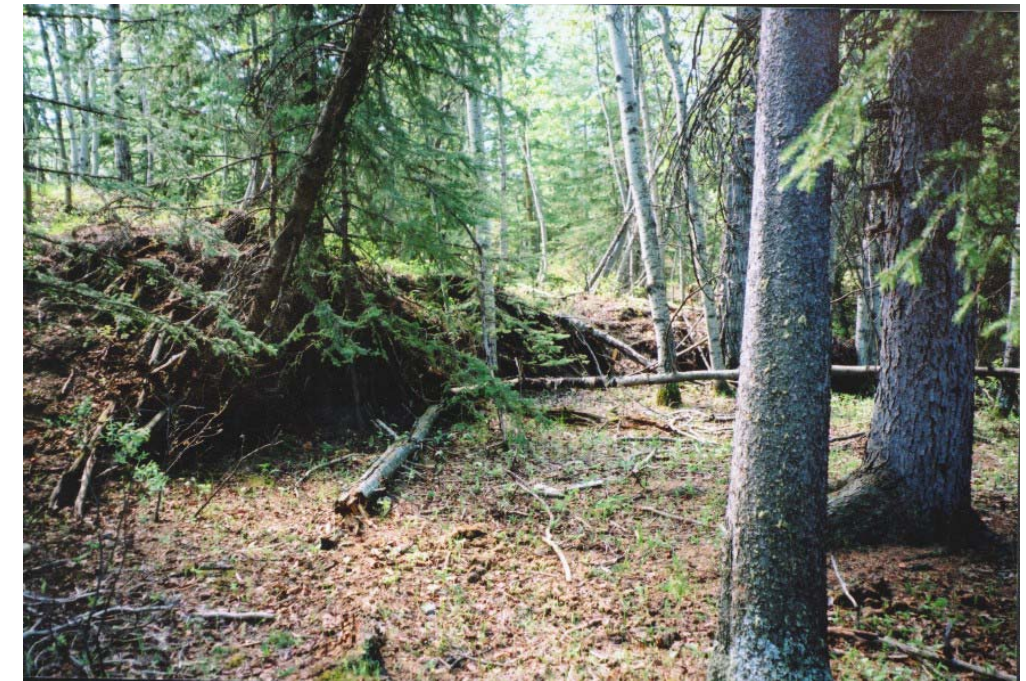
**Photo 7** (lower right) – May 2002  
Same area as Photo 6, as seen during the May 2002 site inspection.
