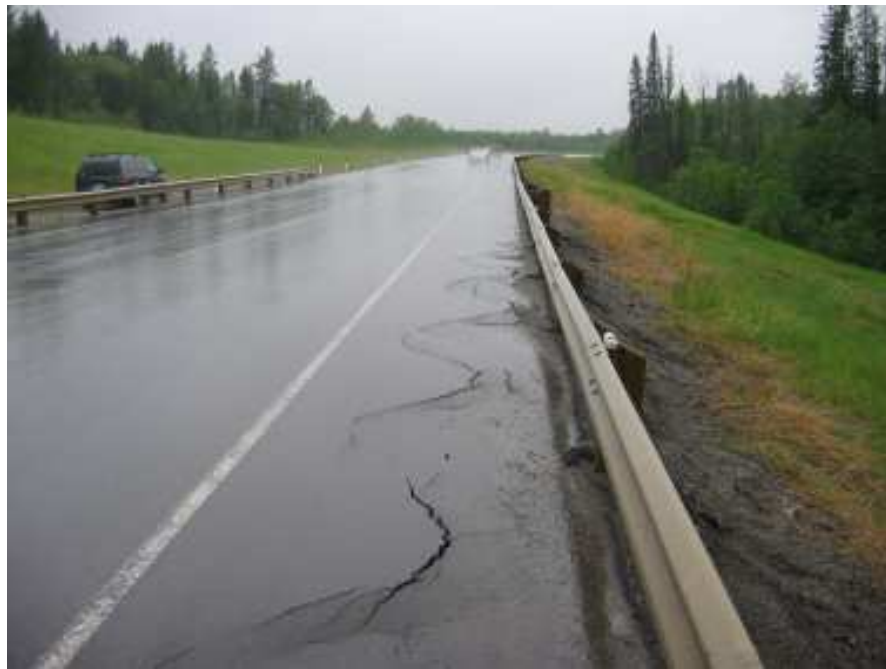
Photo S2-1 (upper left) – June 2005 – Cracking in the westbound lane. Cracking developed between the time of the instrument readings in May 2005 and the annual inspection in June 2005. Based on the pattern of the cracks and settlement down to the north (right hand side of photo), it appears that the existing pile wall is resisting slope movement downslope of the road.

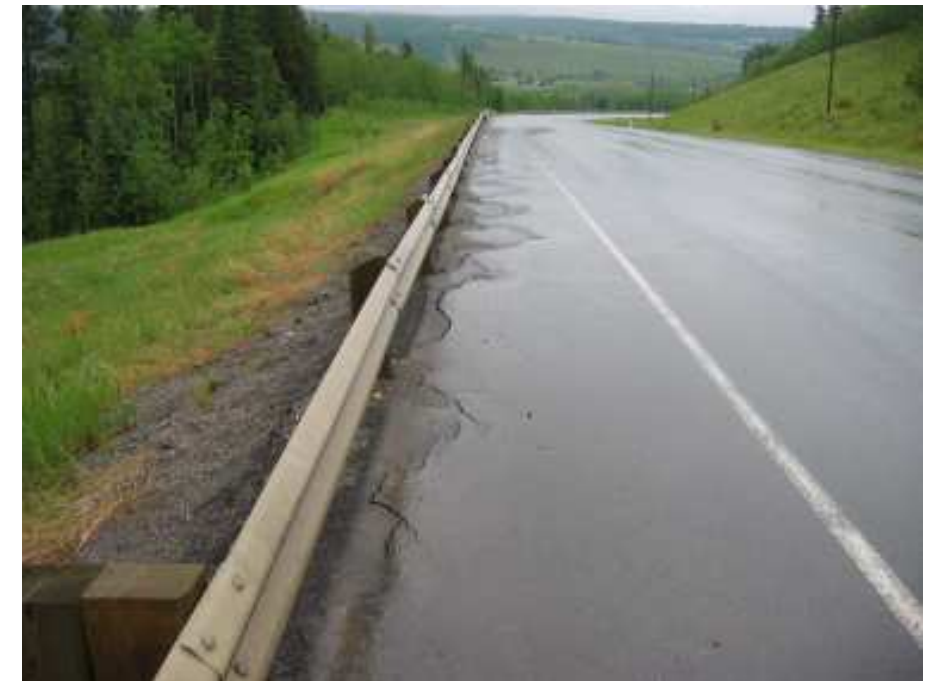
Photo S2-2 (upper right) – June 2005 – Cracking in the westbound lane, facing east.

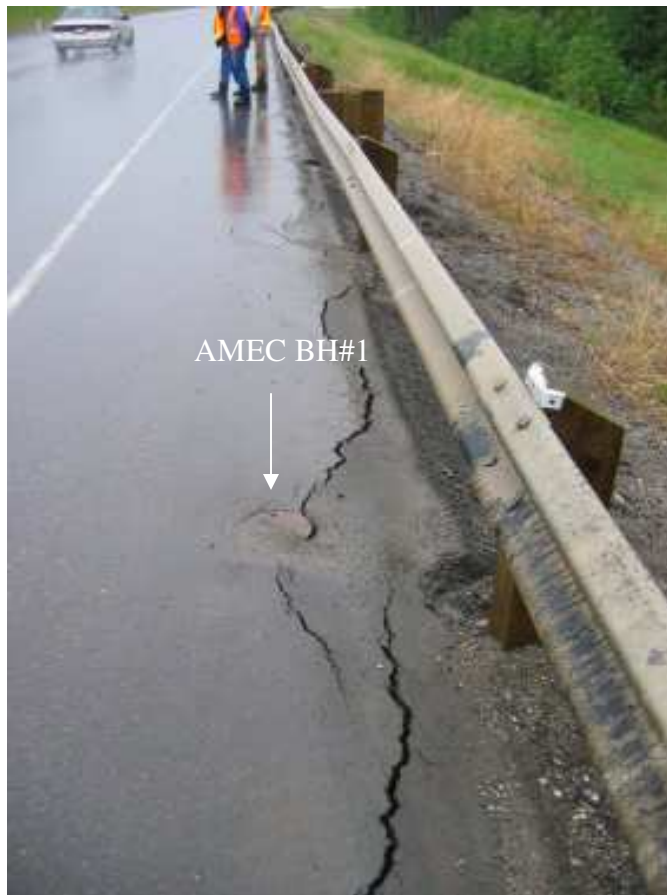
Photo S2-3 (lower left) – June 2005 – Closer view of cracking in the westbound lane. Note the downslope movement of the guardrail post evidenced by the edge of the asphalt.

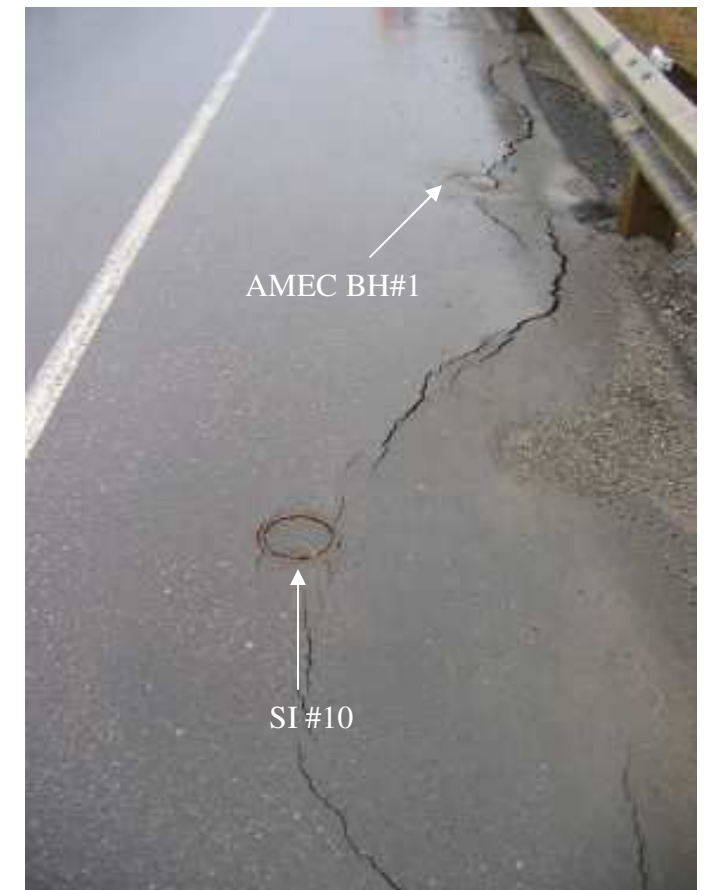
Photo S2-4 (lower right) – June 2005 – Cracking in the westbound lane passes right next to SI#10 and AMEC BH#1. The instruments were read in May 2005 and prior to the development of the cracks.

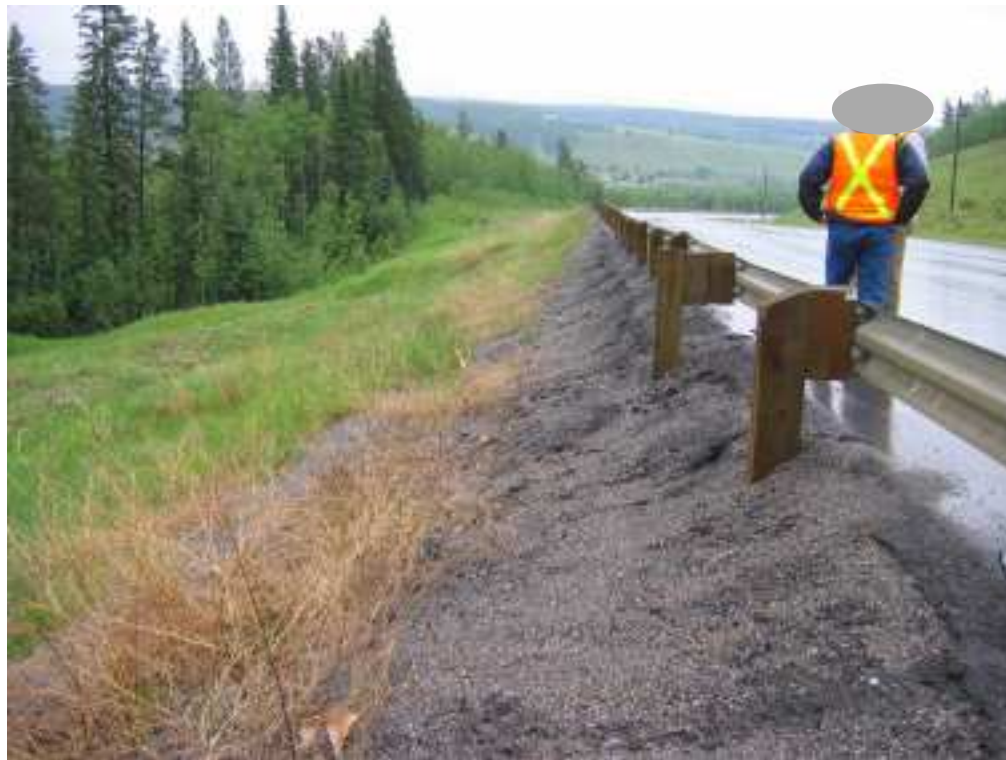
Photo S2-5 (upper left) – June 2005 – View of slope face below the road along the guardrail.

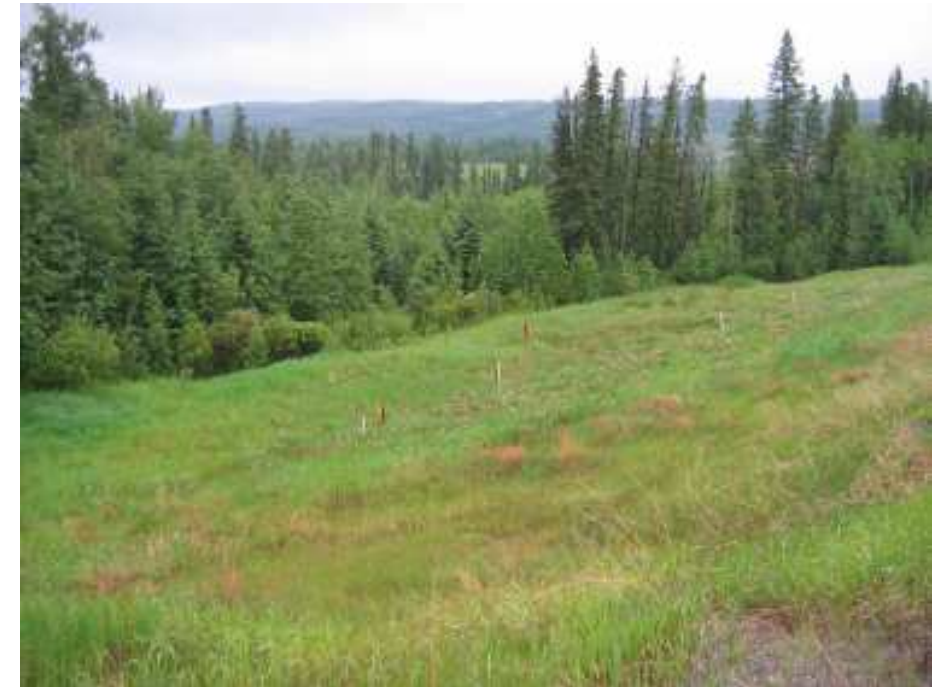
Photo S2-6 (upper right) – June 2005 – General view of the slope face below the road with instruments visible near the toe of the slope.

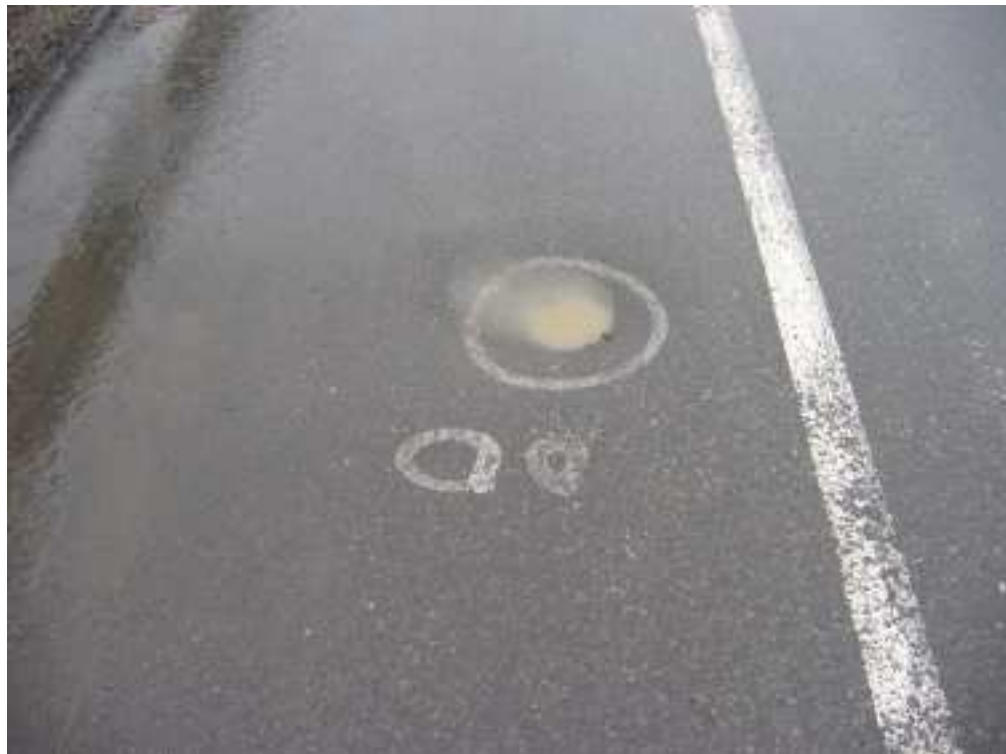
Photo S2-7 (lower left) – June 2005 – SI#9 on road surface. Repeated repavings have left SI's #9, #10, and #11 below the road grade and difficult to access. The protective cover over the SI in AMEC BH#1 was also damaged by repaving in 2004 and can no longer be removed to read the SI.
