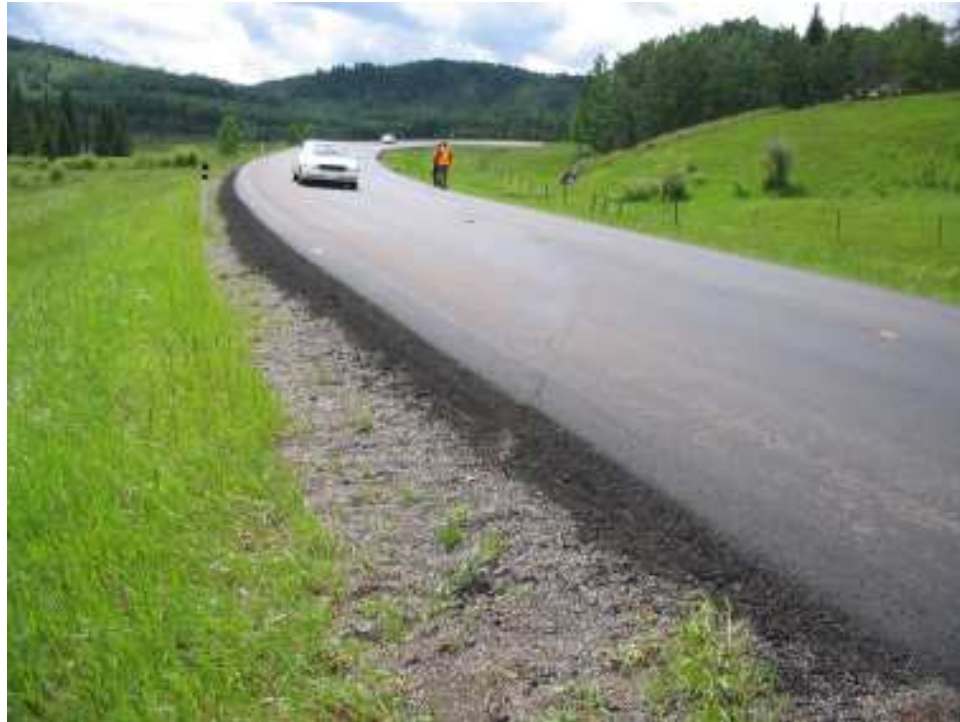
Photo S22-1 – June 2007 (upper left)
Facing southwest along the highway near boreholes 2007-7 and 2007-8, which are on the shoulder of the road just beyond the delineator post visible on the left. An overlay was placed across the entire road width a short time before the site inspection and the visible crack across the southbound lane and part of the northbound lane has formed since the overlay. Significant cracking and settlement was noted at this same location before the recent overlay – see Photos S22-3, 4 and 5.

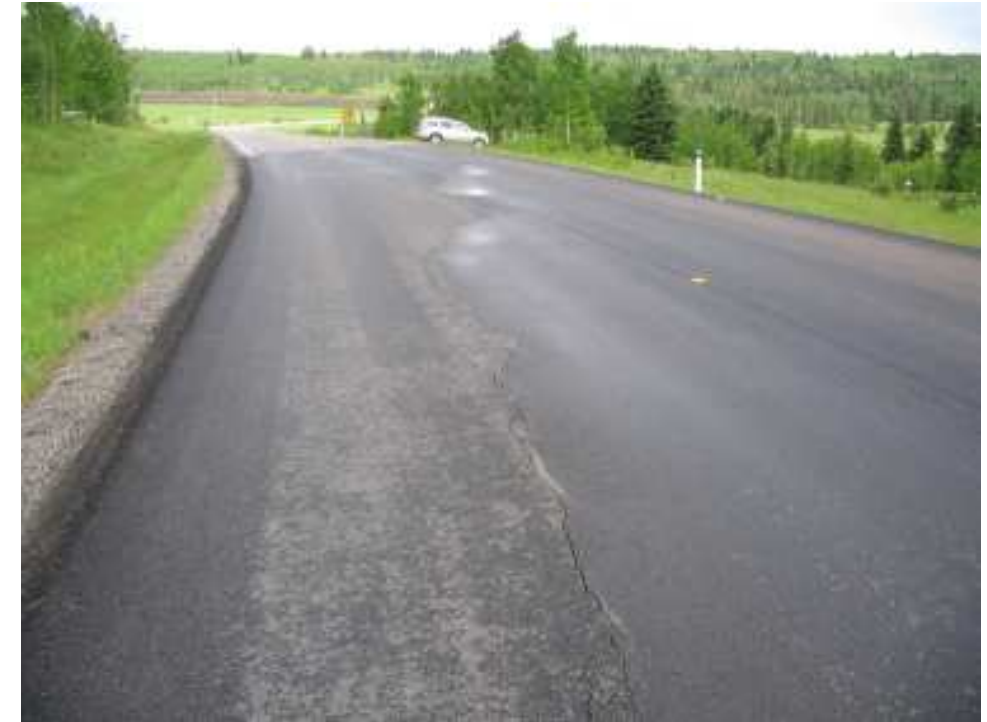
Photo S22-2 – June 2007 (upper right)
Another view of the cracked area shown in Photo S22-1, this time facing northeast. At the time of the June 2007 site inspection the cracking was well-defined however the east side had not yet settled.

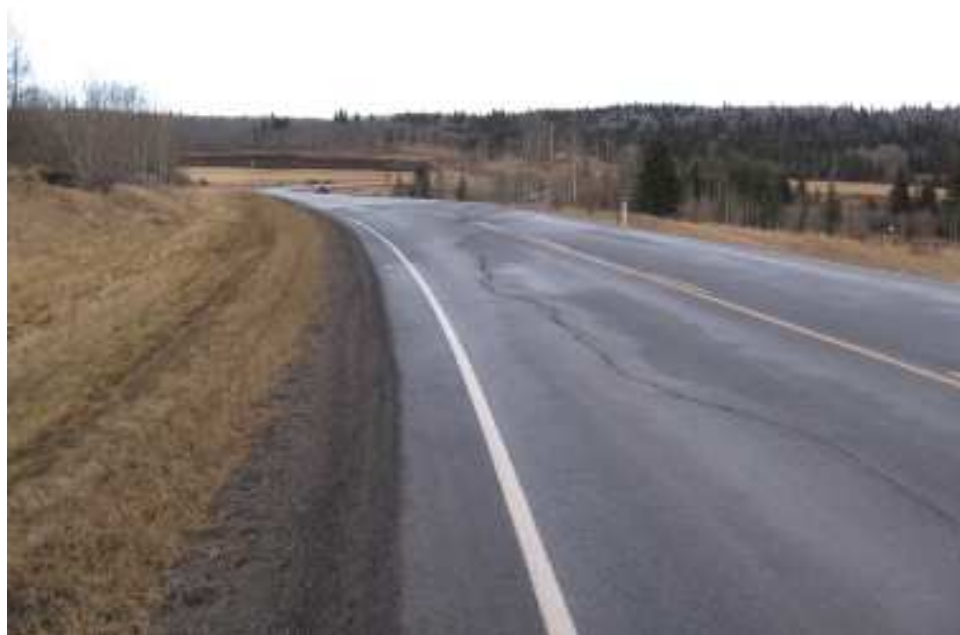
Photo S22-3 – March 2007 (lower left)
Another view of the cracked area shown in Photos S22-1 and 2, as seen in March 2007 during the borehole drilling and instrument installations. This photo was taken prior to the June 2007 overlay and illustrates the degree of cracking and settlement that had developed in this area. A similar degree of damage had formed at this location in recent years but has been treated as a maintenance concern with repeated overlays and patching.

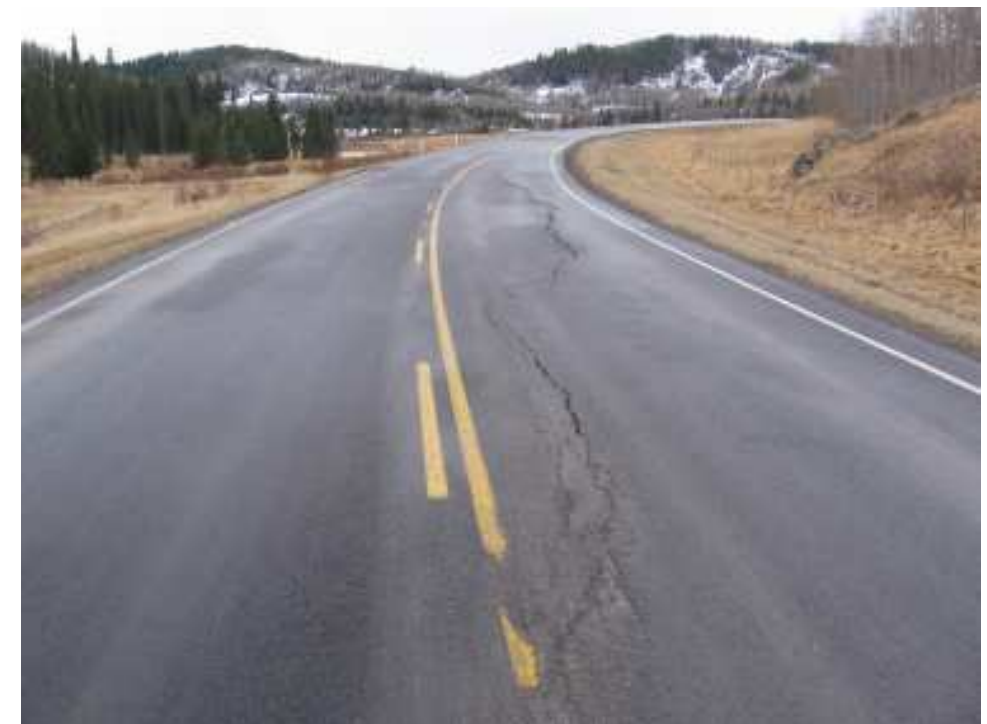
Photo S22-4 – March 2007 (lower right)
Another view from March 2007, showing the well-developed cracking and settlement that had retrogressed into the northbound lane.

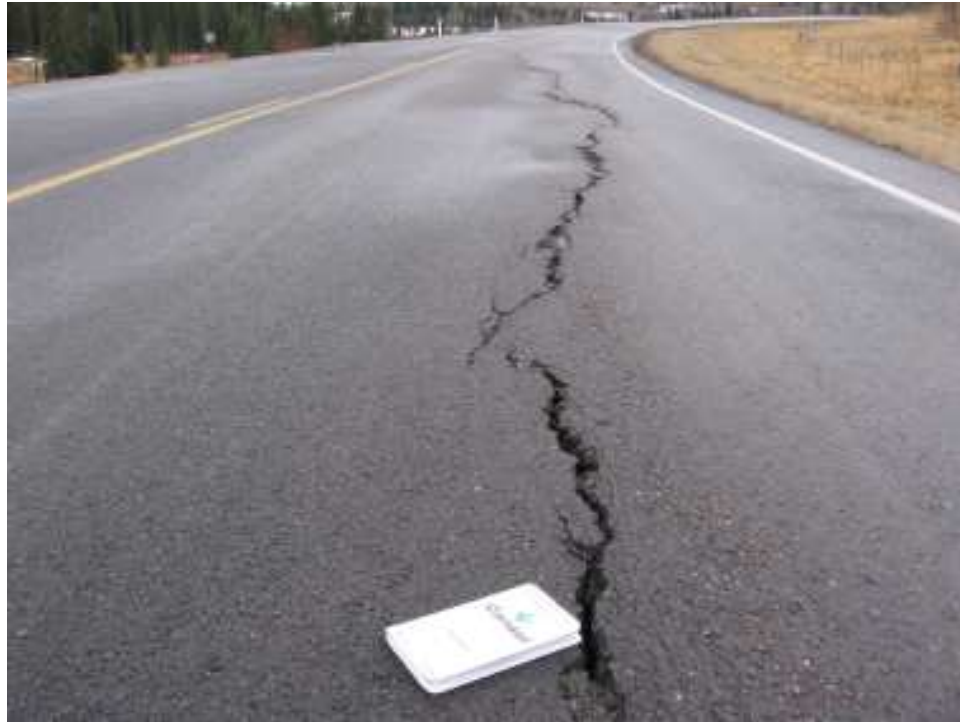
Photo S22-5 – March 2007 (upper left)
Closer view of the cracking and settlement in the
northbound lane as it appeared in March 2007.
