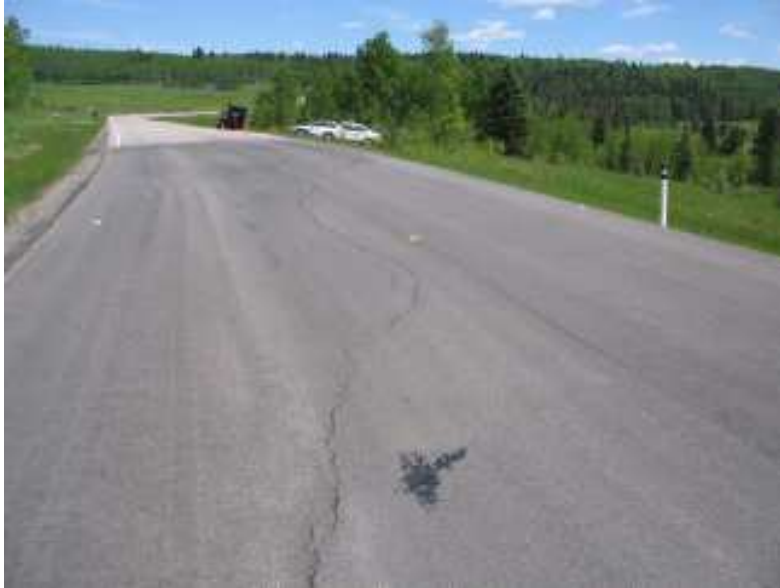
Photo S22-1 (top) – June 2008

Facing northeast across the east end of the site. The tension crack visible in the recent overlay has reformed through several overlays since 2006 and is interpreted to delineate the headscarp of the landslide movement detected in SI's 2007-7 and 2007-9 that were installed in the southeast shoulder of the highway.

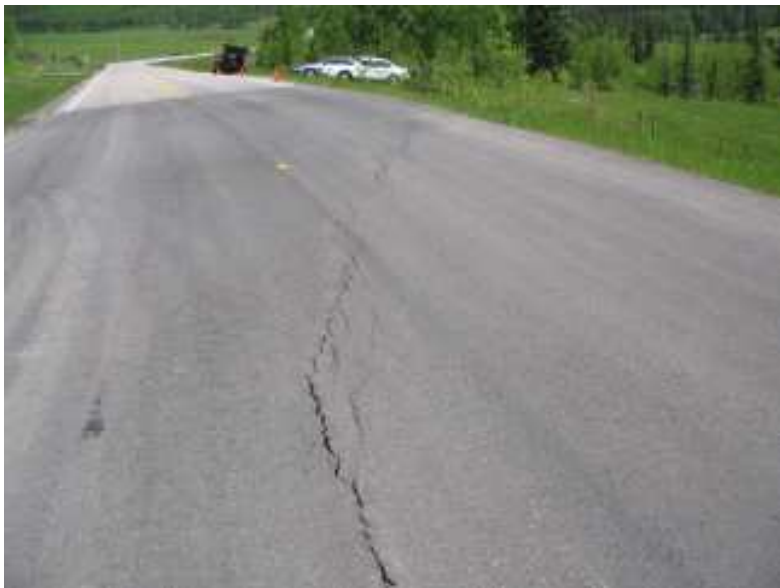
Photo S22-2 (bottom) – June 2008

Closer view of the tension cracking in the recent overlay at the east end of the site. The dropdown of the southbound lane (right hand side of the photo) was not too significant at the time of the June 2008 site inspection, however in past years has been in the order of 10's of mm.

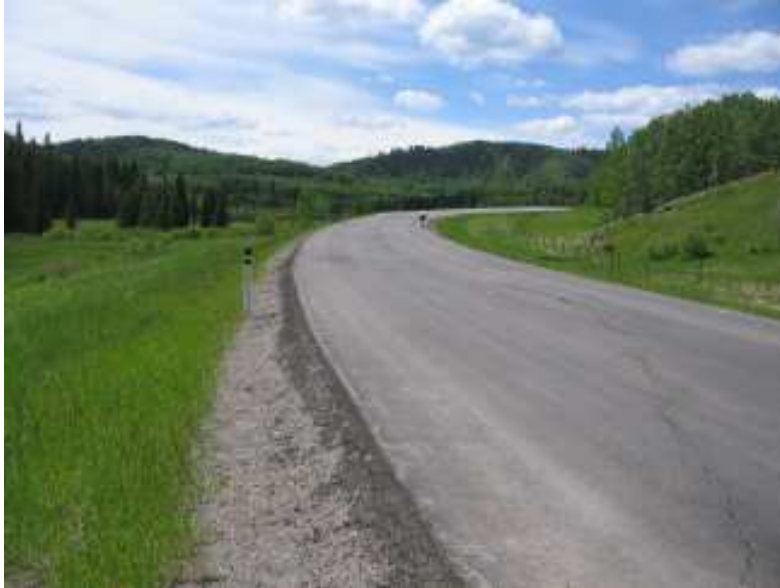
Photo S22-3 (top) – June 2008

Facing southwest across the west end of the site. Tension cracking is visible across the southbound lane (left hand side of the road in this view) and has retrogressed into the northbound lane – similar to previous years.

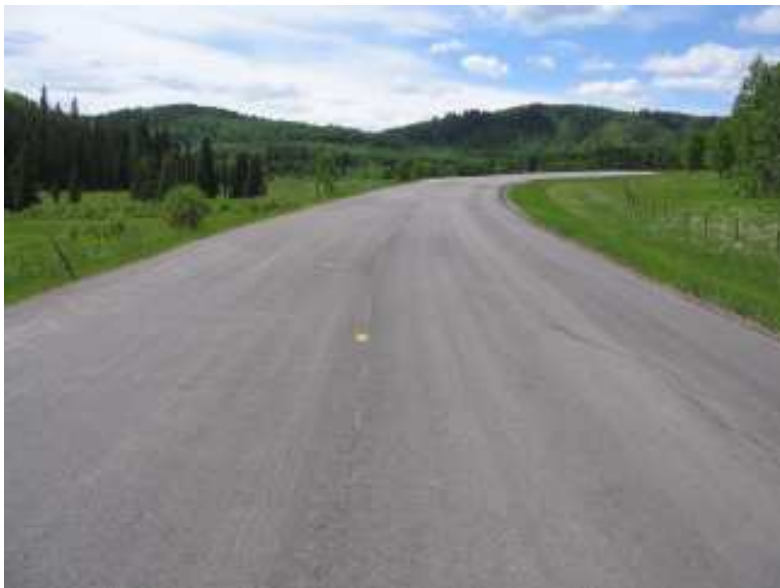
Photo S22-4 (bottom) – June 2008

Another view facing southwest across the western end of the site. The extent of tension cracking extending across both lanes of the highway is visible.
