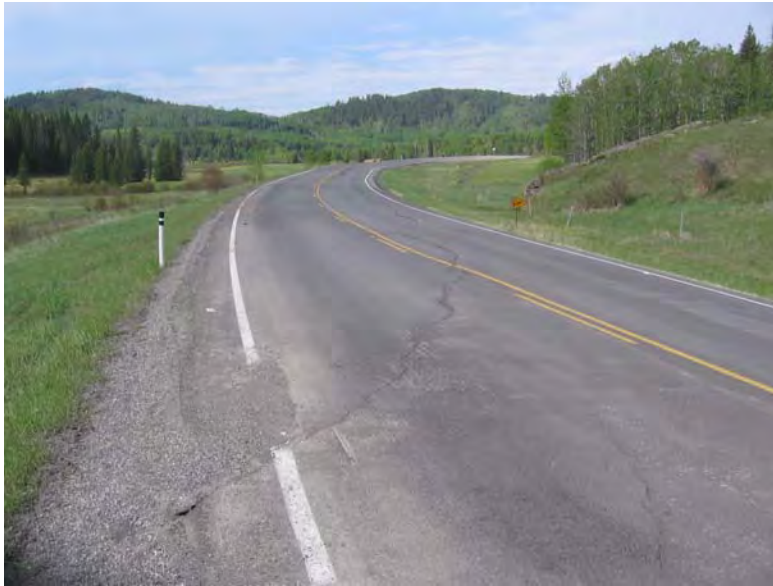
Photo S22-1 (top) – June 2009
Facing northbound across the current asphalt overlay at the site. The visible cracking and settlement of the southbound lane is similar to that noted during past inspections. It appears that at least one asphalt overlay has been placed at this site since the 2008 inspection, and the damage to the road surface visible in the photo has developed since that time.

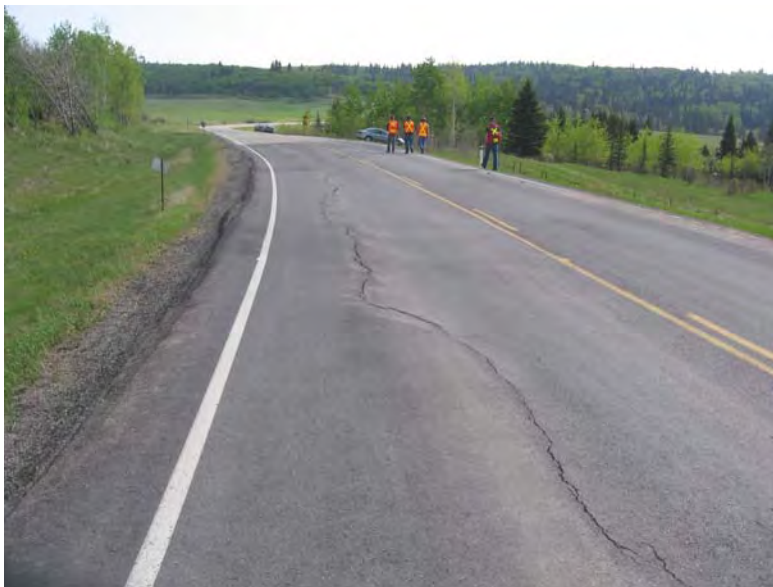
Photo S22-2 (bottom) – June 2009
Facing southbound across the current asphalt overlay at the site.

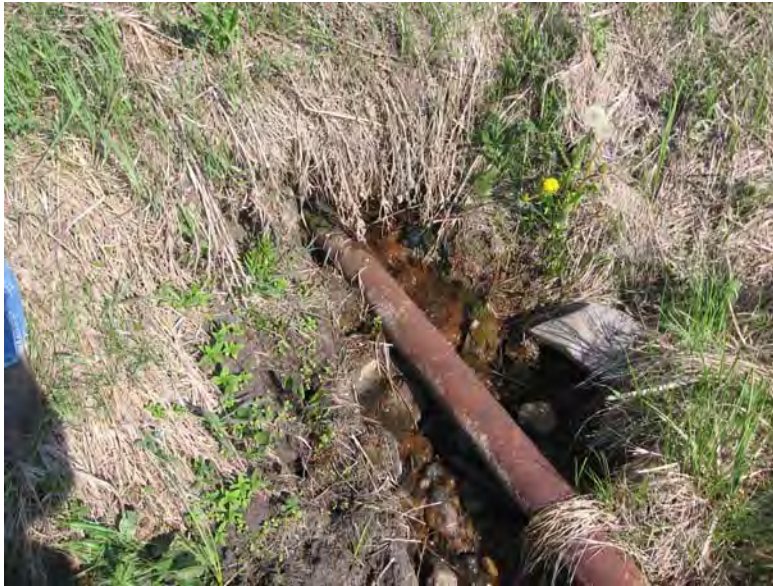
Photo S22-3 – June 2009

100 mm diameter steel pipe protruding from the toe of the road embankment slope around the location shown on Figure S22-1. The pipe was discharging approximately 2 L/minute of clear water at the time of the inspection, and it appeared that it had been installed many years ago as a horizontal drain for the slope.
