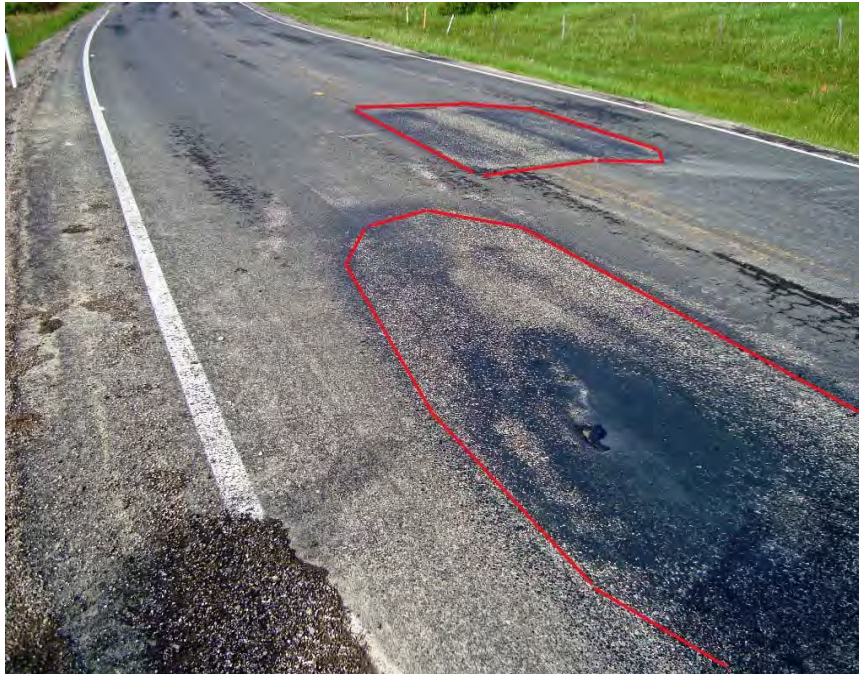
**Photo S22-1 – June 2012**  
Facing west (along the southbound lane) from the east end of the site. The recent milling work has exposed asphalt experiencing sub-grade failure (outlined in red). Milling may have caused the sub-grade failure.

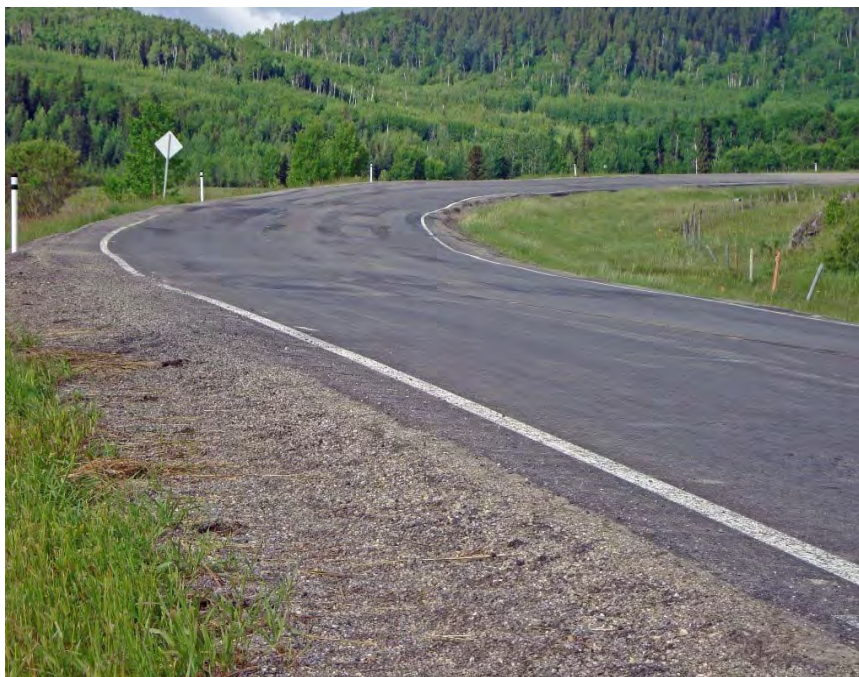
**Photo S22-2 – June 2012**  
Facing west (along the southbound lane) from the east side of the site. The damage to the road surface is similar to that noted during past inspections.
