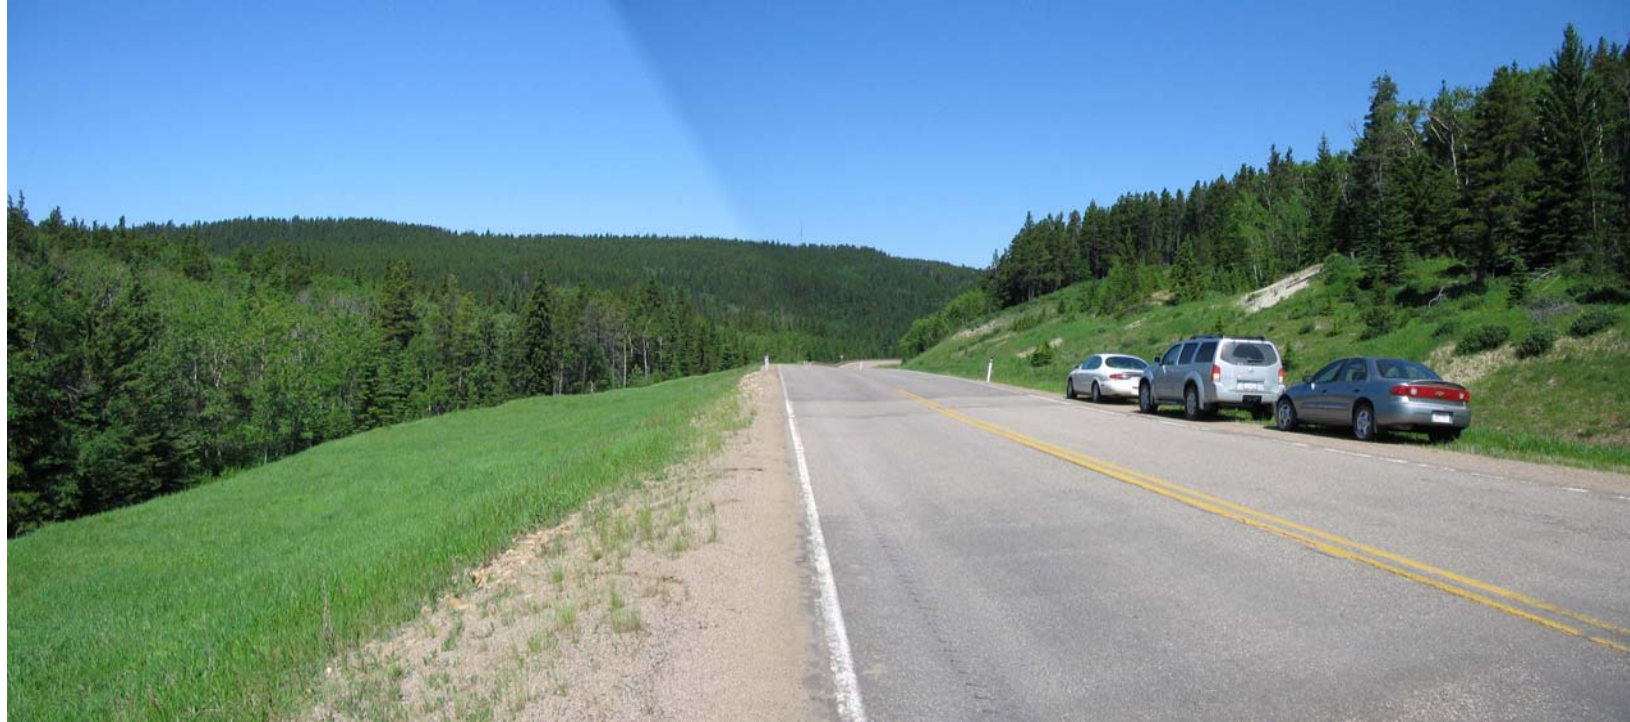
Photo S26-1 – June 2007 (top)

Facing northbound across the landslide damaged segment of the highway surface at the south end of the site. There is visible landslide terrain both upslope (see Photo S26-2) and downslope of the highway in this area and the road surface shows that numerous patches and overlays have been placed over the years to maintain the road grade.

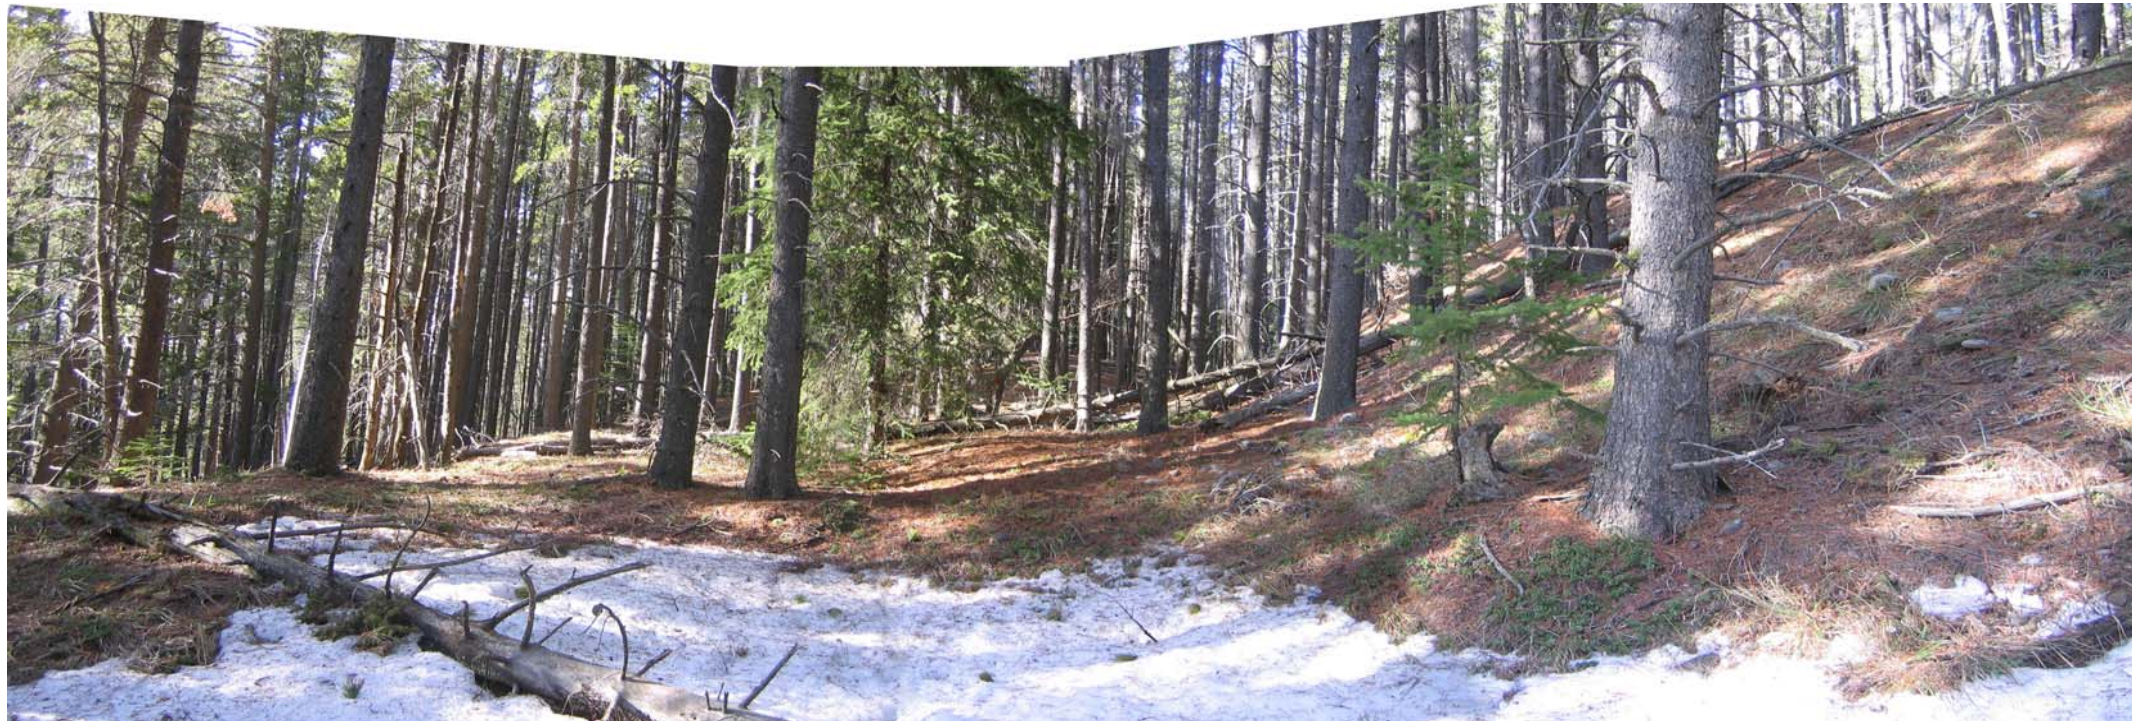
Photo S26-2 – March 2007 (bottom)

Landslide slump block profile in the slope face upslope of the highway in the area shown in Photo S26-1.

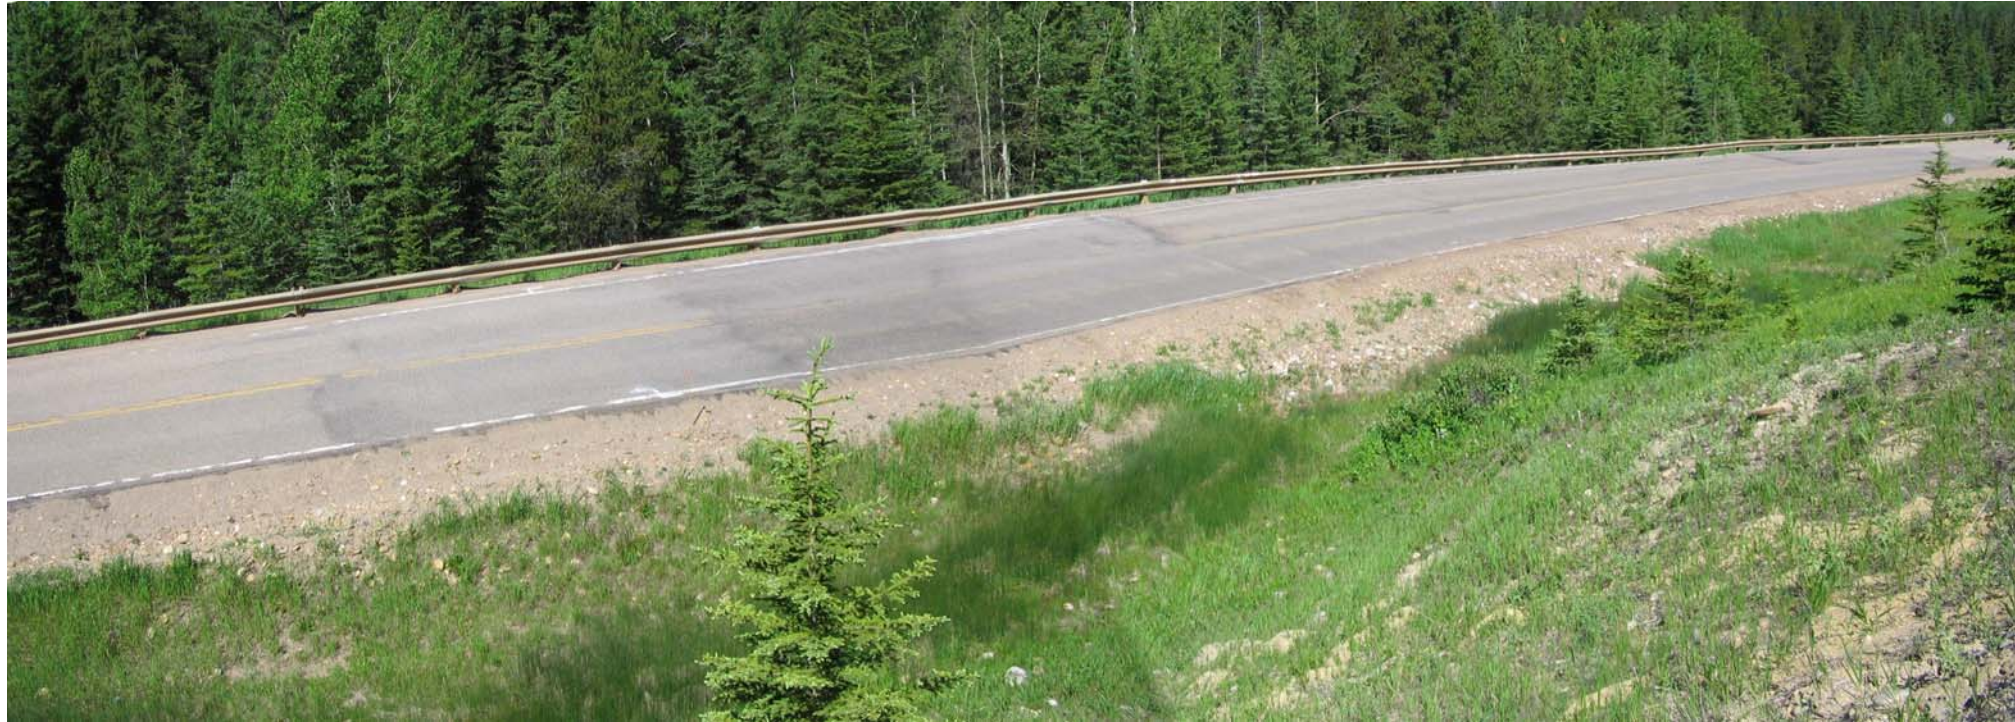
Photo S26-3 – June 2007 (top)
Multiple overlays and patches visible along the landslide-damaged segment of the highway at the north end of the site.

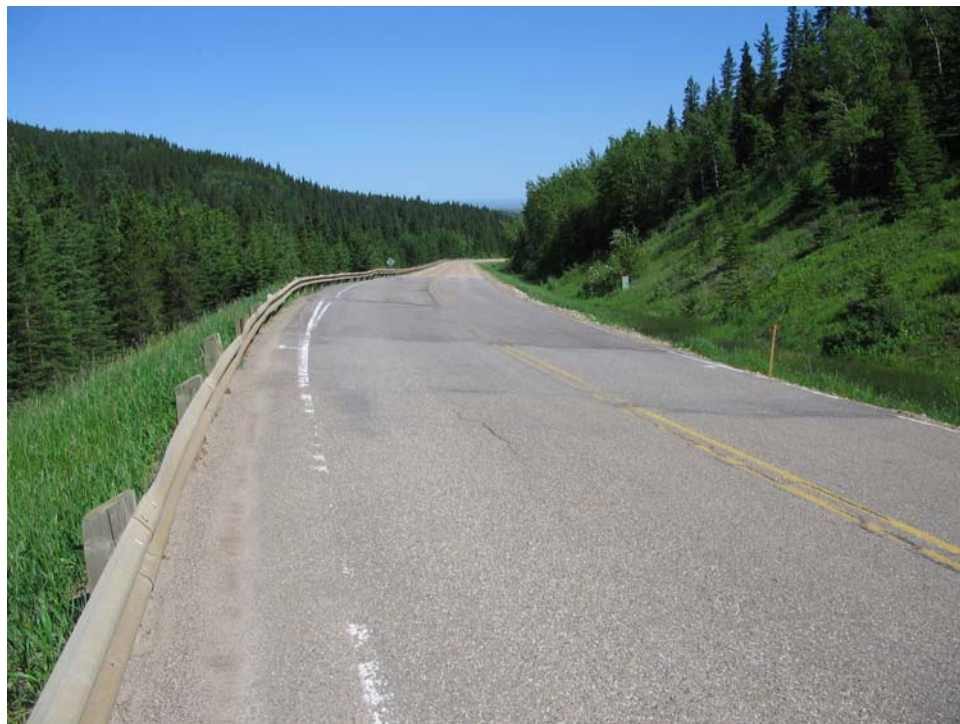
Photo S26-4 – June 2007 (bottom left)
Facing northbound along the segment of highway shown in Photo S26-3. Note the bumps and dips in the road grade due to landslide damage.

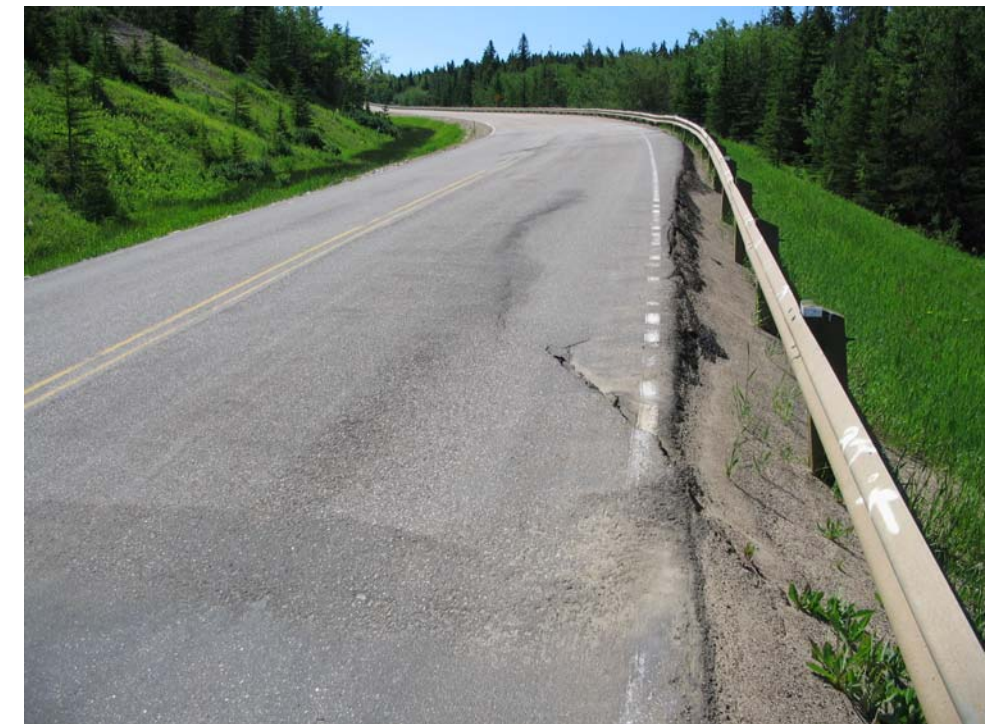
Photo S26-5 – June 2007 (bottom right)
Facing southbound along the segment of highway shown in Photo S26-3. Note the cracking and downdrop of the road surface that is indicative of landslide damage.
