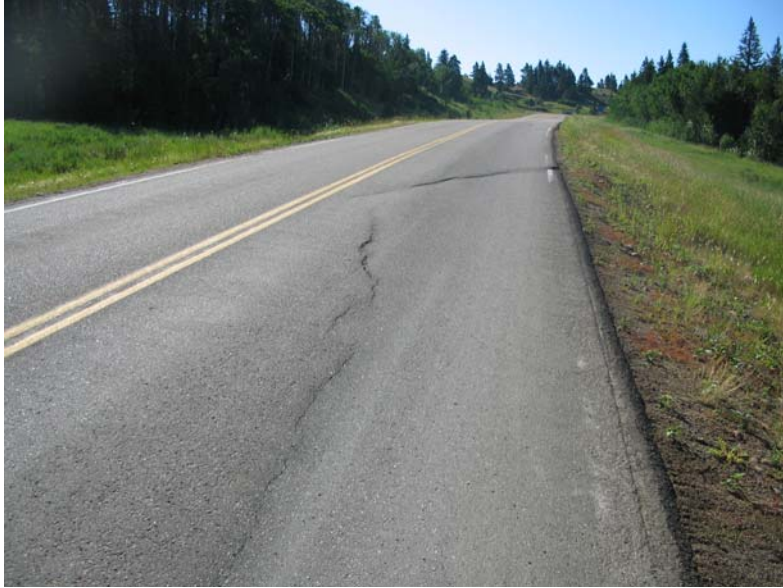
Photo S26-1 (top)

Facing south across the southern end of Area A, with tension cracking and down-drop of the southbound lane visible.

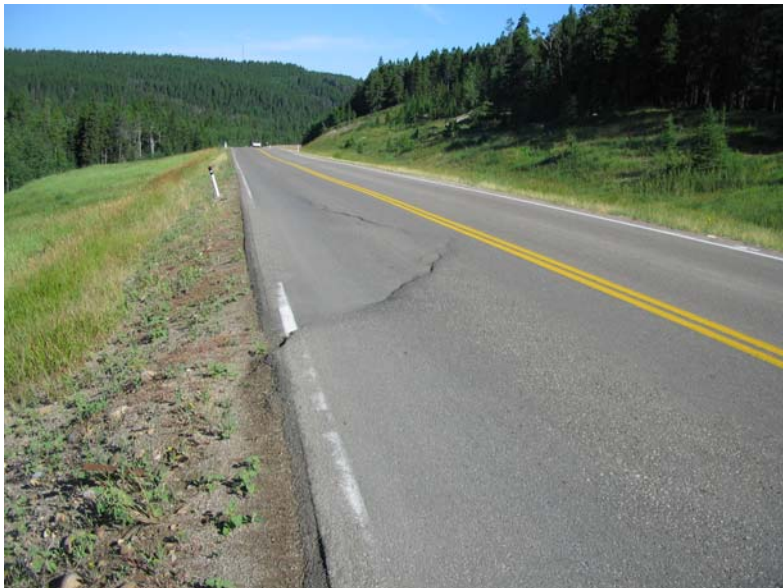
Photo S26-2 (bottom)

Another view, facing north, of the damaged segment of road at the south end of Area A.

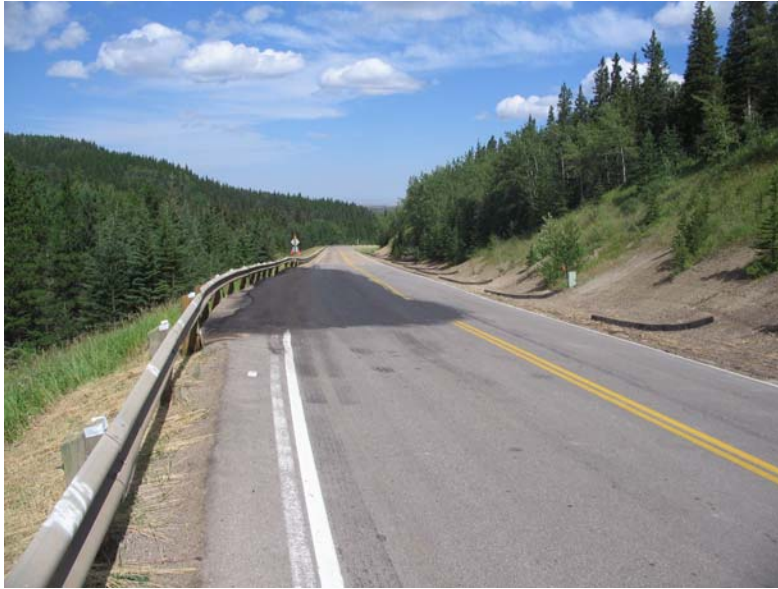
Photo S26-3 (top)
Facing northbound across the damaged segment of the highway. The segment of the ditch where the trench drain was installed in July 2008 is visible on the right hand side of the photo.

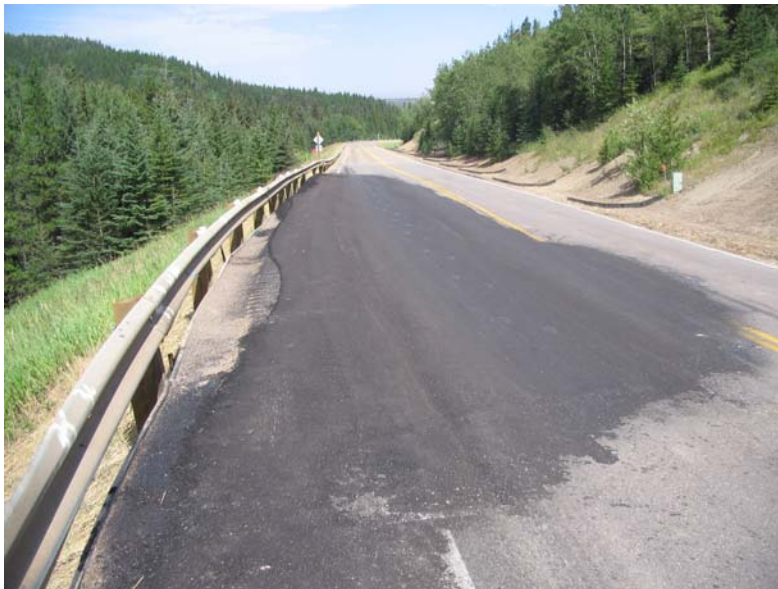
Photo S26-4 (bottom)
Closer view of the damaged segment of the highway, facing northbound. The fresh overlay was placed at the end of July 2008, and tension cracking and settlement has occurred on both the north and south flanks of the patch since then. The layout of the overlay illustrates the shape and extent of the past damage to the road surface – consistent with an arc-shaped slump headscarp that has retrogressed just beyond the centerline of the highway.

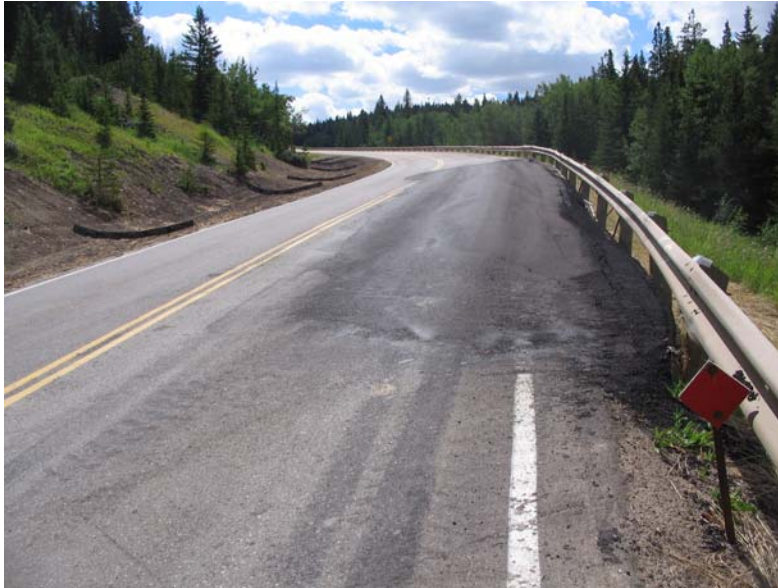
Photo S26-5 (top)
Another view of the damaged segment of the highway, facing southbound.

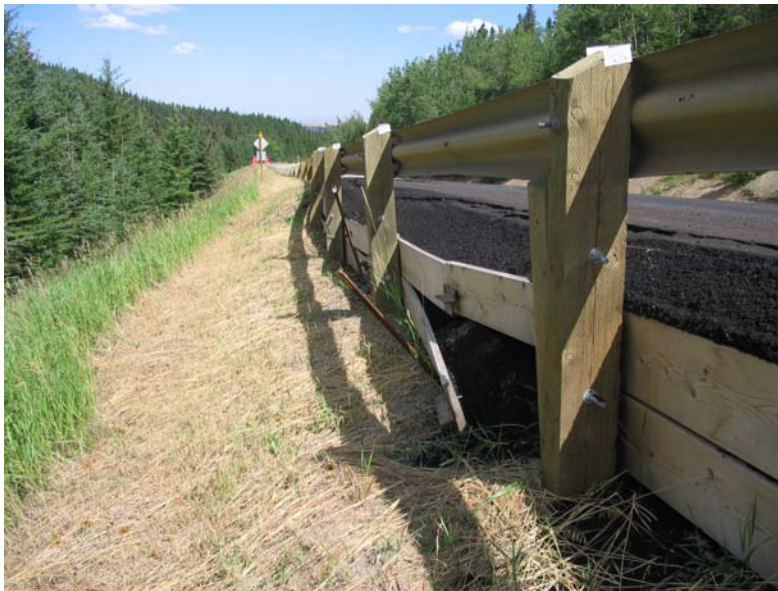
Photo S26-6 (bottom)
Timber lagging installed along the upslope edge of the guardrail at the north flank of the damaged segment of the highway. The accumulated thickness and weight of the multiple overlays has caused the lagging to bulge outwards.
