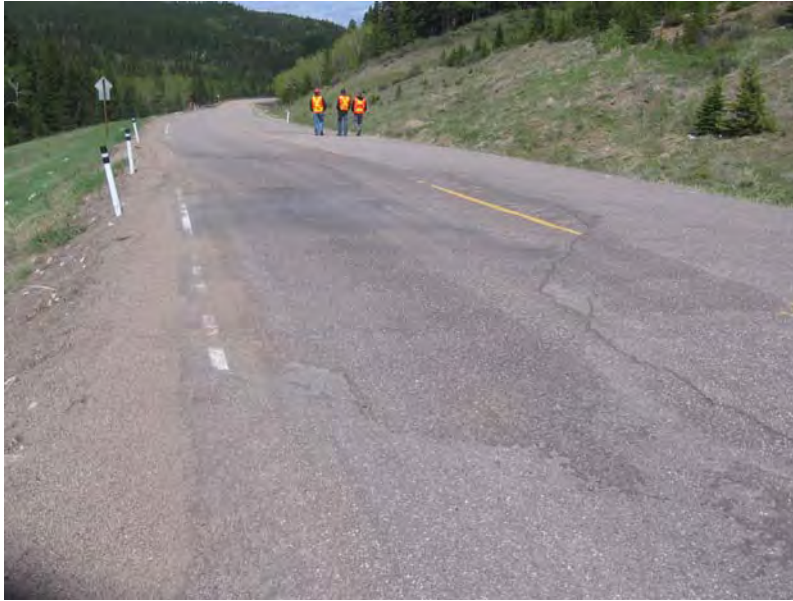
Photo S26-1 – June 2009

Looking towards the northwest at the northwest end of the Area A site. Cracking on the road surface appears similar to 2008 conditions.

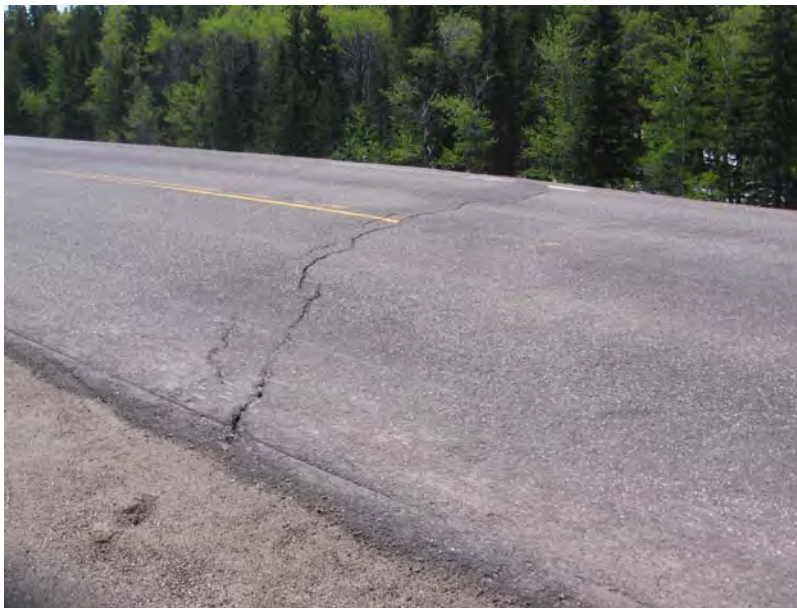
Photo S26-2 - June 2009

Transverse crack at the northwest end of the Area A site with minor vertical displacement. Similar condition as was observed during 2008 annual inspection.

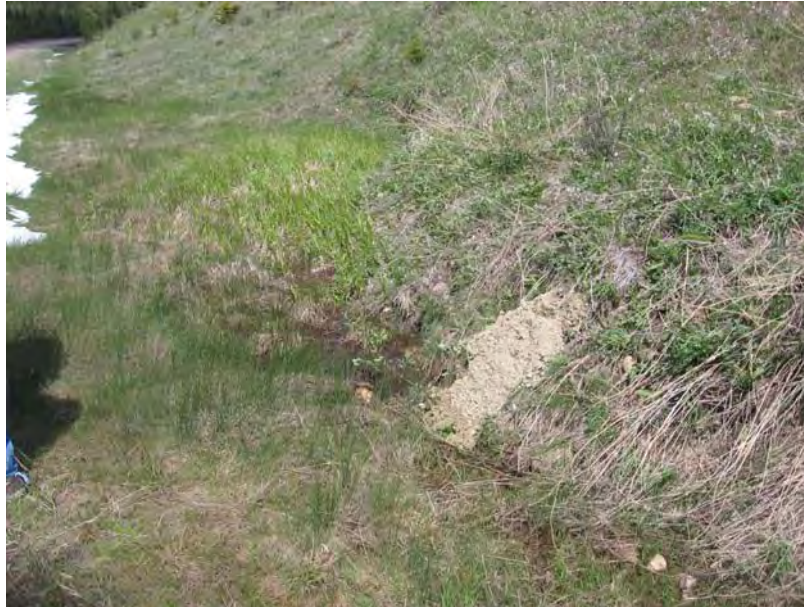
Photo S26-3 – June 2009

Groundwater spring emerges in the upslope ditch a short distance uphill of Area B. Note the thick vegetation indicating consistent flow from the seepage throughout the growing season.

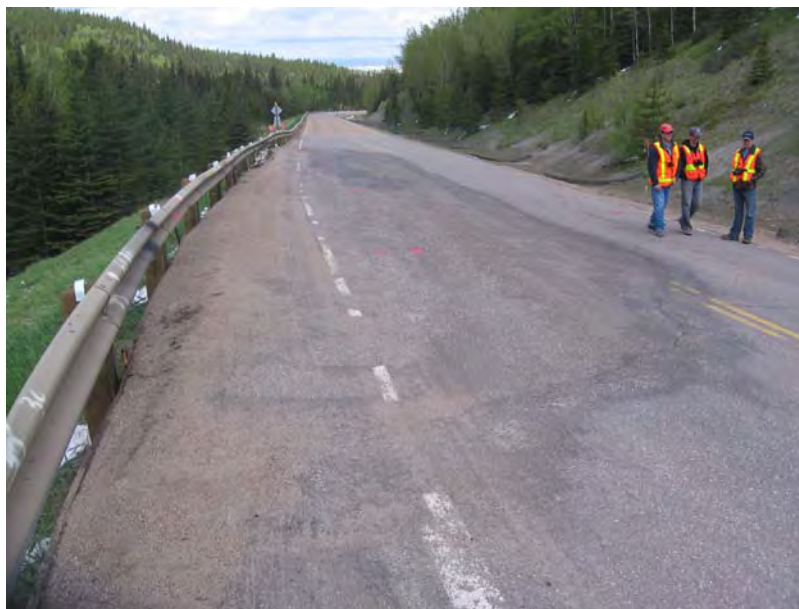
Photo S26- 4 – June 2009

Looking north at damaged road at Area B. Possible retrogression at the upslope extent of cracking with a new crack visible just upslope of centreline.

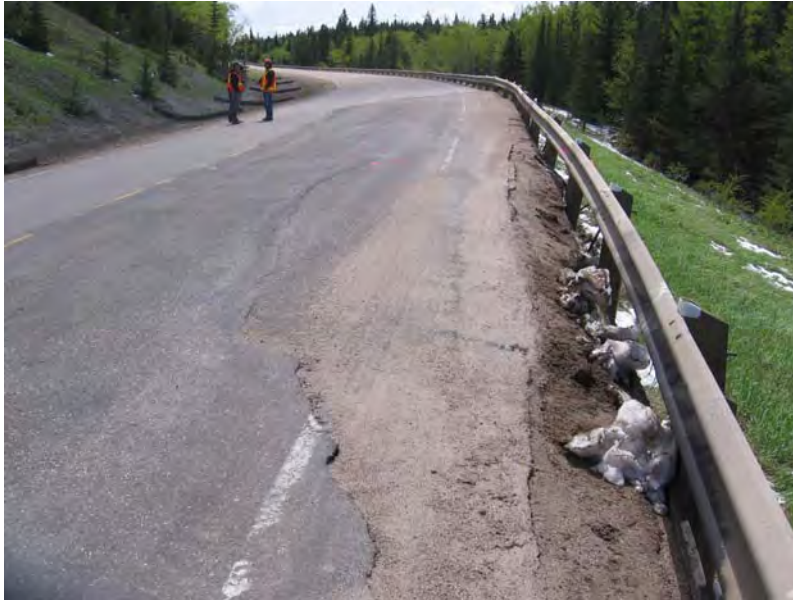
Photo S26- 5 – June 2009

Looking south at damaged roadway at Area B. Asphalt overlay placed in 2008 is showing evidence of significant vertical settlement.
