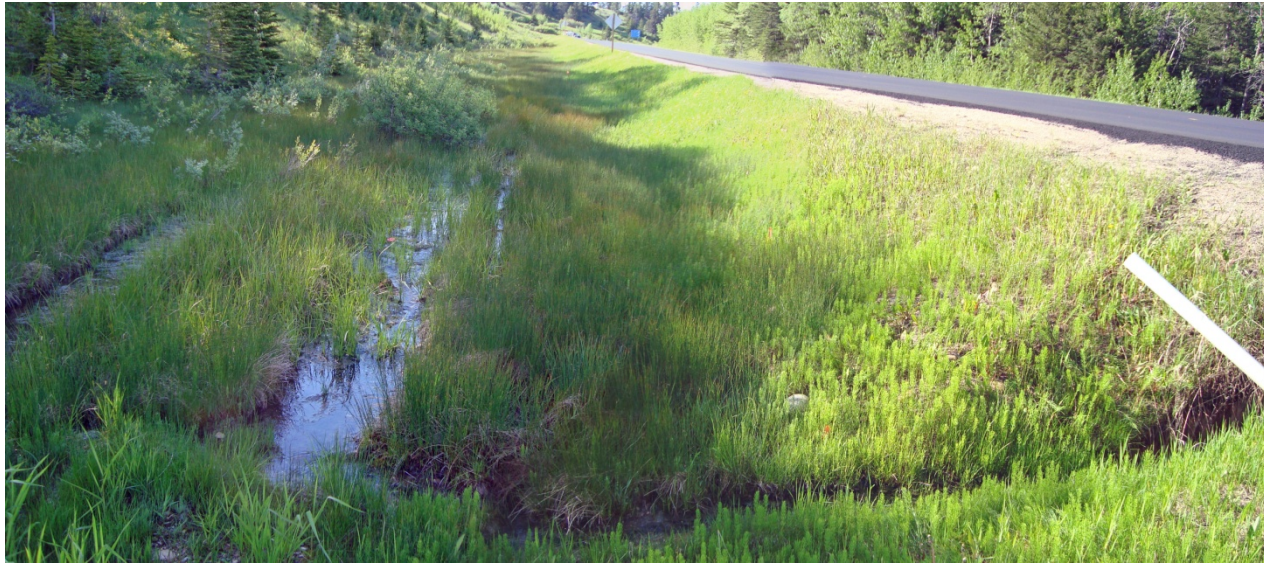
**Photo S26-1 – above - (June 2011)**

Facing southeast from the south end of Area A at the east ditch. The ditch has been consistently wet with ponded water during previous inspections.

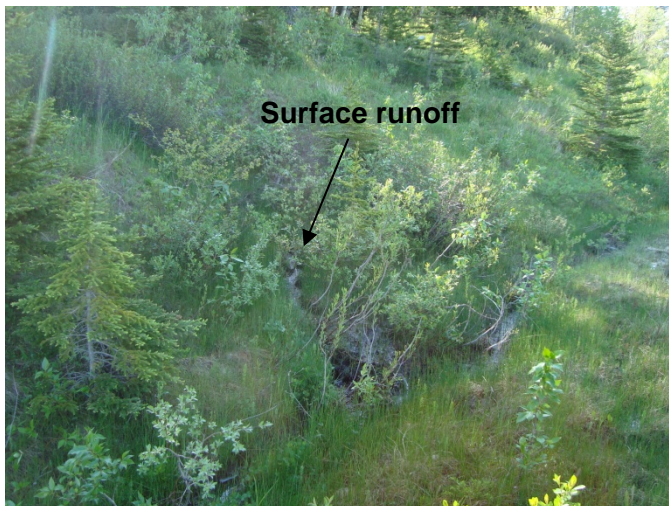
**Photo S26-2 – left - (June 2011)**

A newly observed creek found flowing into the east ditch – south of the culvert at Area A. The creek is incised through a recently formed slide lobe, and was flowing at about 100 L/min.

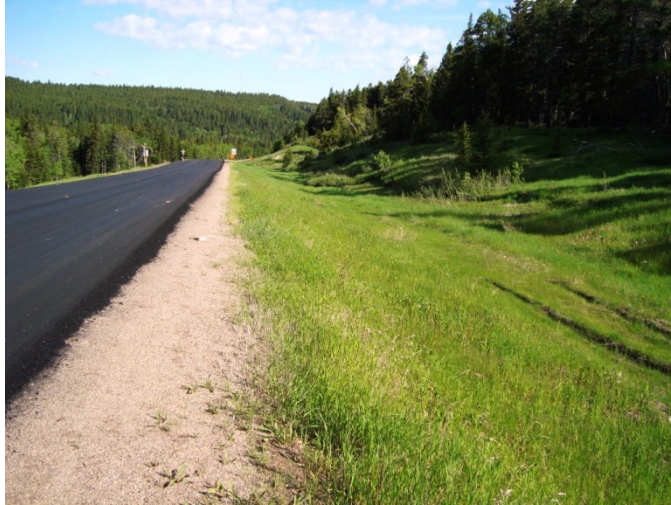
**Photo S26-3 – top left - (June 2011)**

Facing northwest at the recent overlay at Area A and at the backslope slumps formed in 2010.

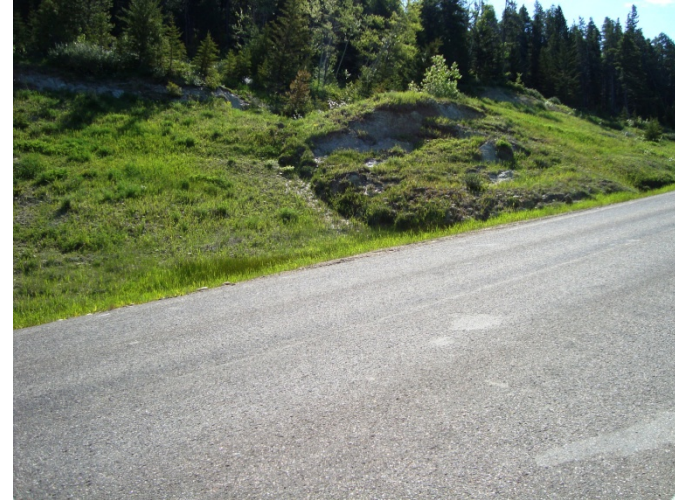
**Photo S26-4 – left - (June 2011)**

A backslope slump at Area A, formed in 2010. The slumps were in much the same condition as during the 2010 inspection.

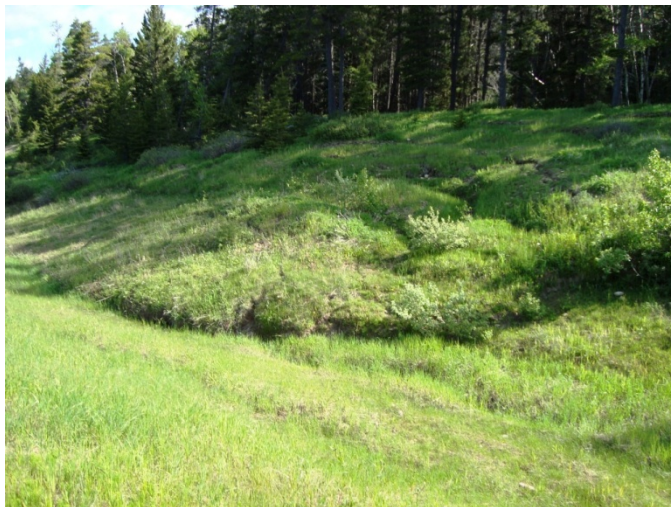
**Photo S26-5 – top right - (June 2011)**

The backslope slump between Area A and B, located at the previously noted groundwater seepage. The seepage continues to flow around and through the slide mass.

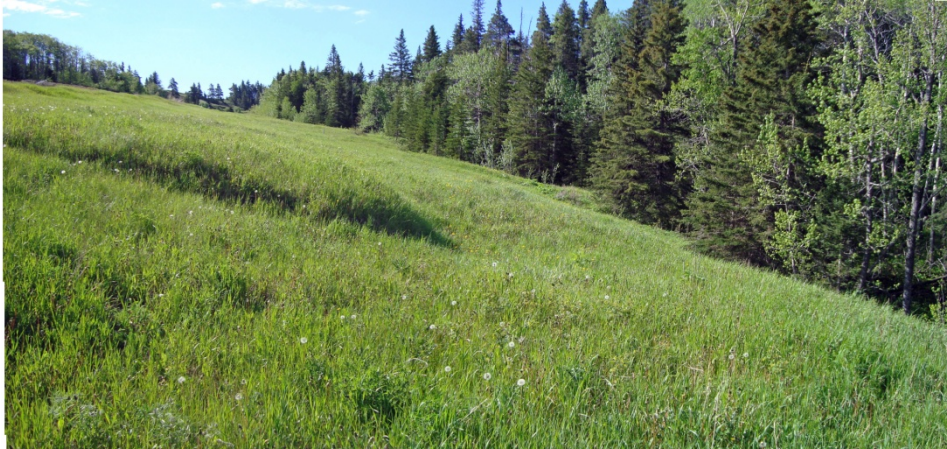
**Photo S26-6 – top - (June 2011)**  
A slump on the lower slope at Area A, in much the same condition as was observed during the June 2010 inspection.

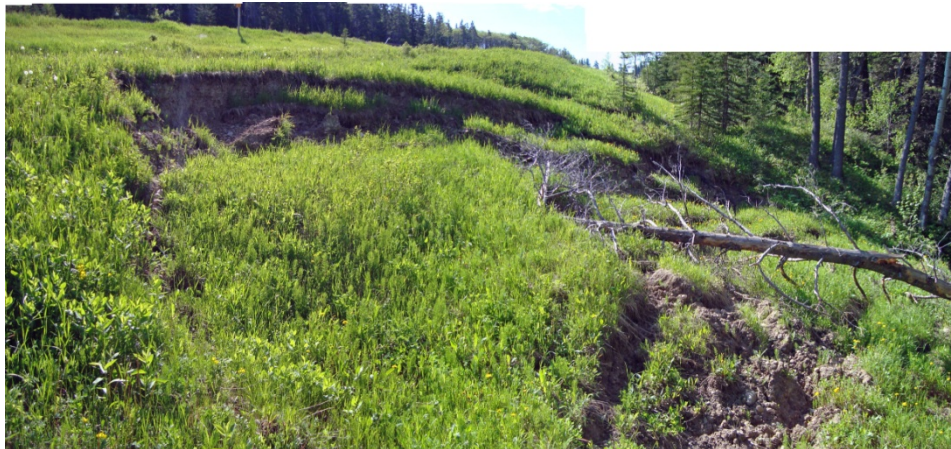
**Photo S26-7 – bottom - (June 2011)**  
A slump on the lower slope at Area A extending to creek level. The slump was active during 2010.

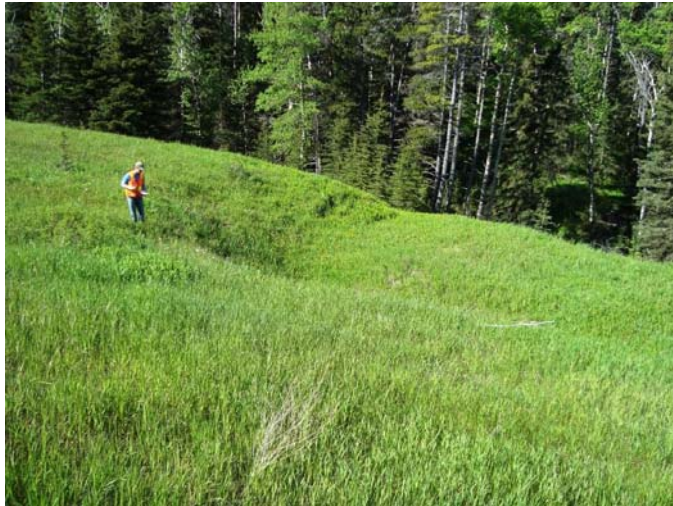
**Photo S26-8 – top left - (June 2011)**

A well-developed slump on the lower slope at Area A, noted during previous inspections.

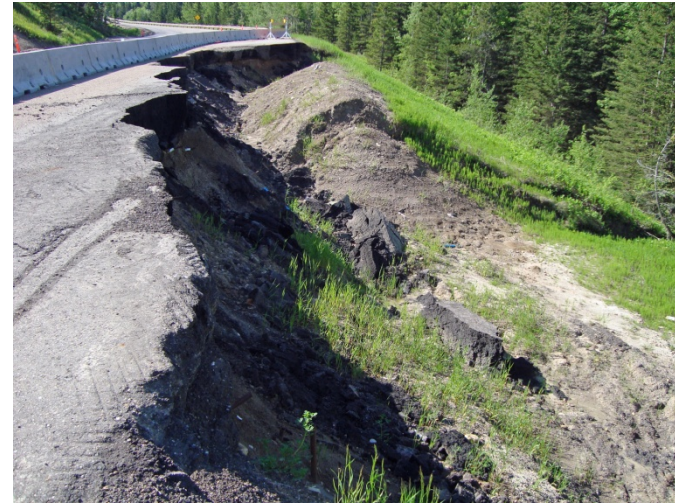
**Photo S26-9 – bottom left - (June 2011)**

Facing north at the temporary detour lane at Area B. The detour was in good condition.

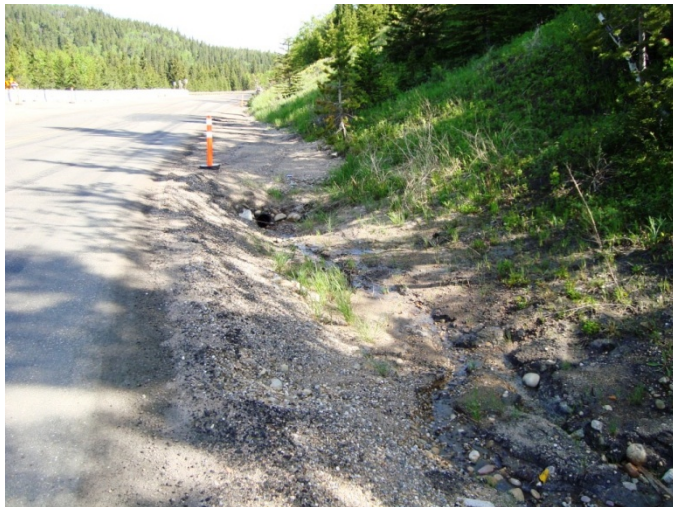
**Photo S26-10 – top right - (June 2011)**

The Area B landslide is mostly unchanged since the June 2010 inspection. Minor retrogression has occurred at the scarp.
