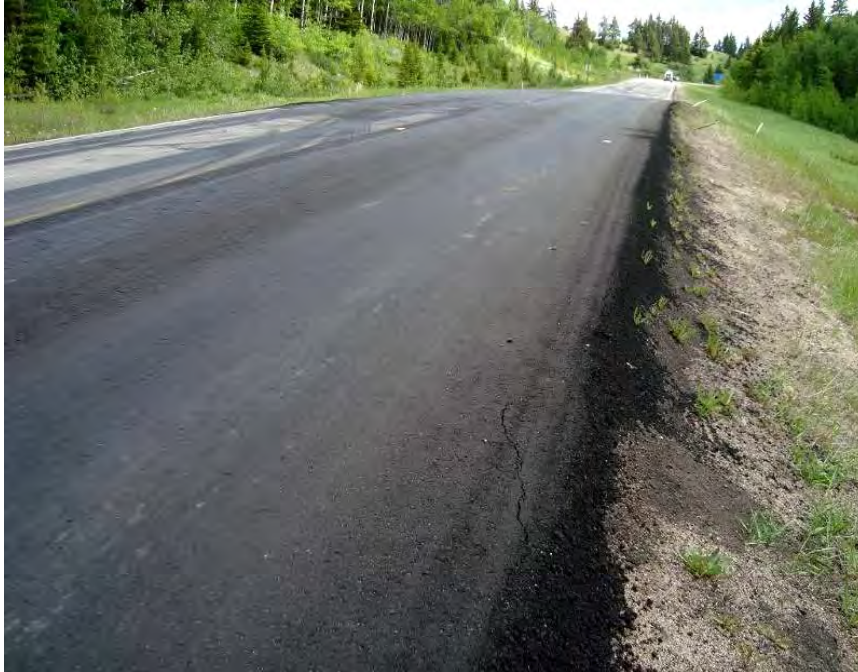
Photo S26-1 - (June 2012)
Facing south from the south end of Area A at the west road shoulder. Overlays have been placed at the damaged areas recently. Minor cracking was visible along the shoulder through the new overlay.

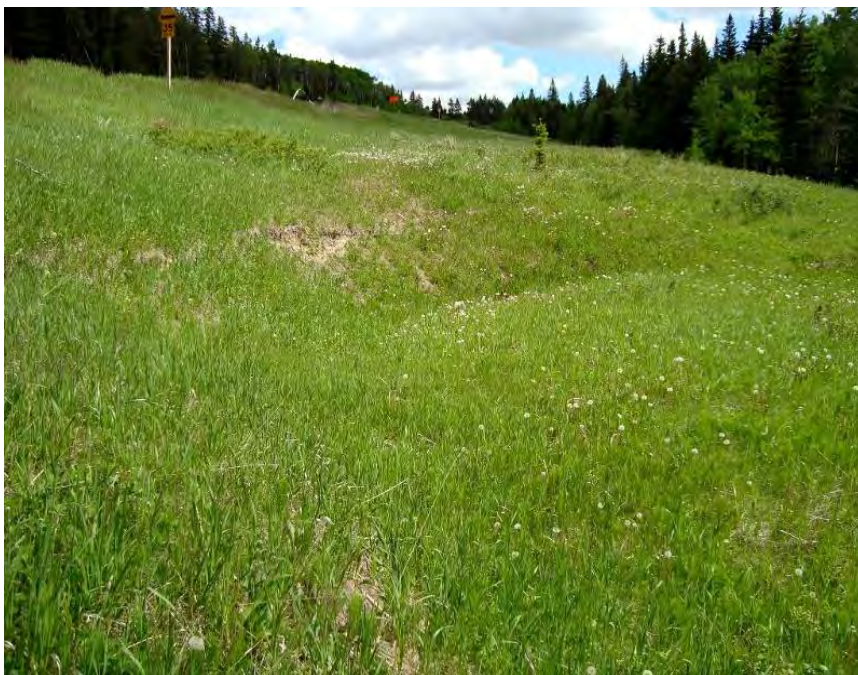
Photo S26-2 - (June 2012)
Facing south from the north end of Area A at the lower west slope. Fresh soil was exposed at the headscarp of one of the main lower slides.

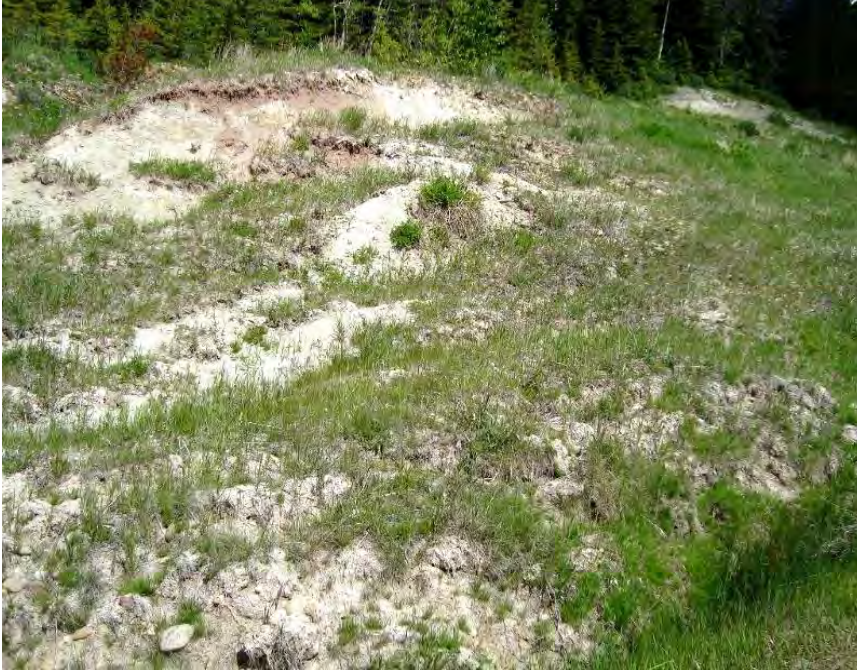
Photo S26-3 - (June 2012)
Facing southeast from the north end of Area A at the seepage area on the east side of the highway. The ditch here was blocked with soil as a result of ongoing back slope movement.

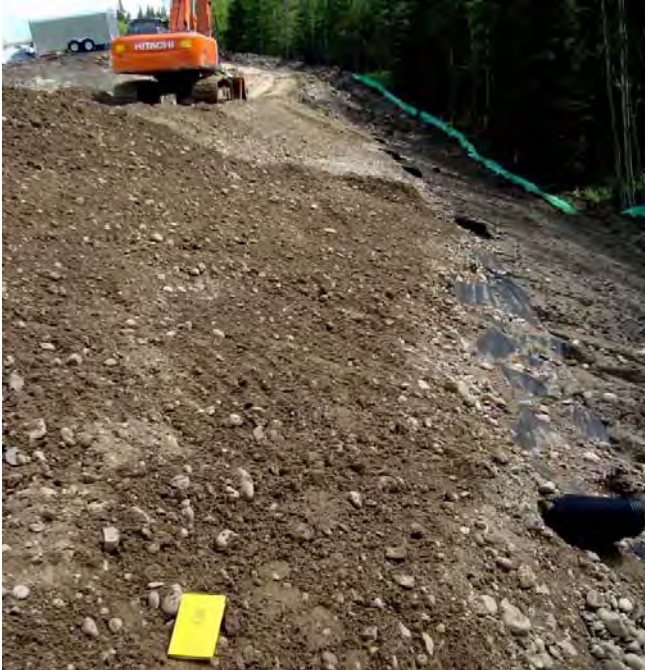
Photo S26-4 - (June 2012)
Facing southwest from the lower west slope at Area B. Construction was underway during the inspection.

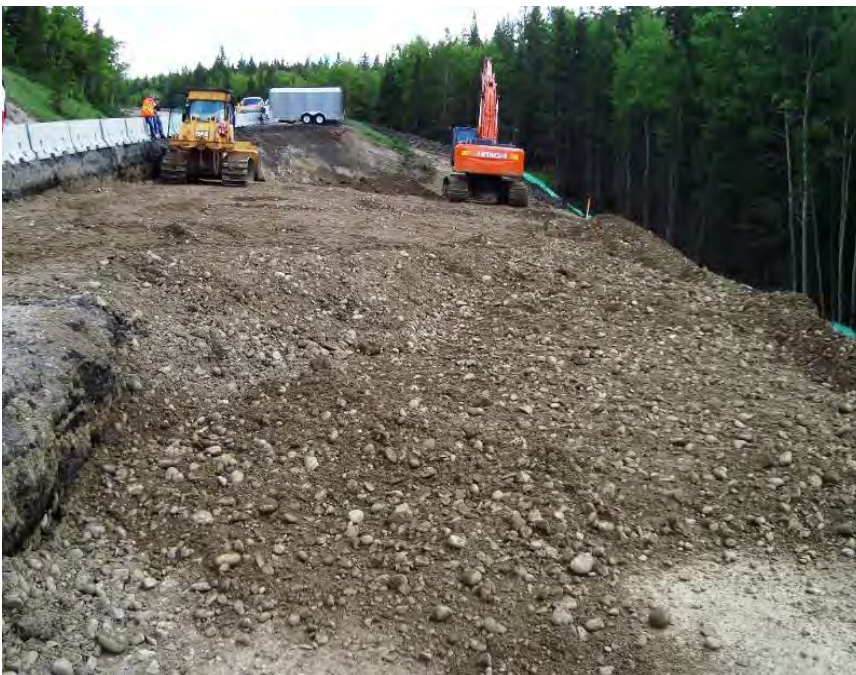
Photo S26-5 - (June 2012)
Facing south from the upper slope on the west side of Area B. Construction of the shear pile repair was underway during the inspection.
