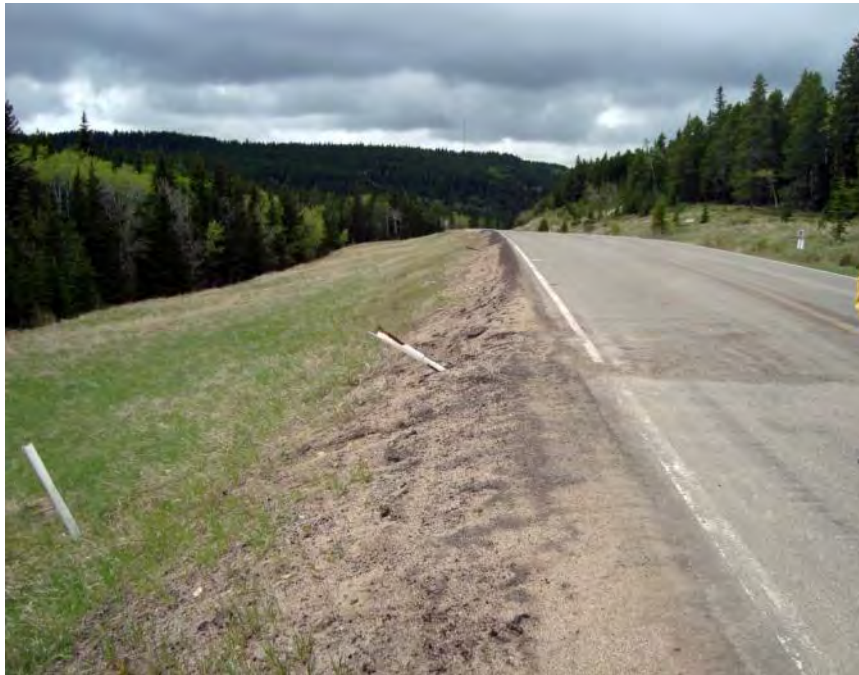
Photo S26-1 - (May 2013)
Standing near the culvert outlet at Area A at the southern edge of the site looking towards the northwest. Numerous overlays and patches have created a drop-off on the downslope road shoulder northwest of the culvert.

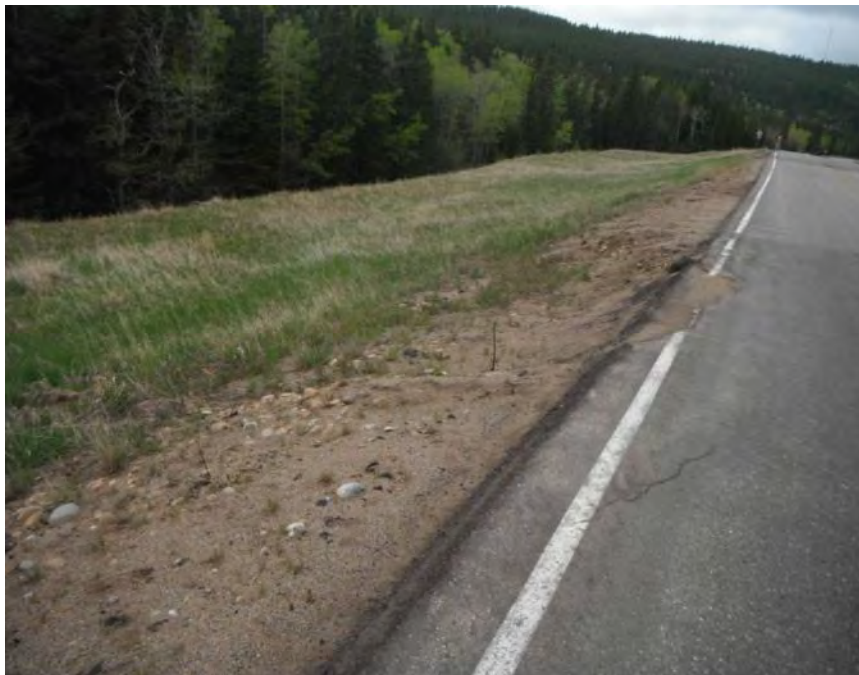
Photo S26-2 - (May 2013)
Facing northwest from the south end of Area A at the west road shoulder. Overlays have been placed at the damaged areas in Fall 2012. Minor cracking and settlement was visible along the shoulder through the new overlay.

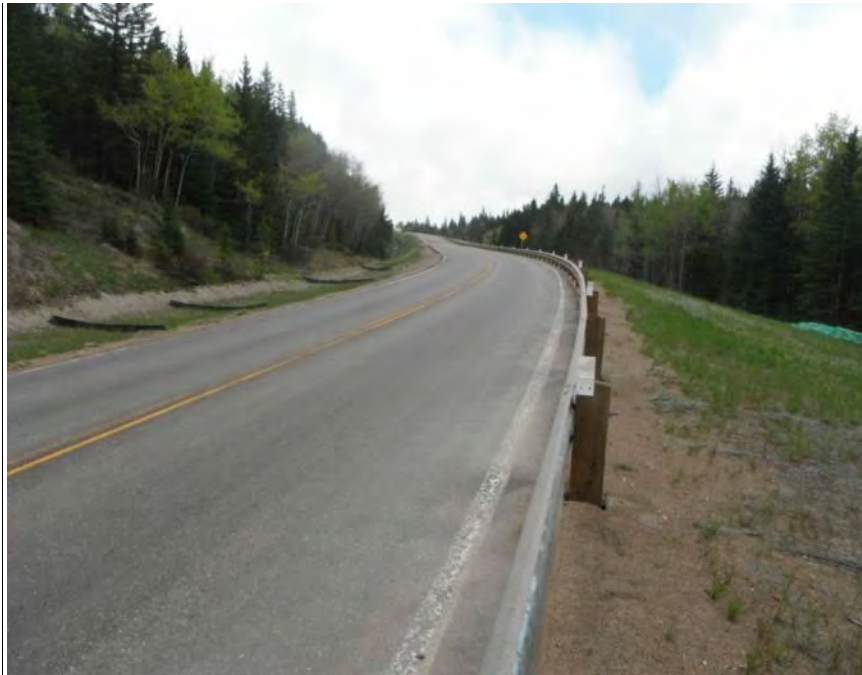
Photo S26-3 - (May 2013)
Facing south from the west side
of Area B.
No new cracking or settlement
was observed on the road
surface.

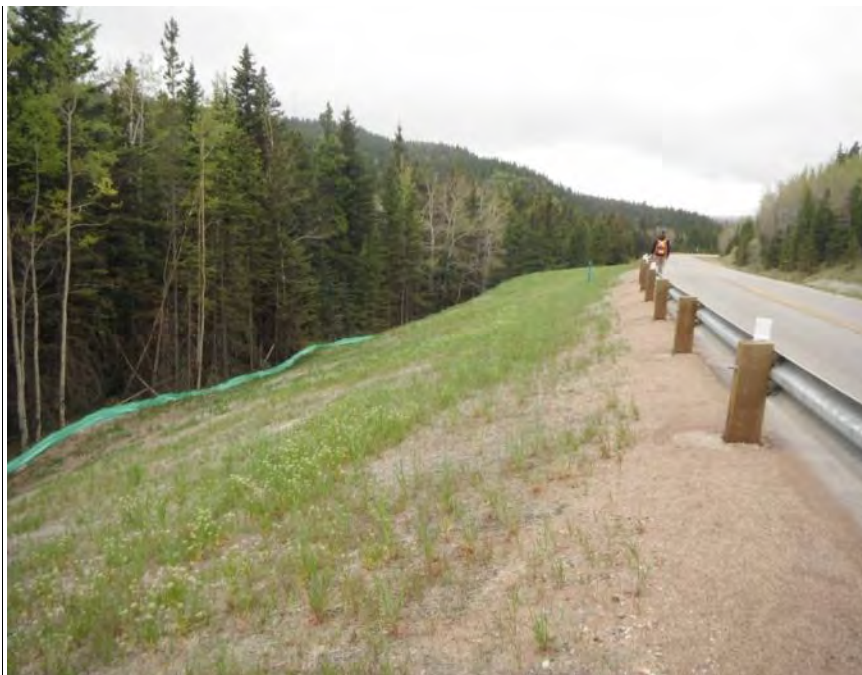
Photo S26-4 - (May 2013)
Facing south from the
upper slope on the west
side of Area B.
Construction of the shear
pile repair was complete in
Fall 2012. Vegetation has
begin to grow during 2013
inspections.
