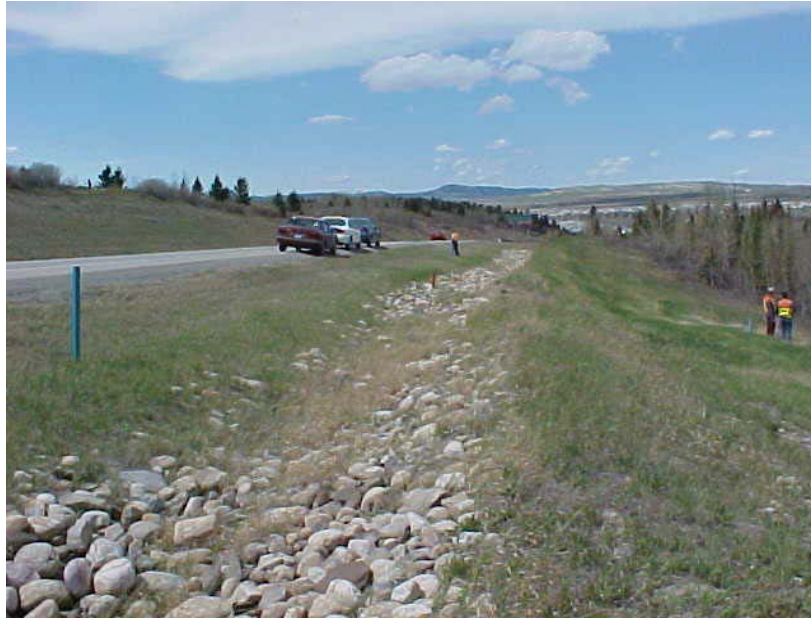
Photo 1 – May 2002 photo of ditch along downslope edge of highway showing area where ditch liner was repaired in summer 2000. Repairs continue to function adequately.

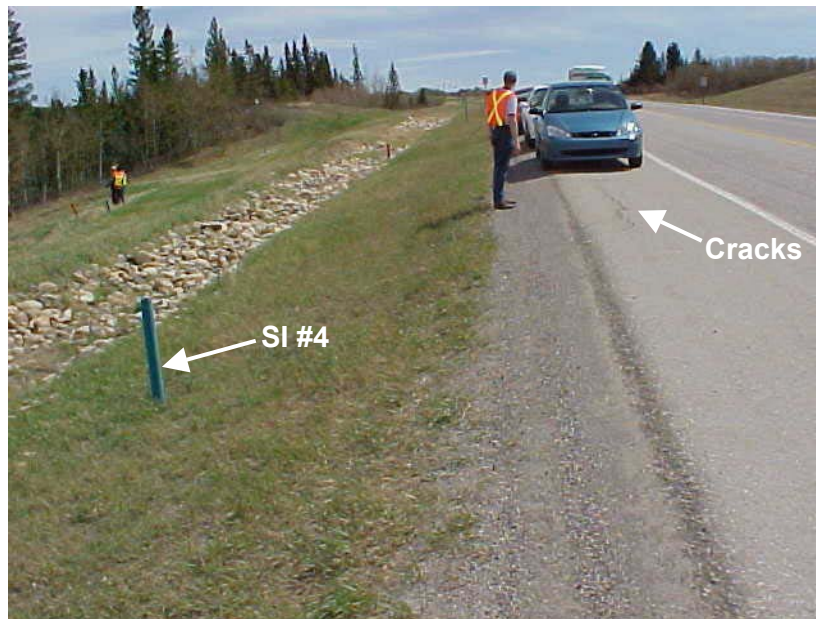
(May 2002)

Photo 2 – Cracking on north shoulder of road adjacent to SI #4 (blue casing on left of photo). The cracking appeared to be longitudinal, but could possibly be associated with continued downslope movement at approximately 2.7 m depth in SI #4.

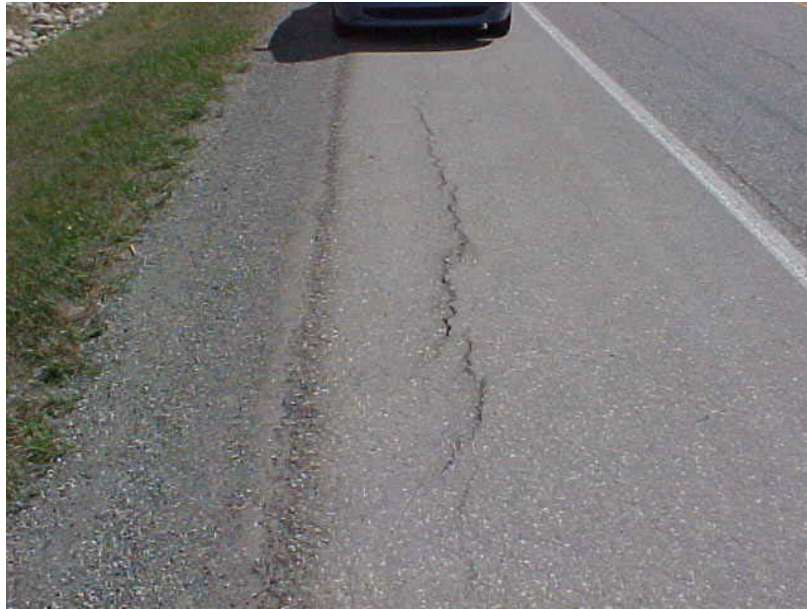
(May 2002)

Photo 3 – Close up view of cracking on north shoulder of road adjacent to SI #4.
