APPENDIX S3
Cochrane

Alberta Transportation
Southern Region Landslide Monitoring Program
Spring 2001 Assessment Report

Site S3 – Cochrane

PROJECT:	SOUTHERN REGION LANDSLIDE MONITORING			
TITLE:	INSTRUMENTATION SITE PLAN HWY 22:00 COCHRANE SLIDE AREA			
CLIENT:	ALBERTA TRANSPORTATION			
DATE:	JOB No.:	CAD FILE:	FIGURE No.:	REV.
OCTOBER 2001	CG25132	25132R03.DWG	FIGURE I-S3	A

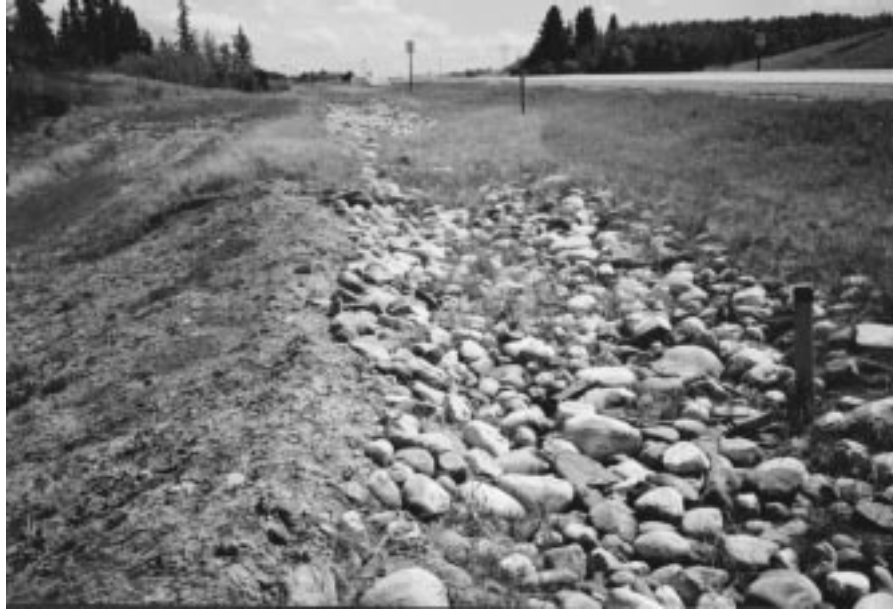
- The liner in the ditch in the downslope side of the road has been repaired as recommended during the spring 2000 site assessment.
- No indications of the slide extending above the highway ditch were observed. No slide related damage to the paved surface was observed.
- The landslide mechanism appeared to be primarily translational and limited to a few meters depth – as was the case during the previous annual inspection. Previous slope inclinometer readings are consistent with this mechanism.
- The slope inclinometer readings since the previous assessment have not shown any significant movement.
- Local scarps within the slide mass (previously noted to be active) were weathered, indicating that movements have not occurred recently.

Photo 1 – Ditch along downslope edge of highway showing area where ditch liner was repaired in summer 2000. Effective drainage should be maintained to minimize the amount of surface drainage entering the slide area.

The ditches preventing surface water from draining into the slide area should be monitored on a regular basis by maintenance personnel and repaired as necessary in the future.

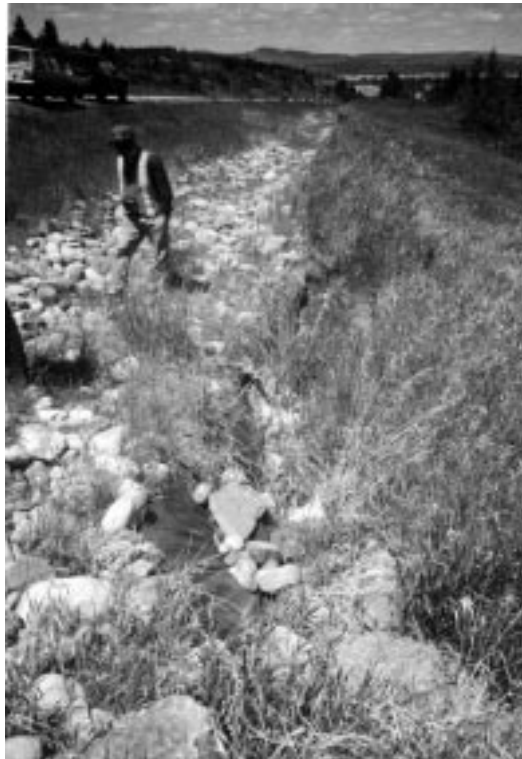
Photo 2 – June 2000 photo showing damaged ditch liner. The damage to the liner likely allowed surface drainage to flow into slide area, possibly exacerbating movements.

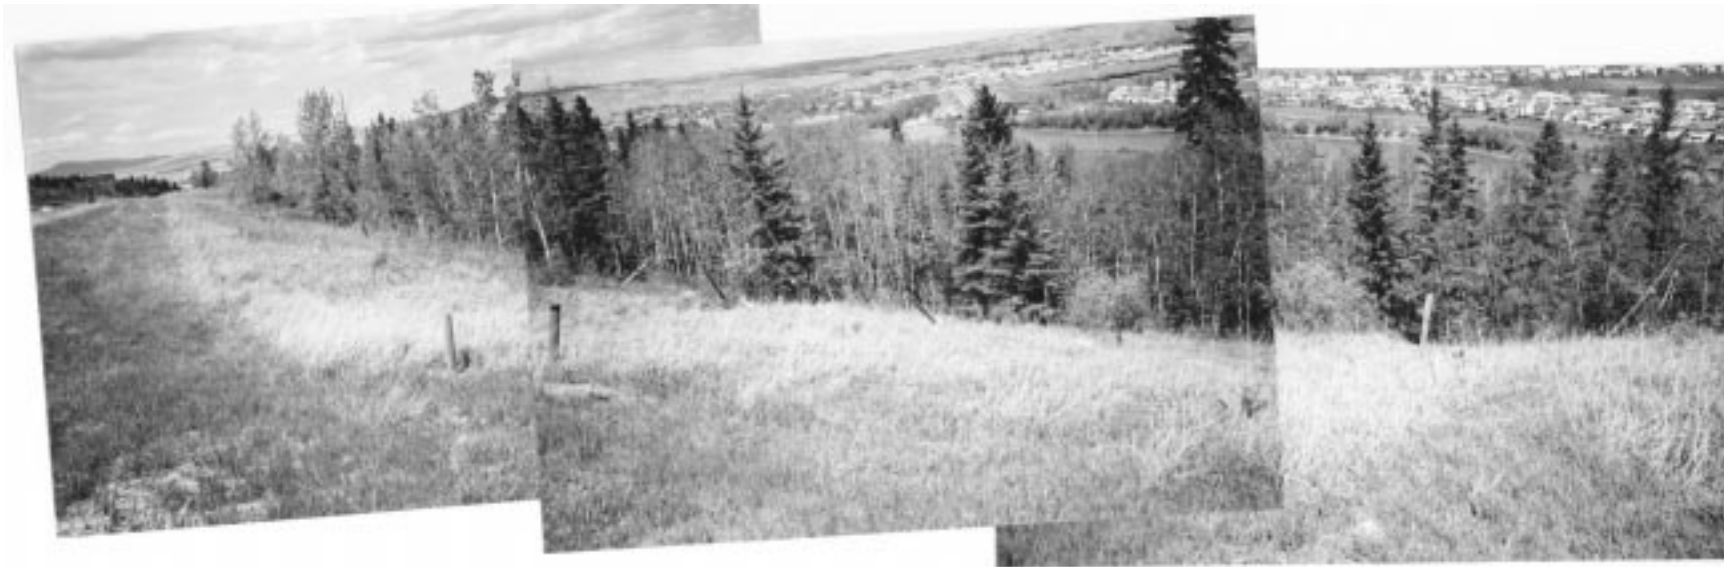
Photo 3 – Panorama across slide area, as seen from downslope edge of road. Note fenceline distorted by shallow movements. Bow River in background separated from toe of overall slope by a low level river terrace.
