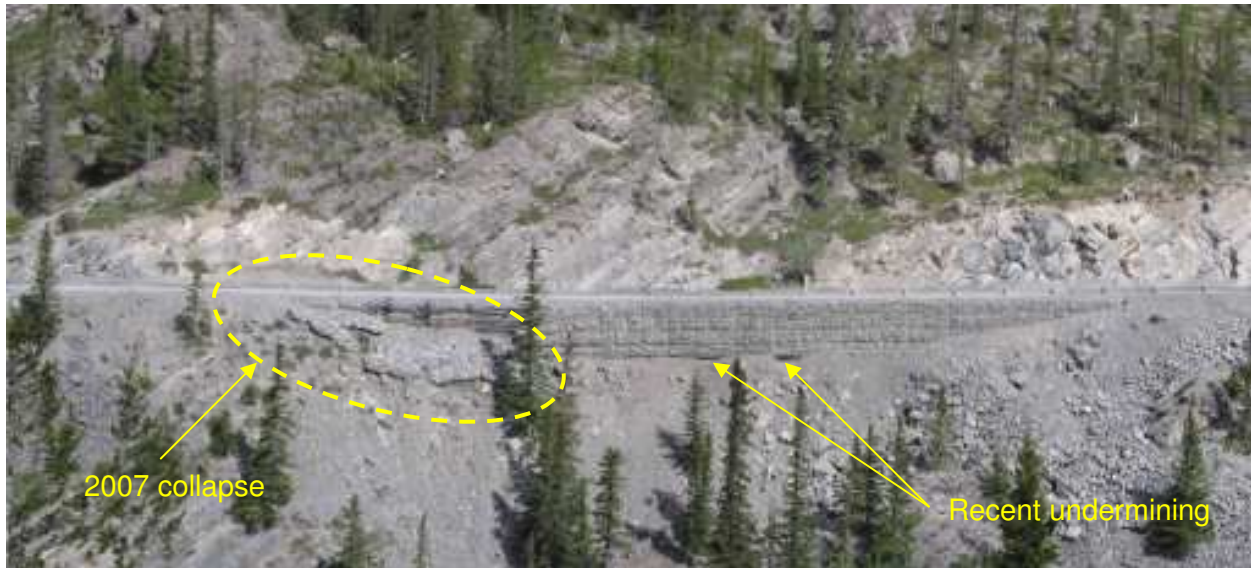
Photo S30-1 (top) – June 2008

Facing north towards the gabion wall from across the valley. The segment of the wall that collapsed in 2007 is visible on the left, and the more recent undermining of the portions of the eastern end of the wall is visible on the right.

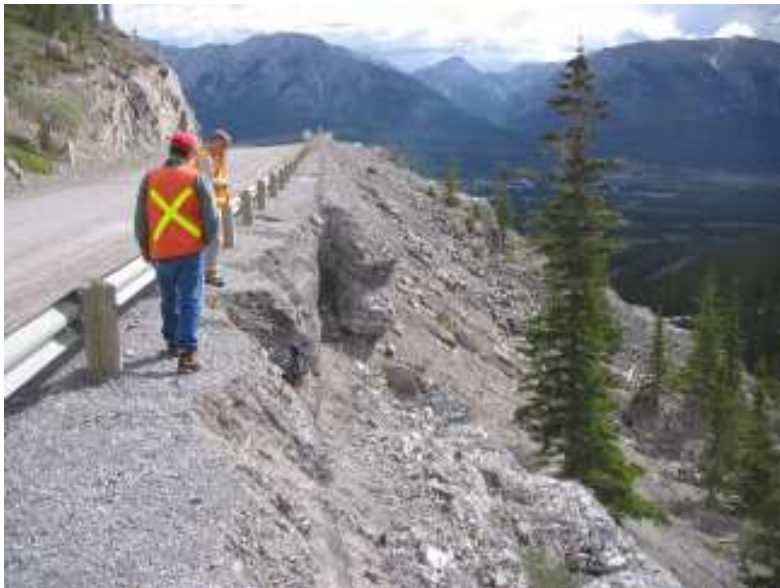
Photo S30-2 (bottom) – June 2008

Facing east along the wall alignment from the west end of the wall. The collapsed segment of the wall is visible in the foreground. Note the erosion gullies that are forming along the downslope edge of the highway above the collapsed segment of the wall.

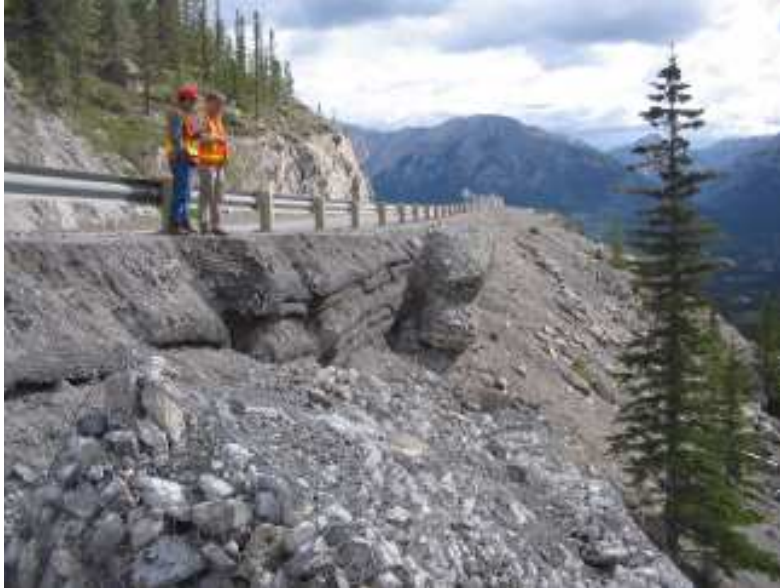
Photo S30-3 (top) – June 2008
Facing east across the collapsed segment of the wall. The exposed front wraps of the geogrid supporting the road embankment fill are visible. Ravelling of the granular fill out from behind the geogrid wraps has been ongoing but has not yet compromised the geogrid support to the highway.

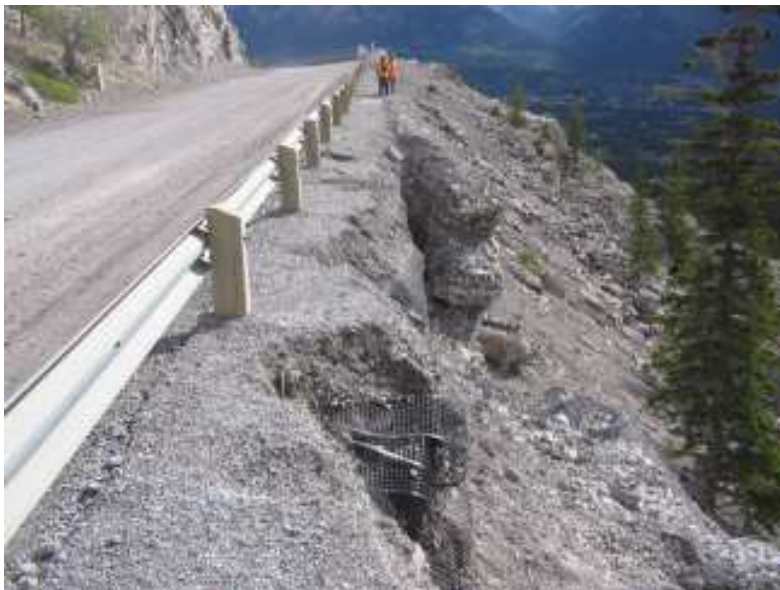
Photo S30-4 (bottom) – June 2008
Gullying and surface erosion along the downslope edge of the highway, above the collapsed segment of the wall. The geogrid within the road embankment continues to support the highway, but the loss of erosion protection provided by the gabion wall has allowed this surface erosion to develop and retrogress back towards the guardrail.

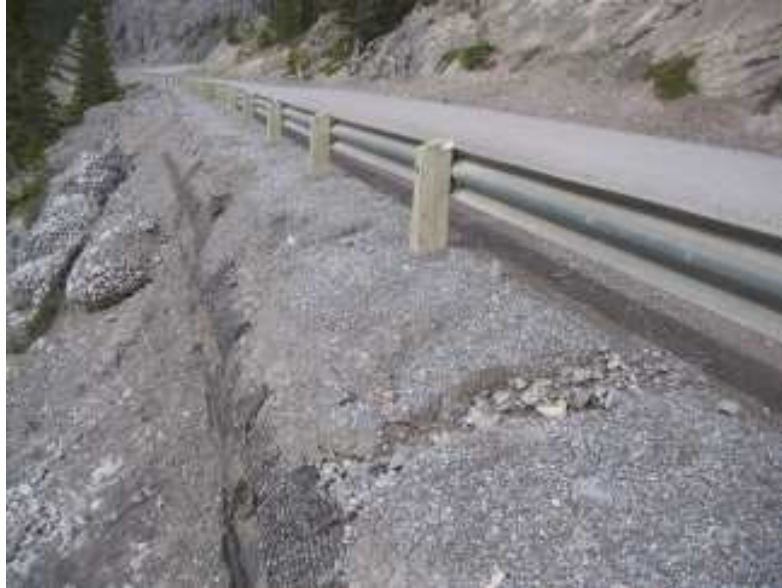
Photo S30-5 (top) – June 2008
Another view of surface erosion developing above the collapsed segment of the wall. Without the erosion protection provided by the gabion wall, surface runoff from the highway is able to downcut through the downslope edge of the embankment and wash away the fill from above the uppermost layer of geogrid.

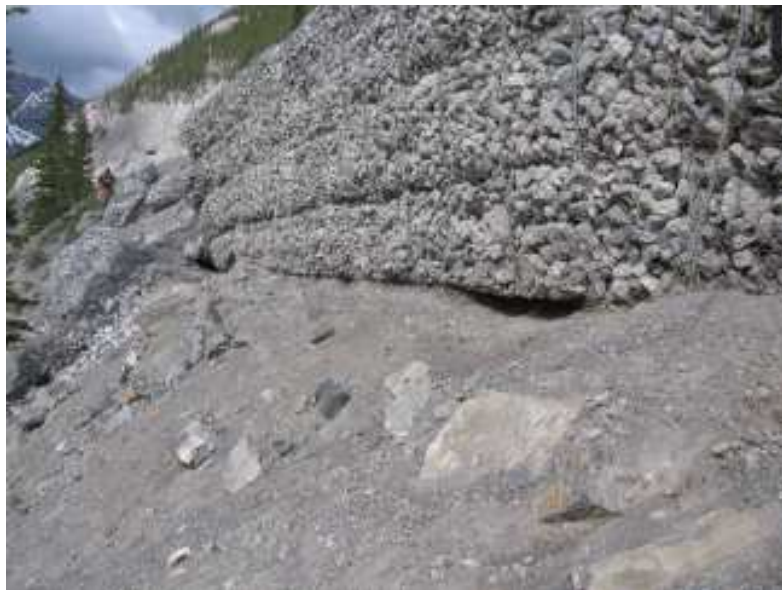
Photo S30-6 (bottom) – June 2008
Recent undermining of a portion of the eastern end of the gabion wall. There was no flow at the time of the site inspection, however it appeared that groundwater discharge (or possibly surface runoff from the highway percolating downwards through the gabion baskets) has been washing away the slope material below the base of the wall. Similar erosion was likely the cause of the 2007 collapse of the western end of the wall.

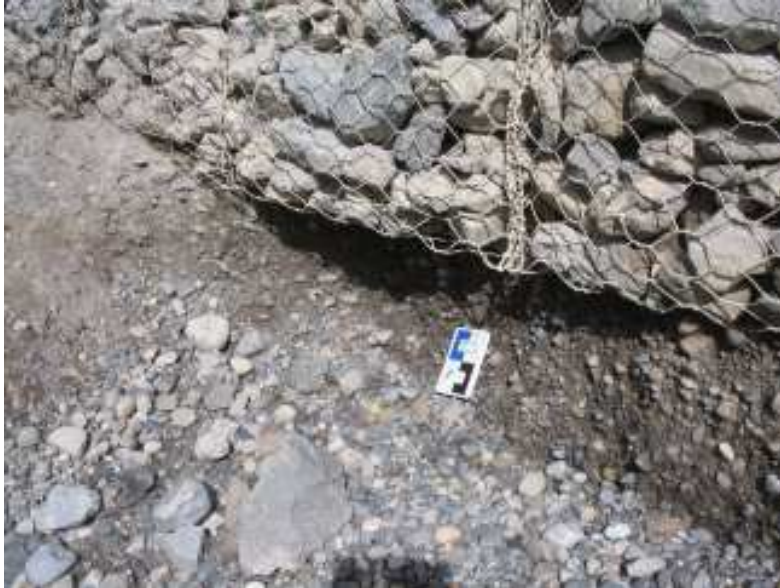
Photo S30-7 (top) – June 2008

Closer view of recent undermining of a portion of the eastern end of the wall. The voids and undercutting of the wall base were up to 2 m wide and 0.3 to 0.4 m laterally under the base of the wall.
