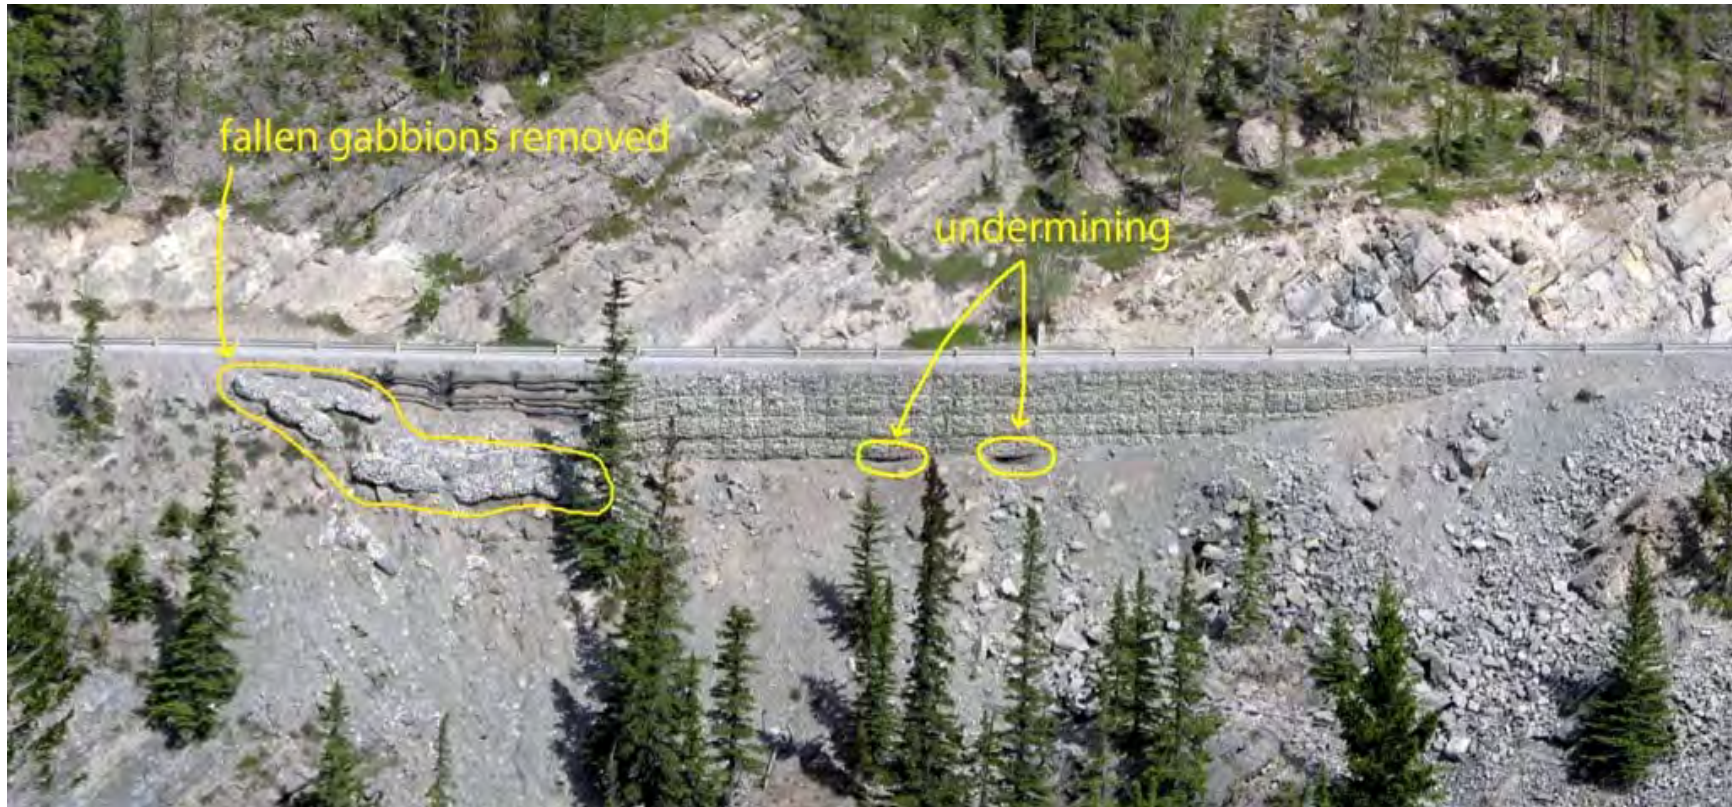
Photo S30-1 – June 2008

Facing north towards the gabion wall from across the valley. The segment of the wall that collapsed in 2007 and the undermined areas are noted.

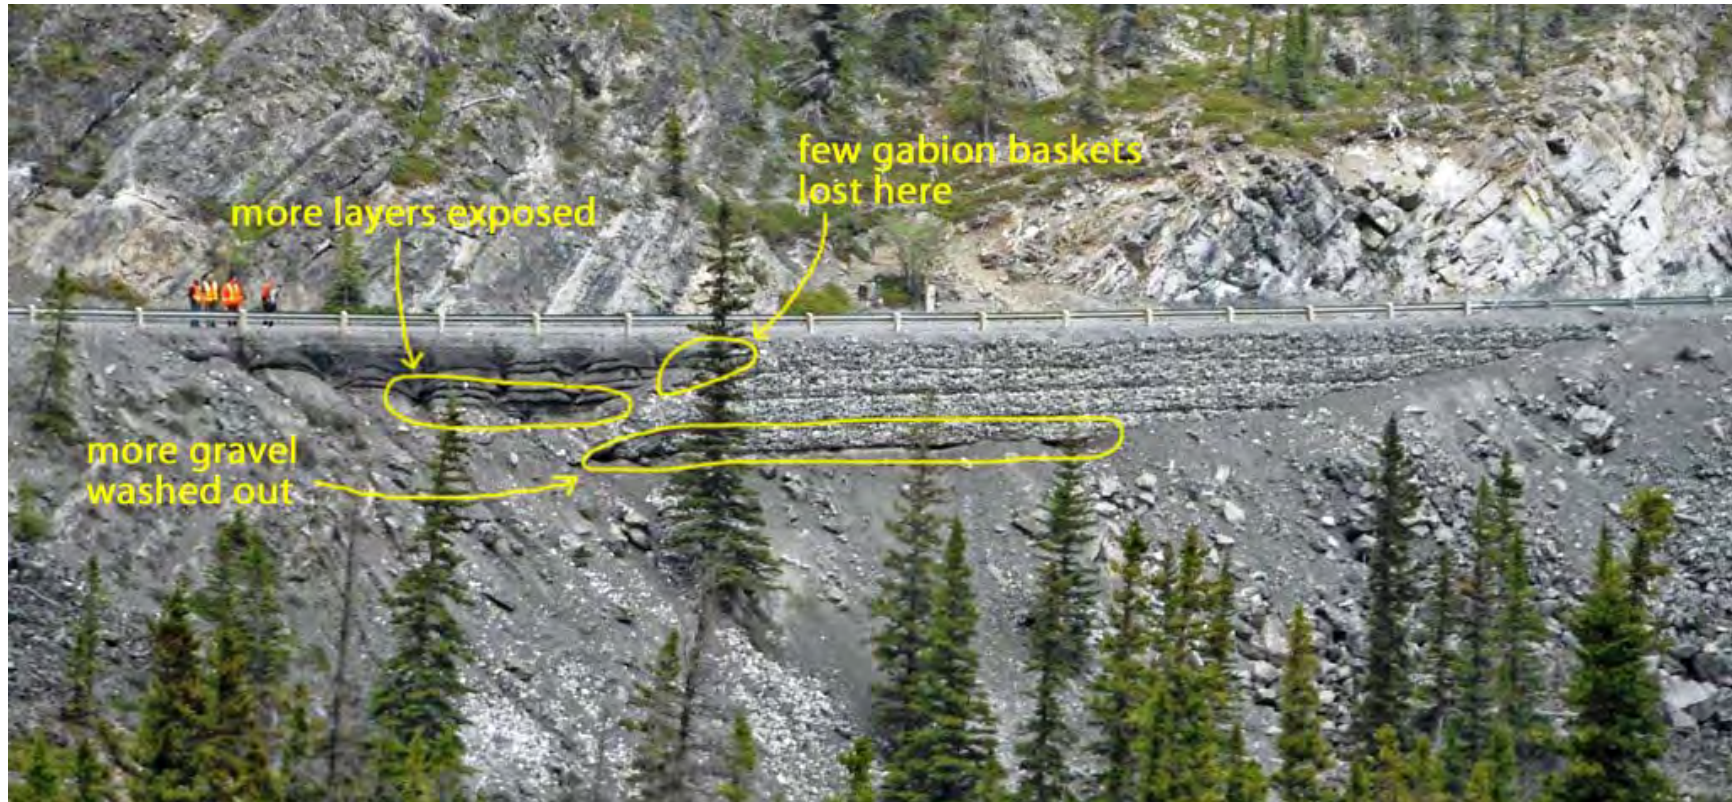
Photo S30-2 – June 2012

Facing north towards the gabion wall from across the valley from the same location as Photo S30-1. The gabion baskets from the collapsed segment of the wall have been removed. The undermining at the base of the wall has expanded.

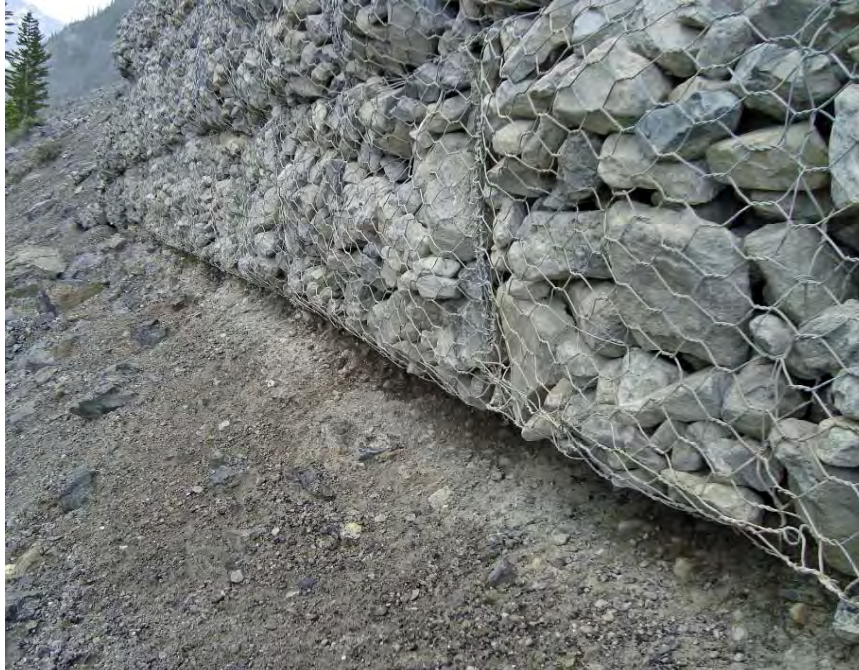
Photo S30-3 – June 2012
Undermining at the base of the eastern end of the gabion wall. There was no flow at the time of the site inspection. The undermining has expanded considerably since 2008.

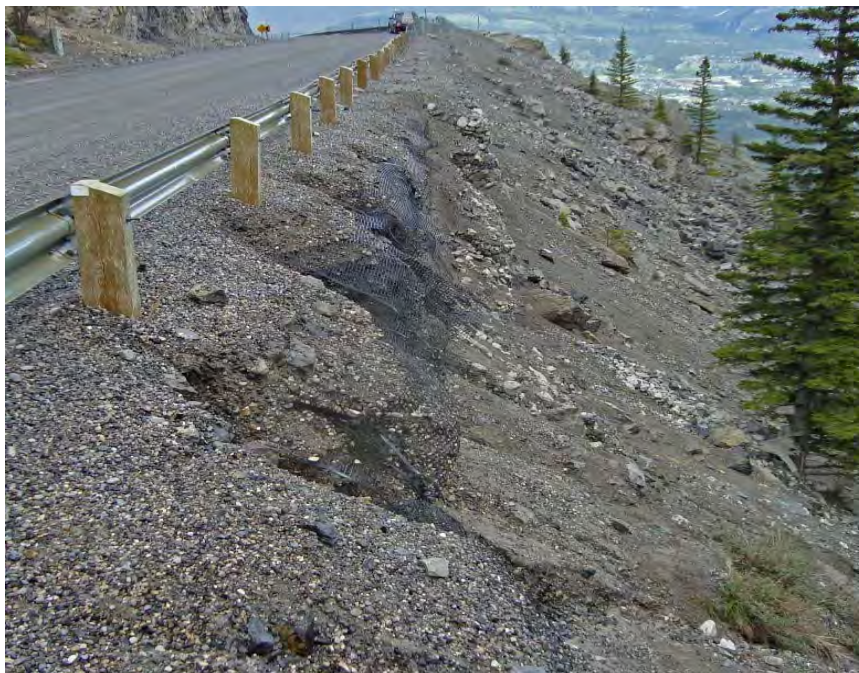
Photo S30-4 – June 2012
Gullying and surface erosion along the downslope edge of the highway, above the collapsed segment of the wall. The geogrid within the road embankment continues to support the highway, but the loss of erosion protection provided by the gabion wall has allowed surface erosion to continue and retrogress back to the edge of the guardrail since the 2008 inspection.
