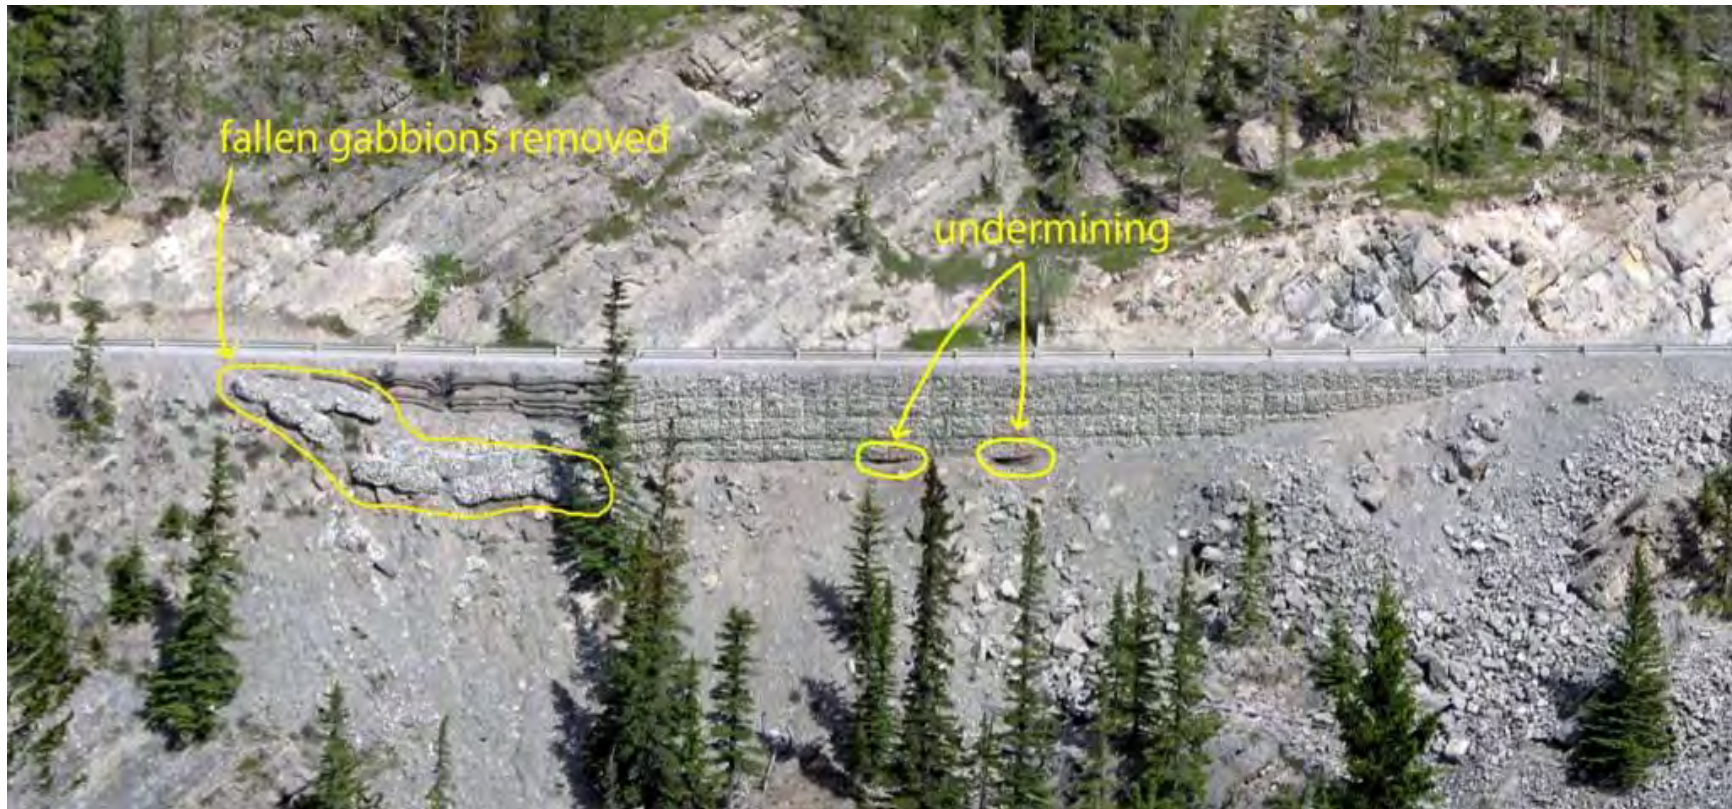
Photo S30-1 – June 2008

Facing north towards the gabion wall from across the valley. The segment of the wall that collapsed in 2007 and the undermined areas are noted.

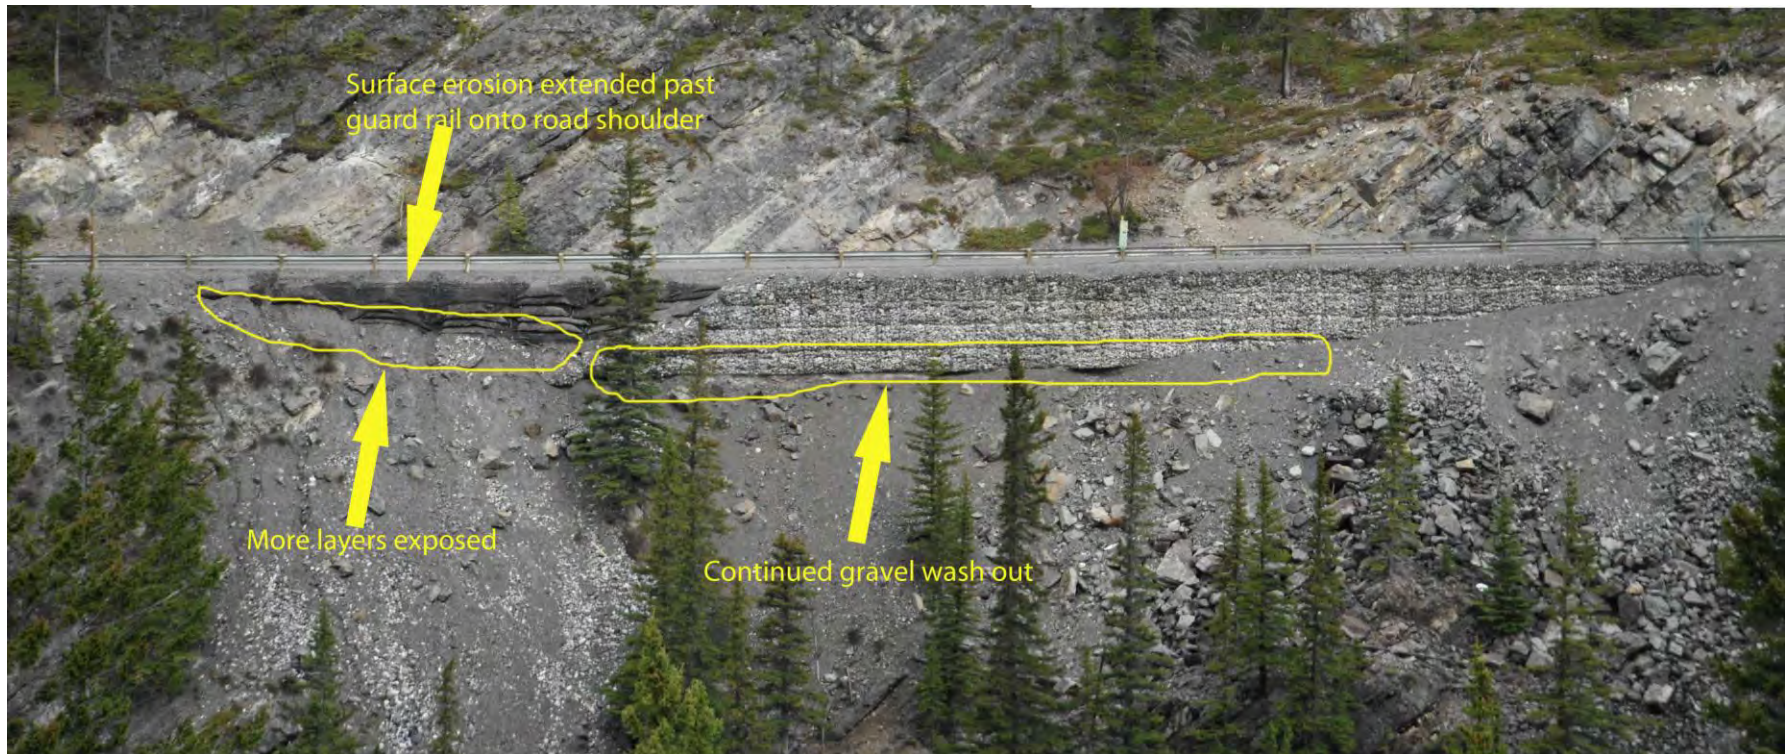
Photo S30-2 – May 2013

Facing north towards the gabion wall from across the valley from the same location as Photo S30-1. The undermining at the base of the wall has expanded and additional gabion baskets are damaged due to erosion. The surface erosion has also extended past the guard rails into the road shoulder.

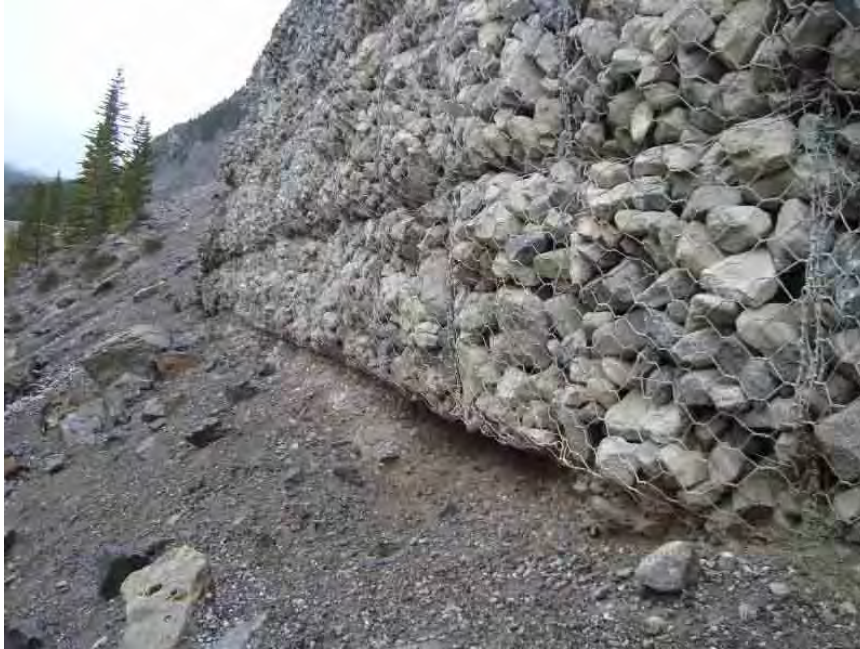
Photo S30-3 – May 2013
Undermining at the base of the northeast end of the gabion wall. There was no flow at the time of the site inspection but the soil was wet.

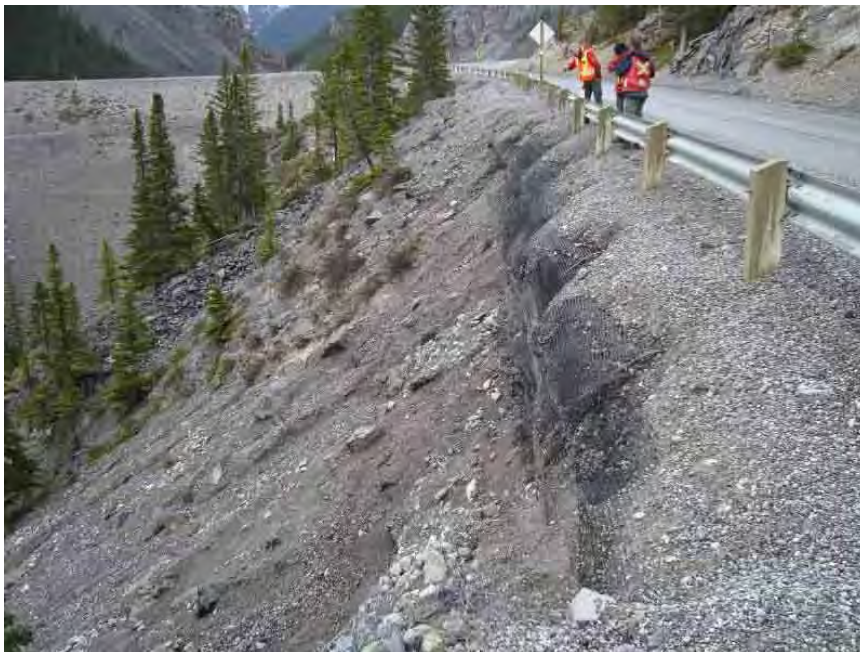
Photo S30-4 – May 2013
Erosion along the downslope edge of the highway, above the collapsed segment of the wall. The geogrid within the road embankment continues to support the highway, but the loss of erosion protection provided by the gabion wall has allowed surface erosion to continue. Since the previous inspection, the erosion has retrogressed onto the shoulder and approximately 200 mm past the guard rails.
