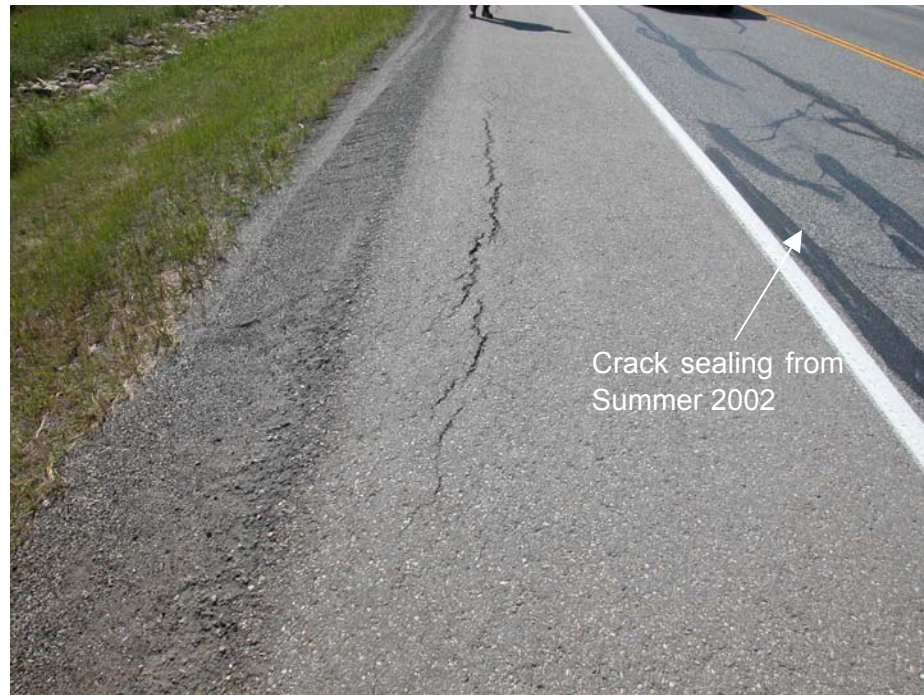
Photo 1 (upper left) – July 2003
Cracking on the north shoulder of the road, adjacent to SI #4. Crack appears to have widened slightly since the May 2002 inspection (compare with Photo 2).

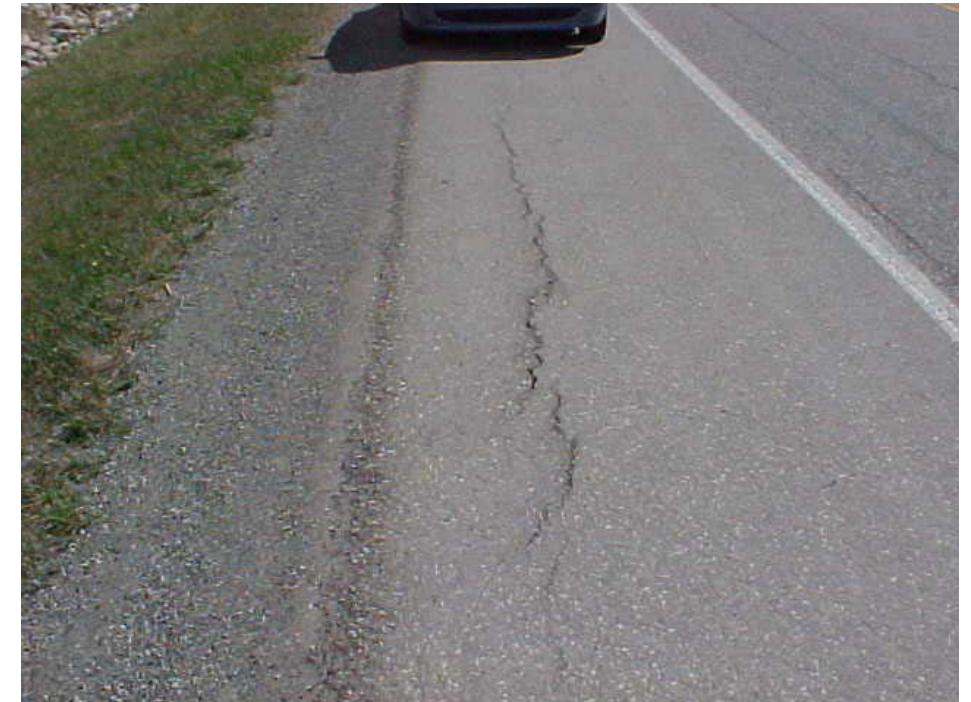
Photo 2 (upper right) – May 2002
Same area as shown on Photo 1, as seen during May 2002 inspection.

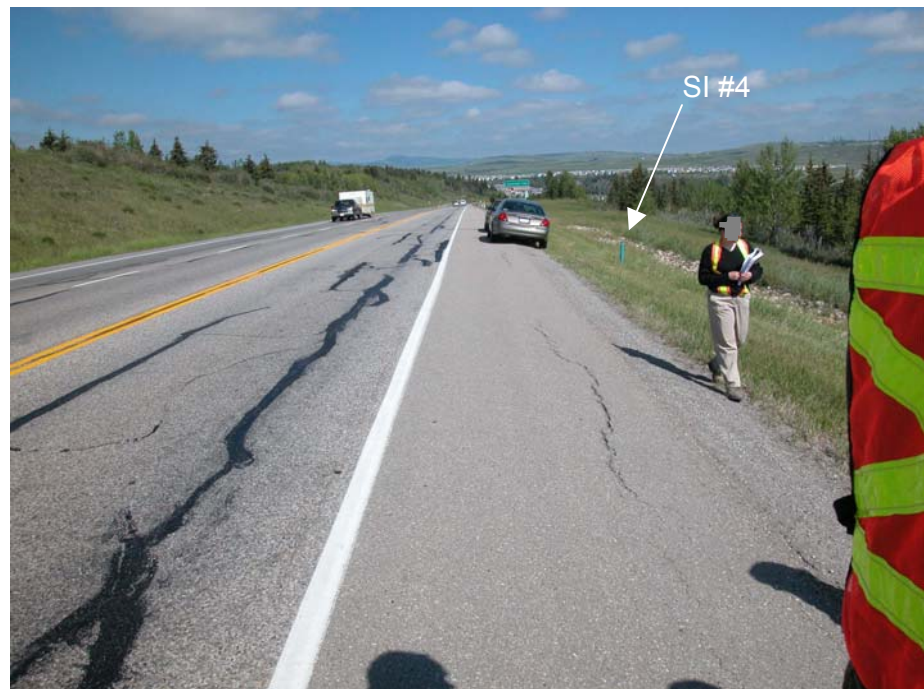
Photo 3 (lower left) – July 2003
General view of cracking in the north shoulder of the road. The crack visible in the foreground appears to have developed since the May 2002 inspection, and is adjacent to SI #2 (just off the right hand side of this photo).

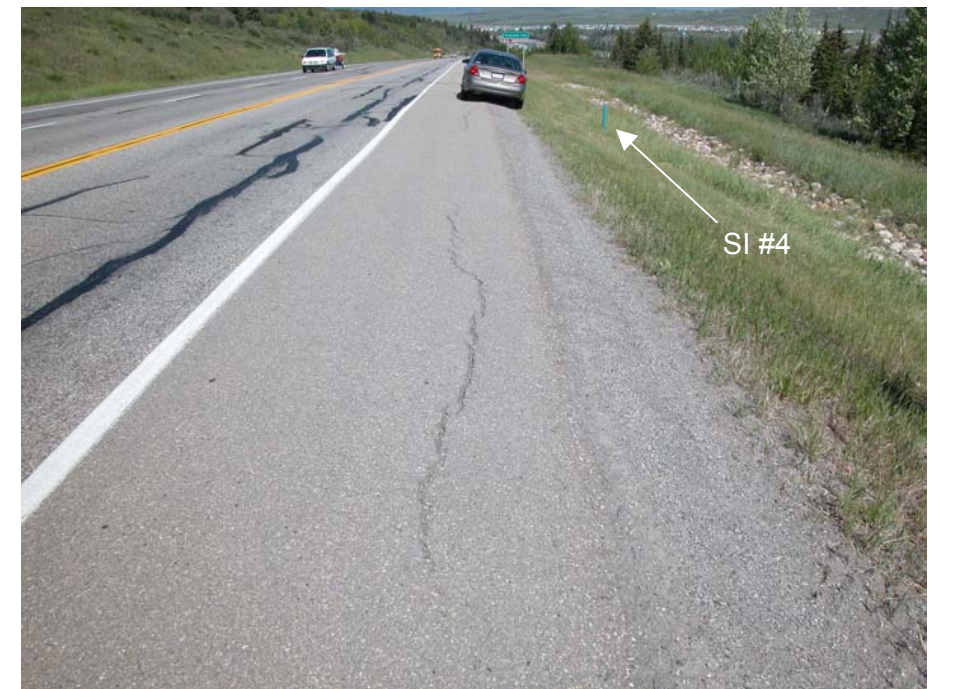
Photo 4 (lower right) – July 2003
Another view of the crack adjacent to SI #2 that has developed since the May 2002 inspection.

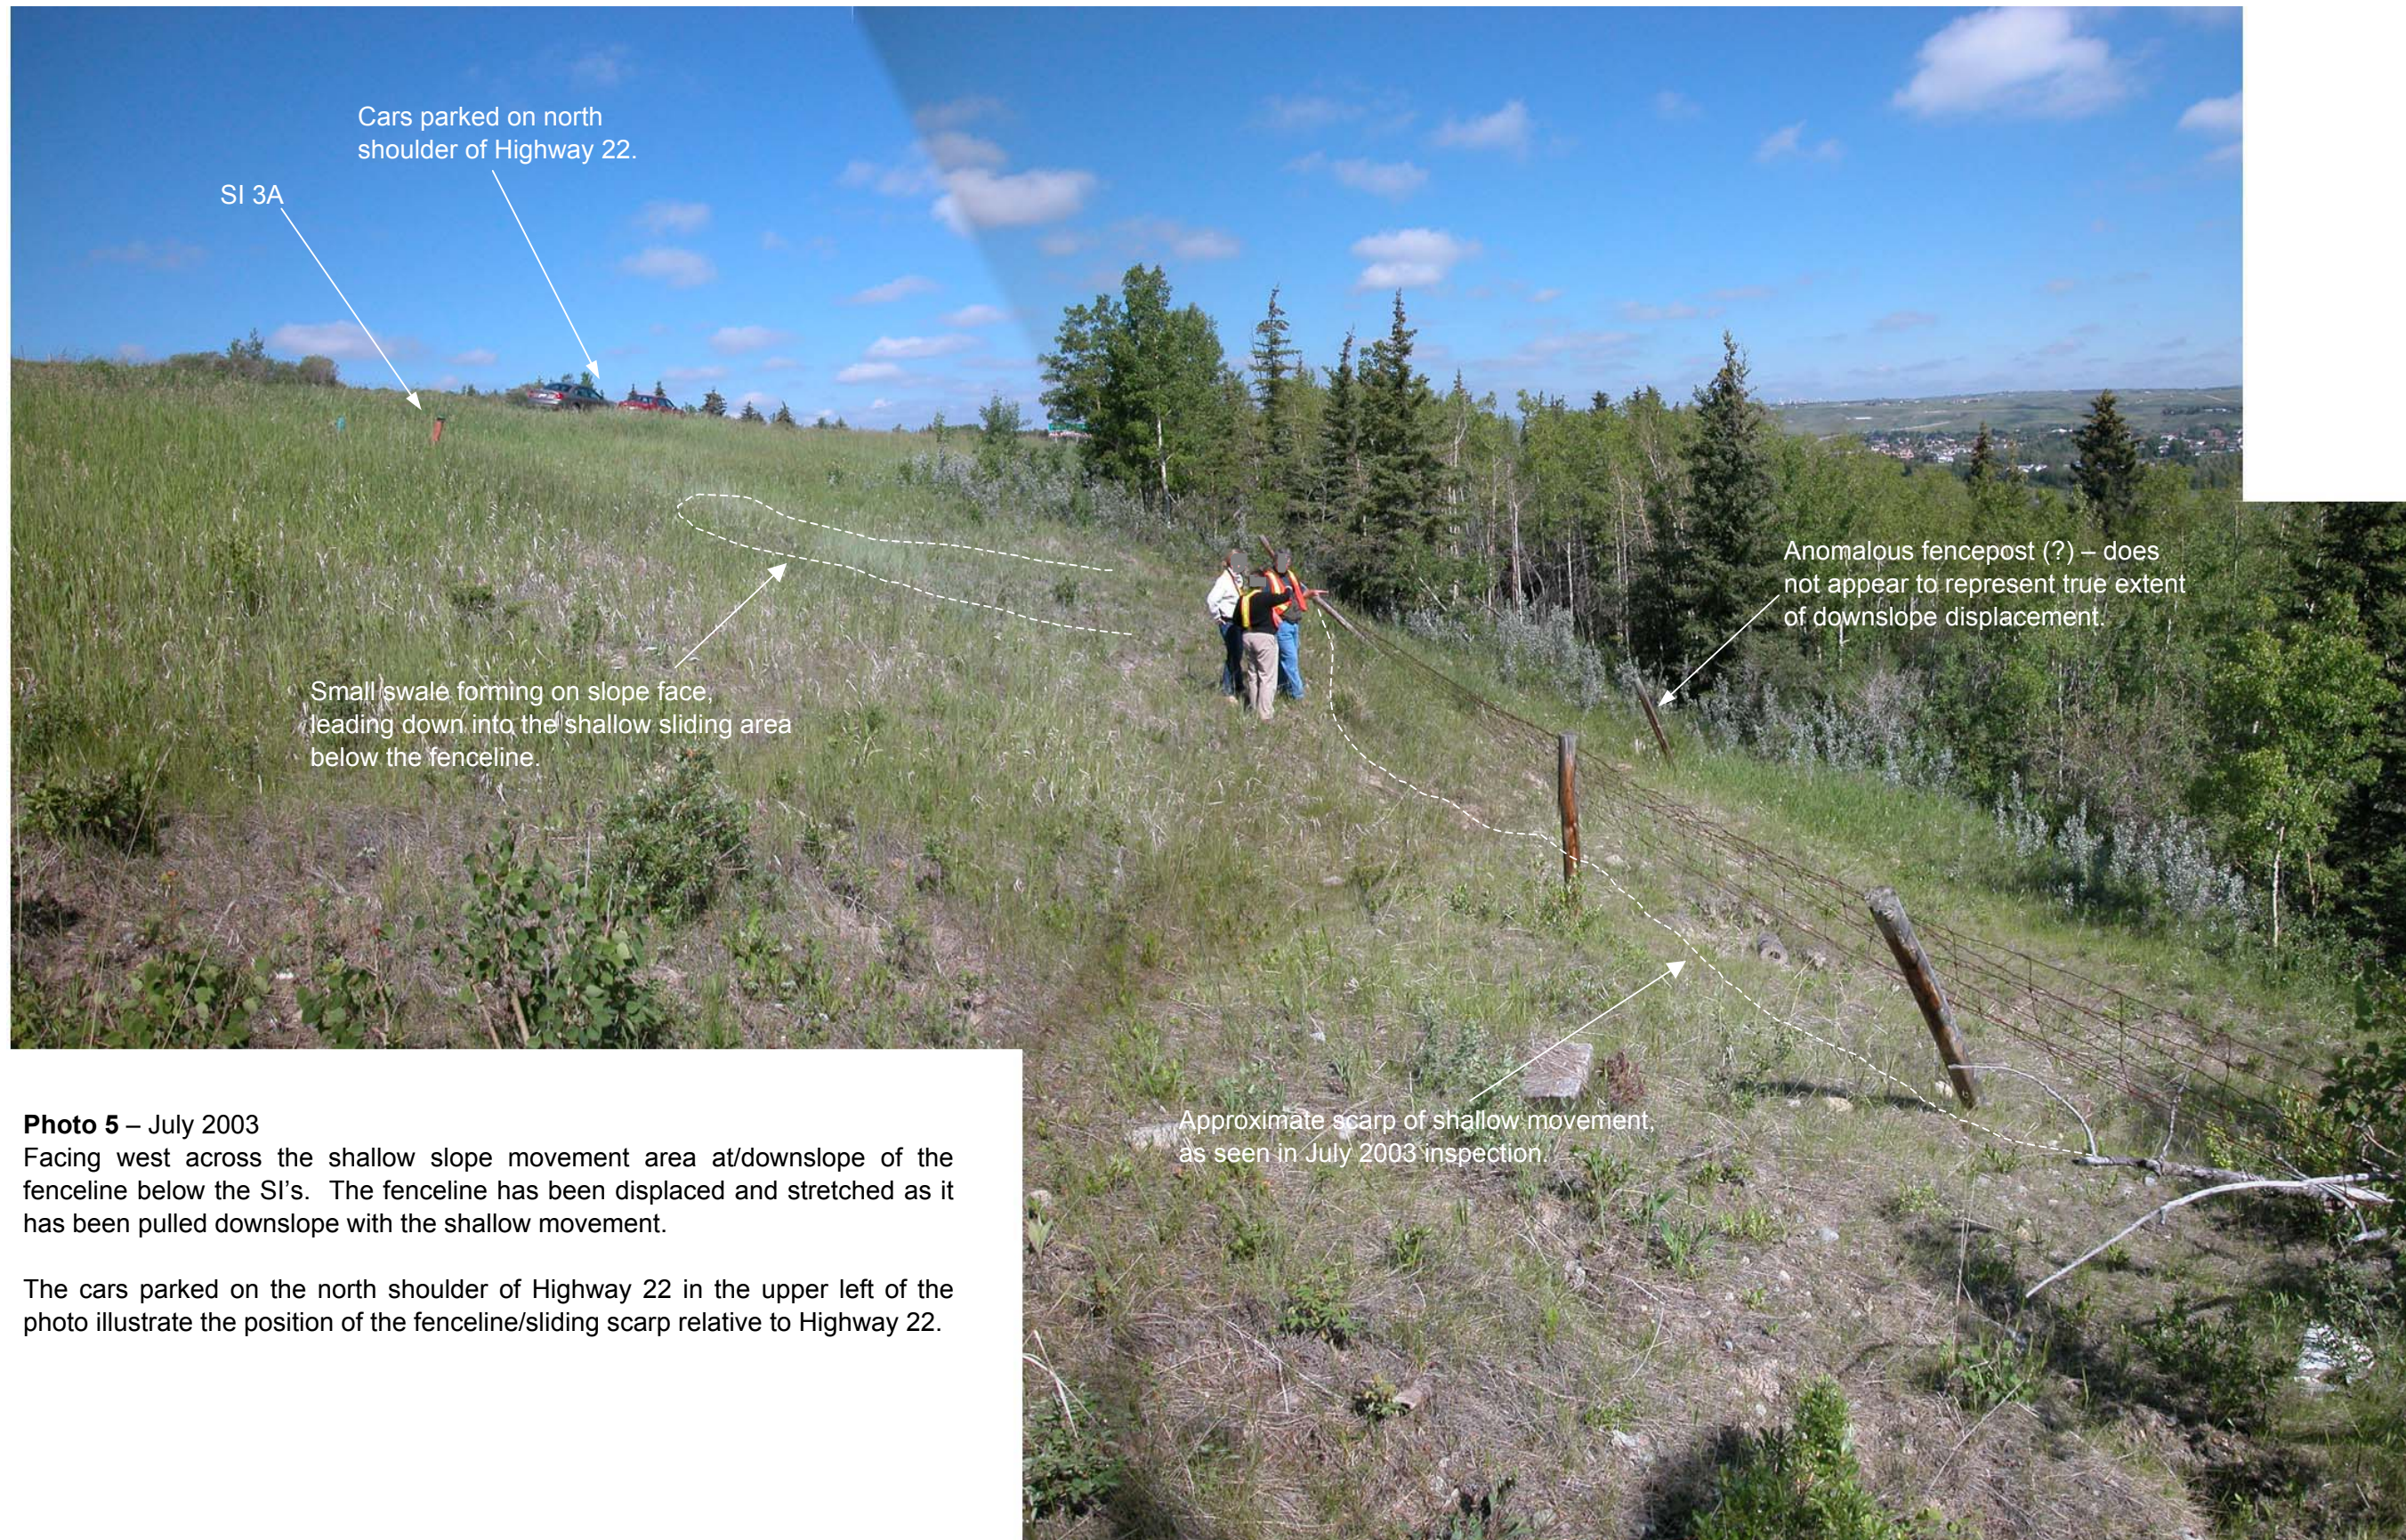
Photo 5 – July 2003

Facing west across the shallow slope movement area at/downslope of the fenceline below the SI's. The fenceline has been displaced and stretched as it has been pulled downslope with the shallow movement.

The cars parked on the north shoulder of Highway 22 in the upper left of the photo illustrate the position of the fenceline/sliding scarp relative to Highway 22.

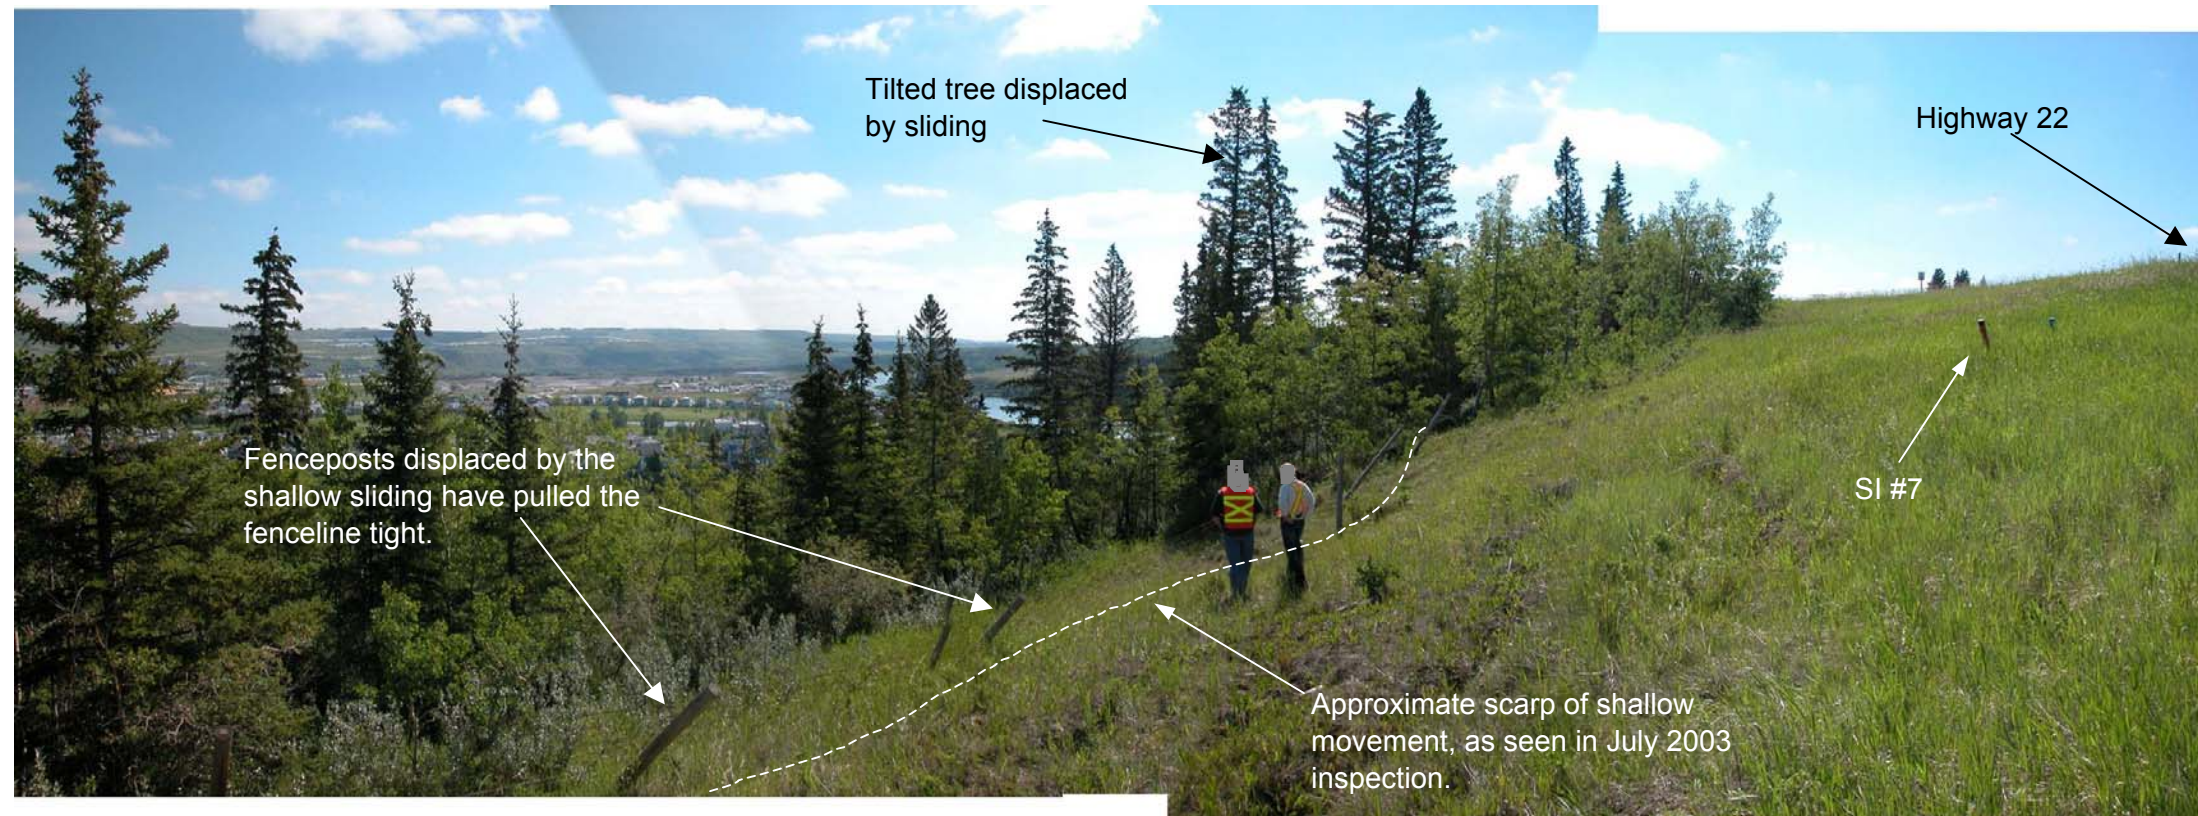
Photo 6 – July 2003
Facing east across the shallow slope movement area at/downslope of the fenceline.

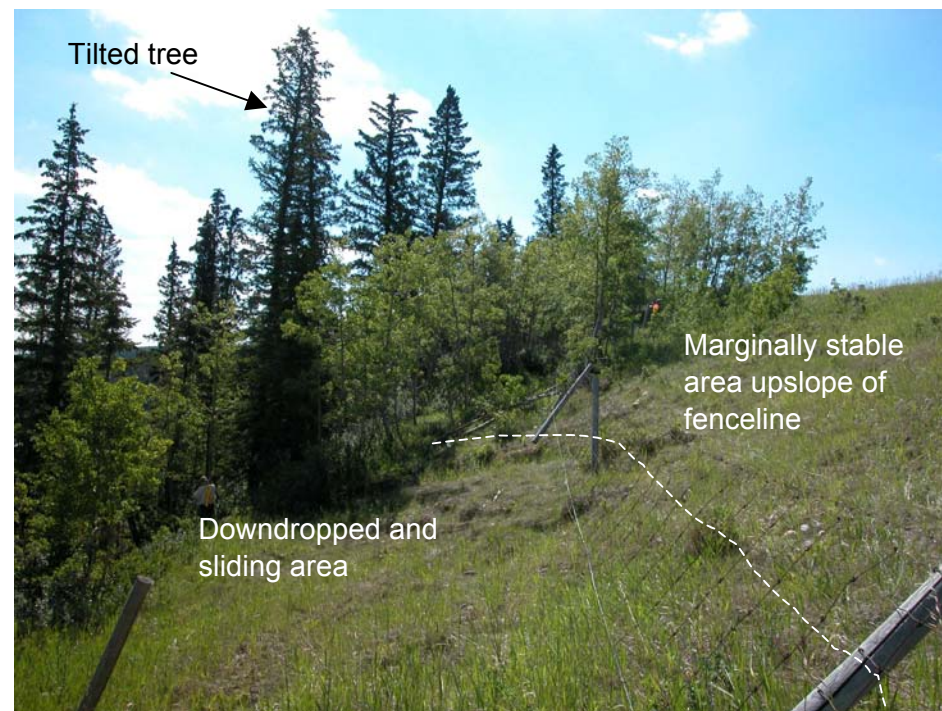
Photo 7 (left) – July 2003
Closer view of the east end of the shallow sliding area. The scarp of the shallow sliding is visible along the fenceline for approximately 25 to 30 m, and then arcs downslope into the trees on both flanks. Ongoing slope movement at moderate rates has displaced the fenceline, opened up tension cracks in the soil cover and back-tilted trees that are in the movement area.

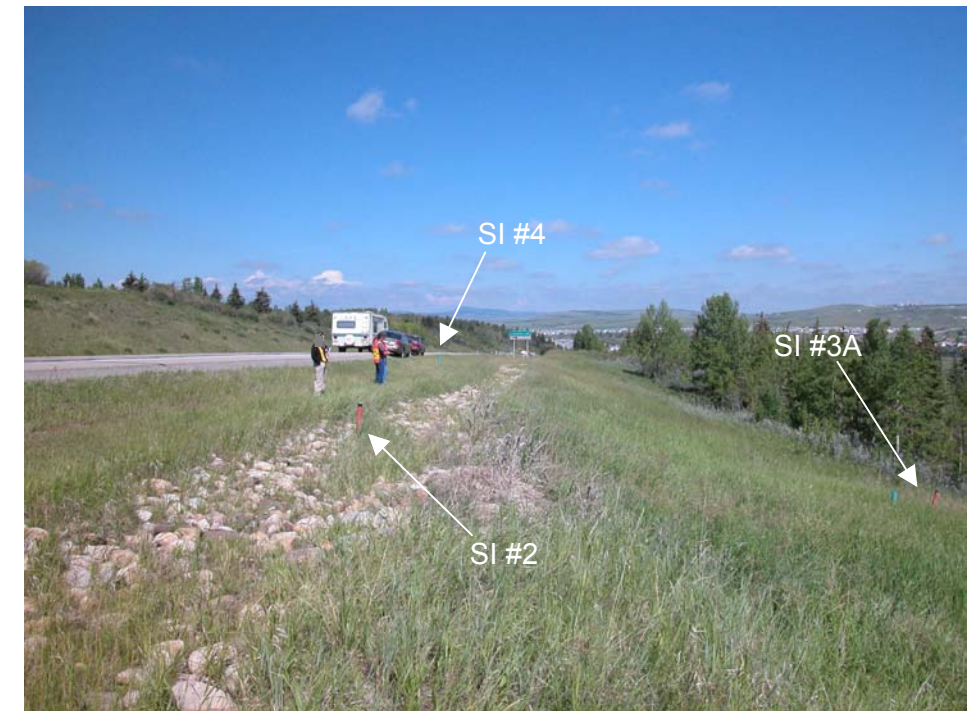
Photo 8 (right) – July 2003
Facing west along ditchline parallel to north shoulder of Highway 22. Repairs to the ditch liner continue to function adequately, however it appears that some relatively low gradient/high spots in the ditch may be allowing water to pool in the ditch and possibly overflow during peak flow times – leading to the development of the minor gully (shown in Photo 5) leading into the shallow sliding area at the fenceline.
