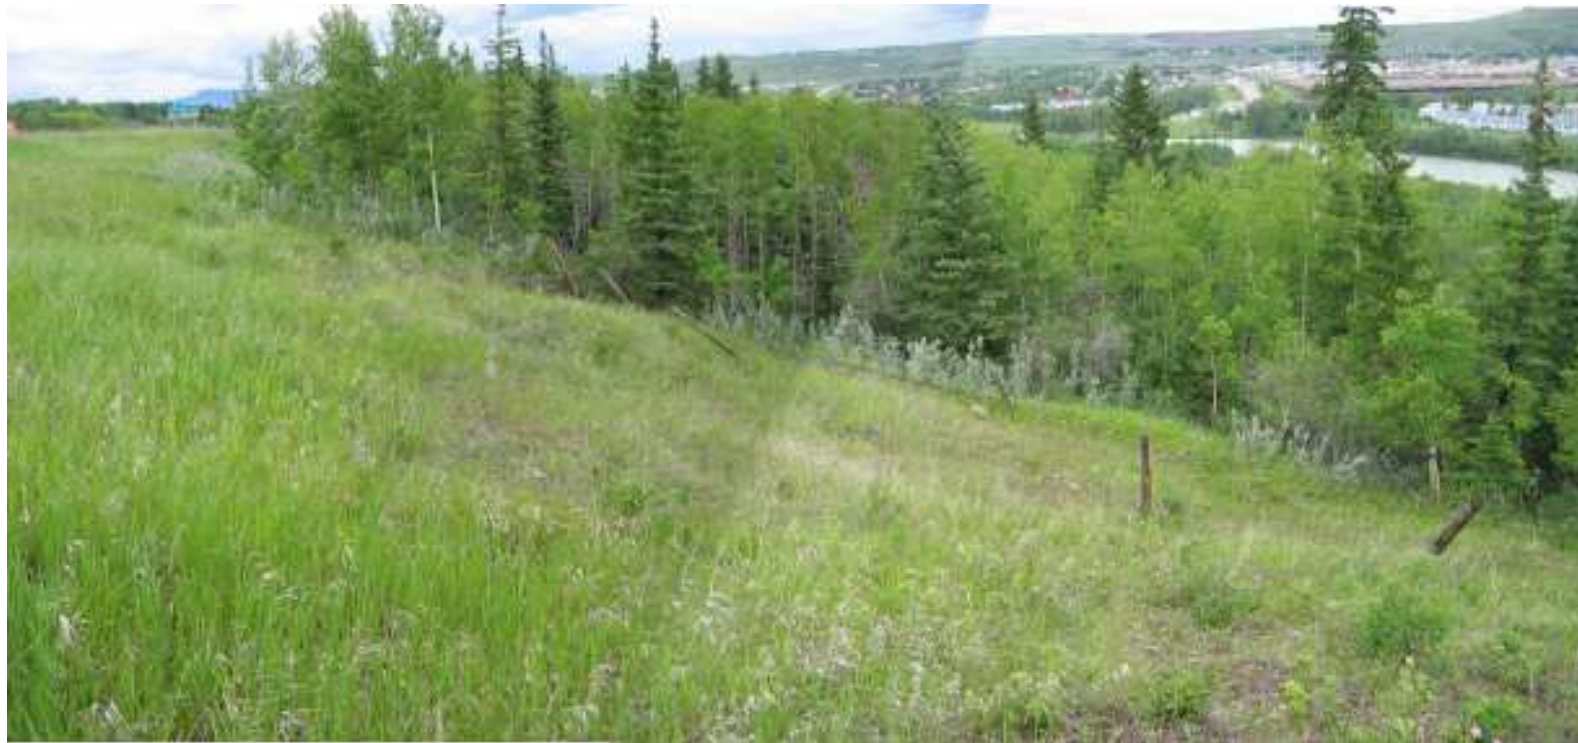
Photo S3-1 (upper left) – June 2005 – Facing west across the S3 – Cochrane site. The fenceline has been displaced and stretched tight as a result of ongoing slope movement. The visible headscarp cracking of this slope movement is approximately 1 m upslope of SI#3A, which is located just off the left edge of the photo.

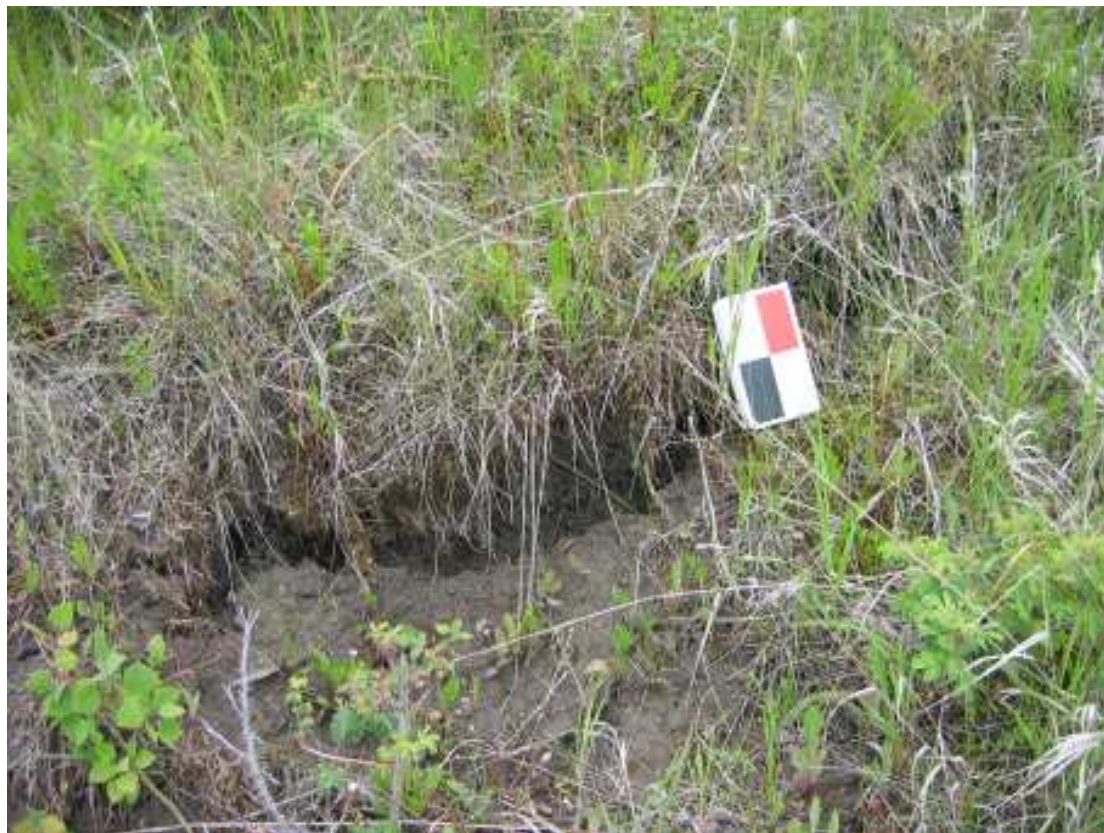
Photo S3-2 (lower left) – June 2005 – tension crack showing recent movement around the north flank of the slope movement shown in Photo S3-1. Field notebook for scale.

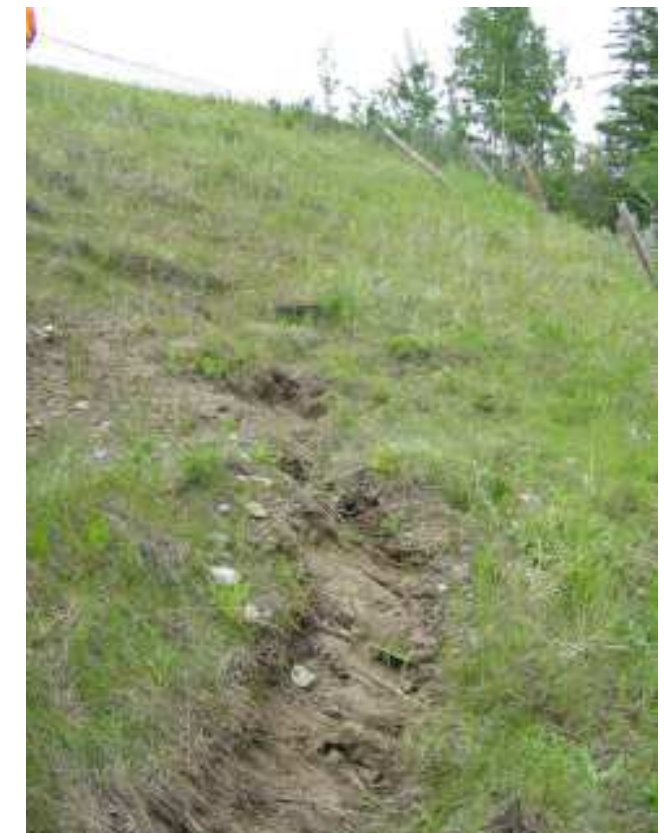
Photo S3-3 (lower right) – June 2005 – shallow sloughing on slope to the north of the road. This particular feature was new this year and most likely developed during heavy rainfall in mid to late June 2005.

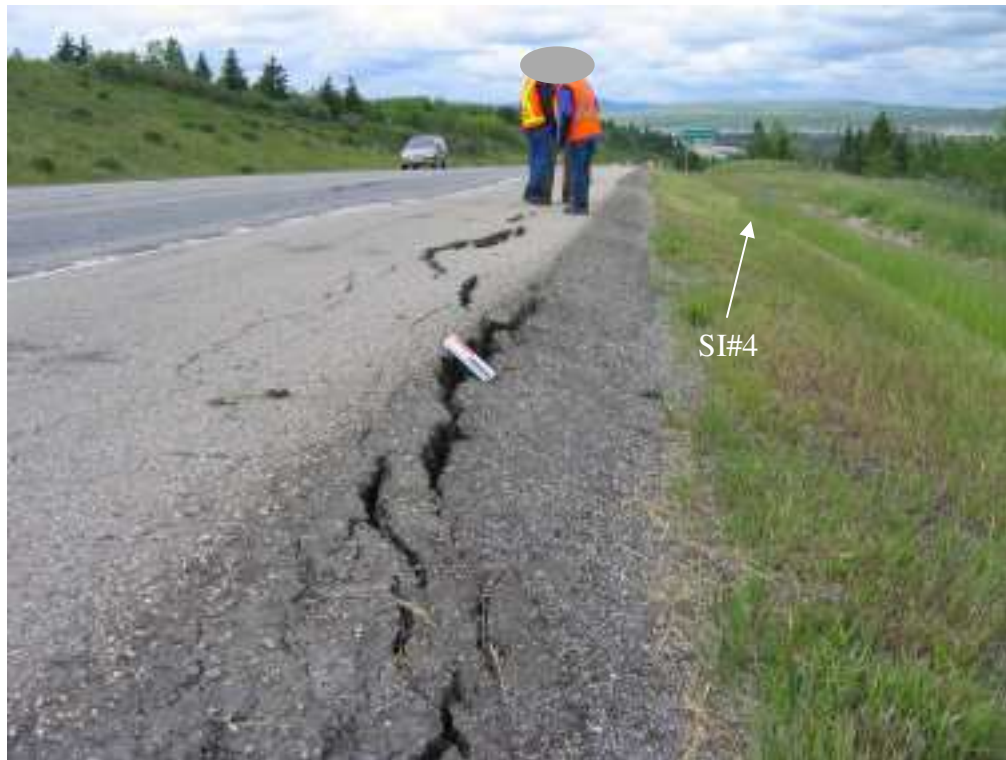
Photo S3-4 (upper left) – June 2005 – facing west along the road. Large cracks in the shoulder developed between the time of instrument readings in May 2005 and the site inspection in late June 2005.

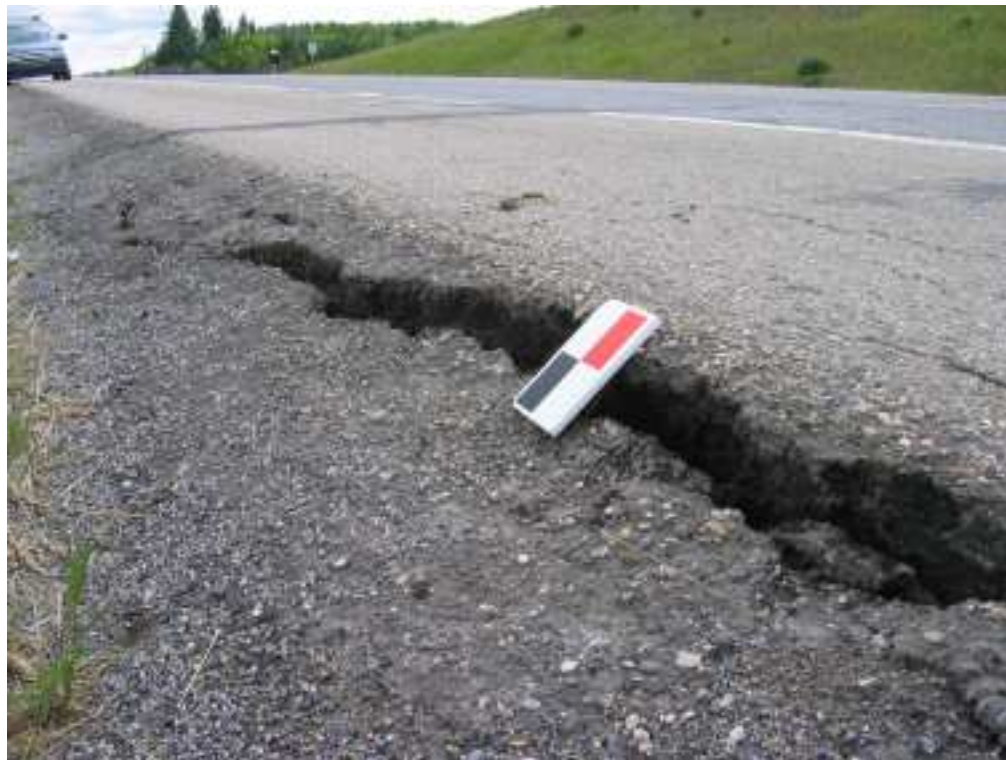
Photo S3-5 (lower left) – June 2005 – closer view of recent cracking in westbound shoulder. Field notebook for scale.

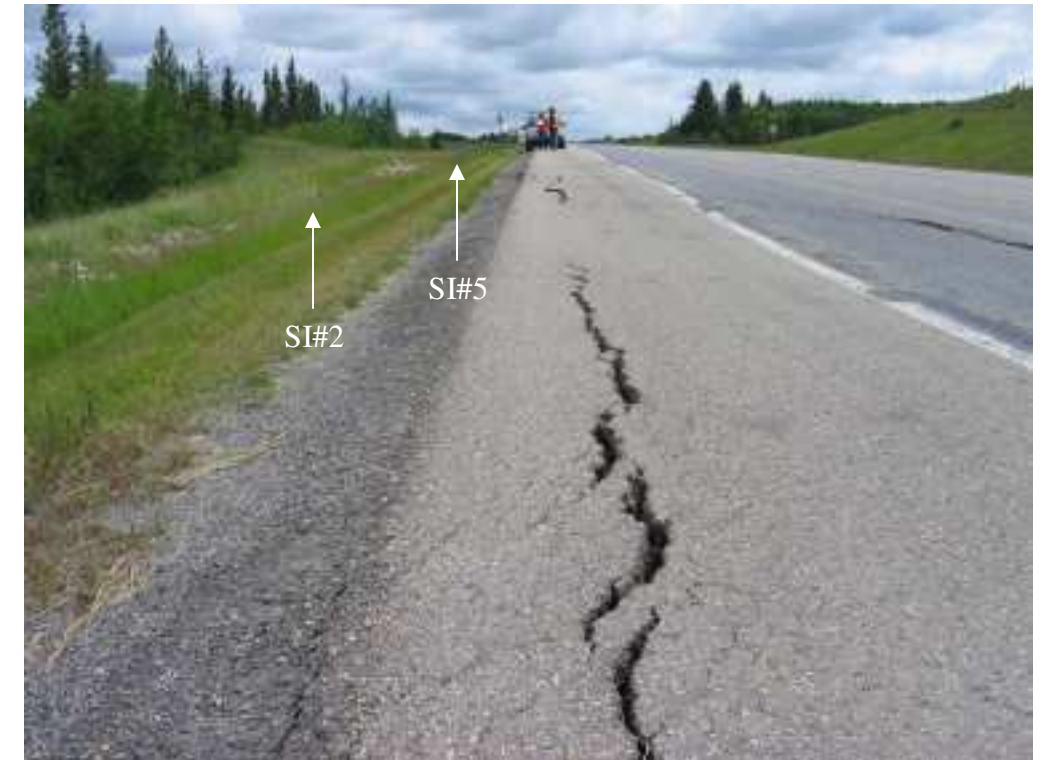
Photo S3-6 (lower right) – June 2005 – facing east along the road with recent cracking visible in the shoulder.
