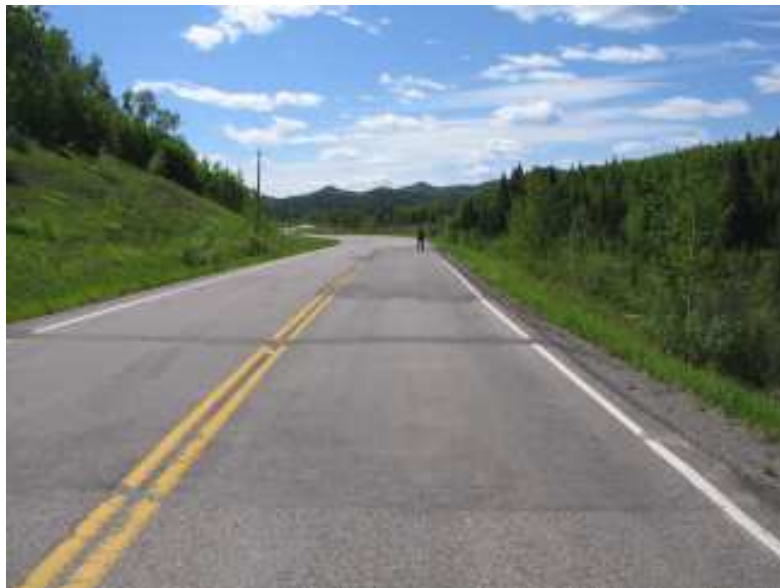
Photo S31-1 (top) – June 2008

Facing downslope/towards the west from near the backslope crest above the damaged segment of the highway. The extent of the overlays on the southbound lane are visible. The person on the far side of the highway is standing near the visible culvert outlet on the slope below the road.

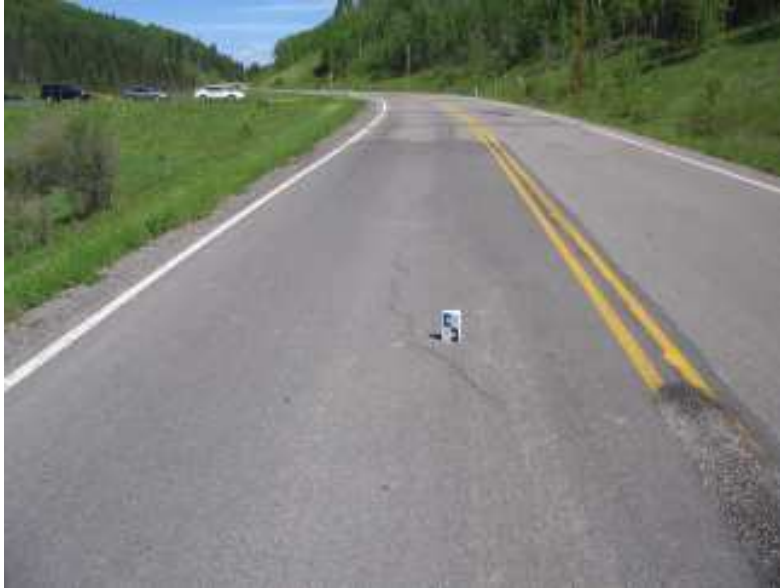
Photo S31-2 (bottom) – June 2008

Facing south across the segment of the highway where a number of overlays from recent years are visible.

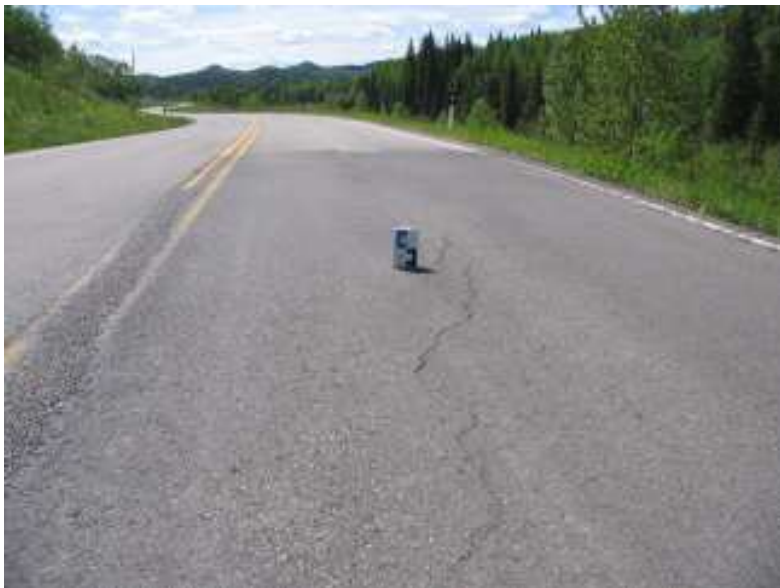
Photo S31-3 (top) – June 2008
Facing north in the north end of the overlays, with recent cracking and very minor settlement of the road surface visible in the southbound lane. The position and pattern of these cracks suggest that they are the north flank of overall circular cracking roughly centered around the culvert outlet visible on the slope face below the road.

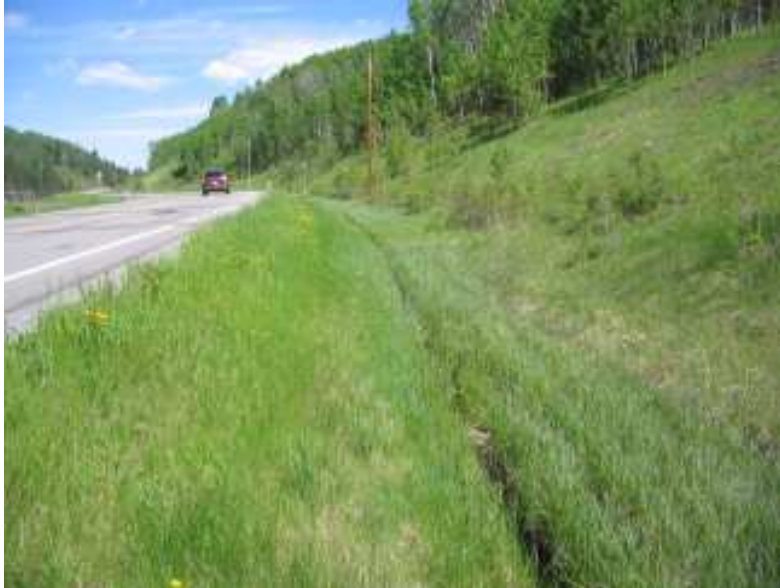
Photo S31-4 (bottom) – June 2008
Facing south across the central portion of the overlays, with tension cracking visible in the middle of the southbound lane.
