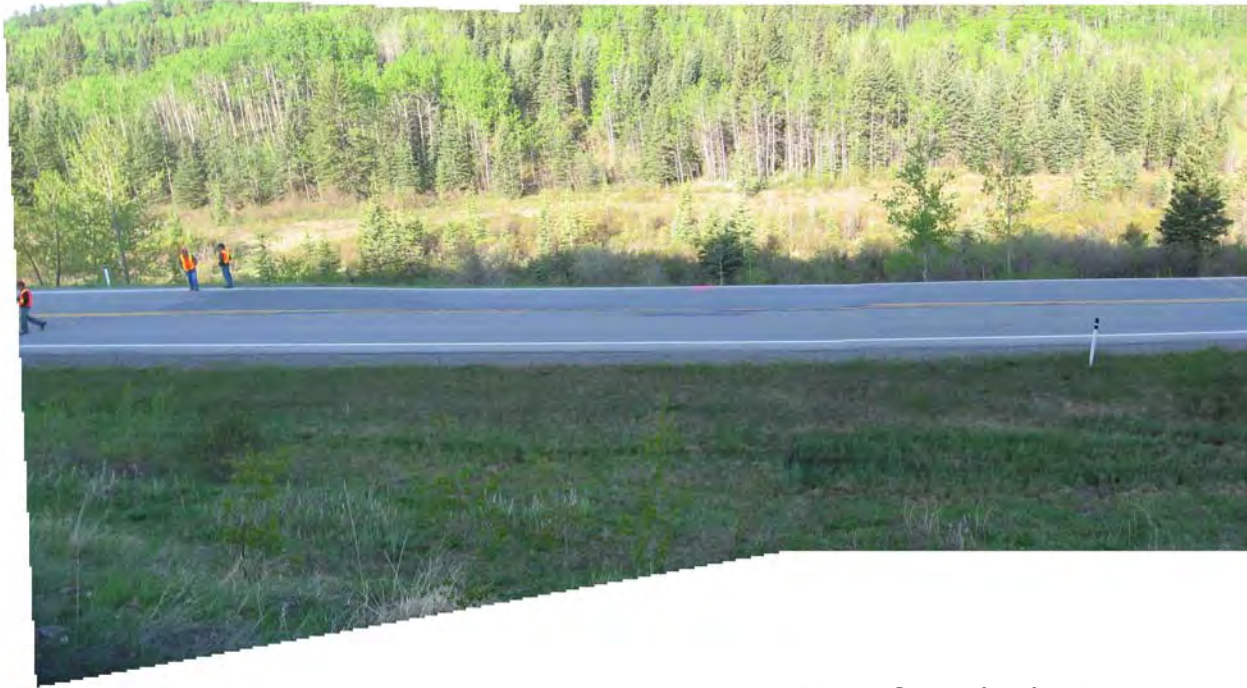
Photo S31-1 (top) – June 2009

Looking west from the slope above the site. Recent patching visible on the road surface. Planned SI location marked on pavement (pink paint marking).

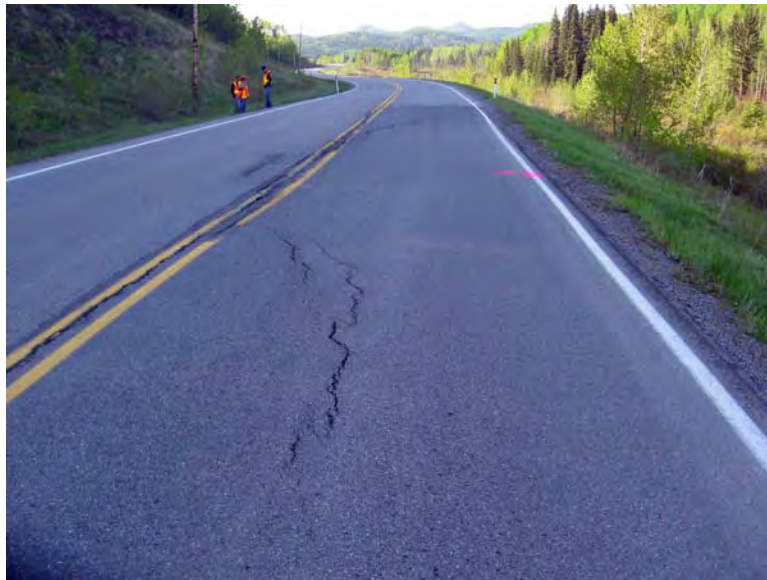
Photo S31-2 (left) – June 2009

Looking southbound from north end of site. Cracking has worsened since 2008 inspection with a nearly continuous arc formed through the site area. Planned SI location marked on pavement (pink paint marking).

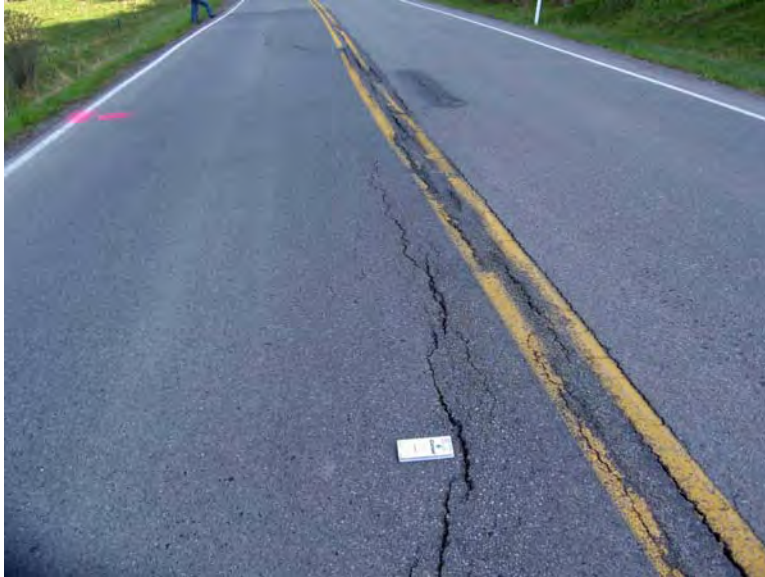
Photo S31-3 – June 2009
Close-up view of the cracking taken from the south facing north. Planned SI location marked on pavement (pink paint marking).

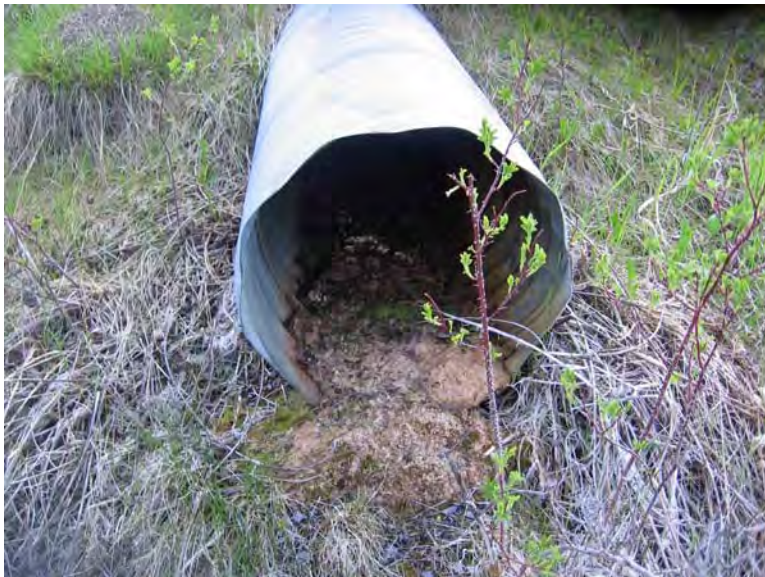
Photo S31-4 – June 2009
The culvert outlet was not flowing at the time of the inspection but appeared to have carried water recently.

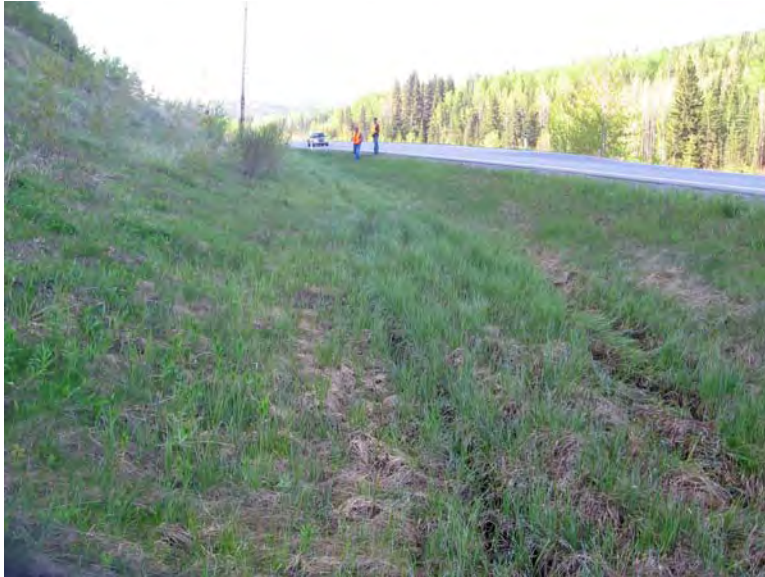
Photo S31-5 – June 2009

The upslope ditch above the site was wet with ponded water in the tire ruts. The ditch was reportedly capped with clay during the drain installation, however the shallow grade of this ditch does not allow the water to flow away from the site.
