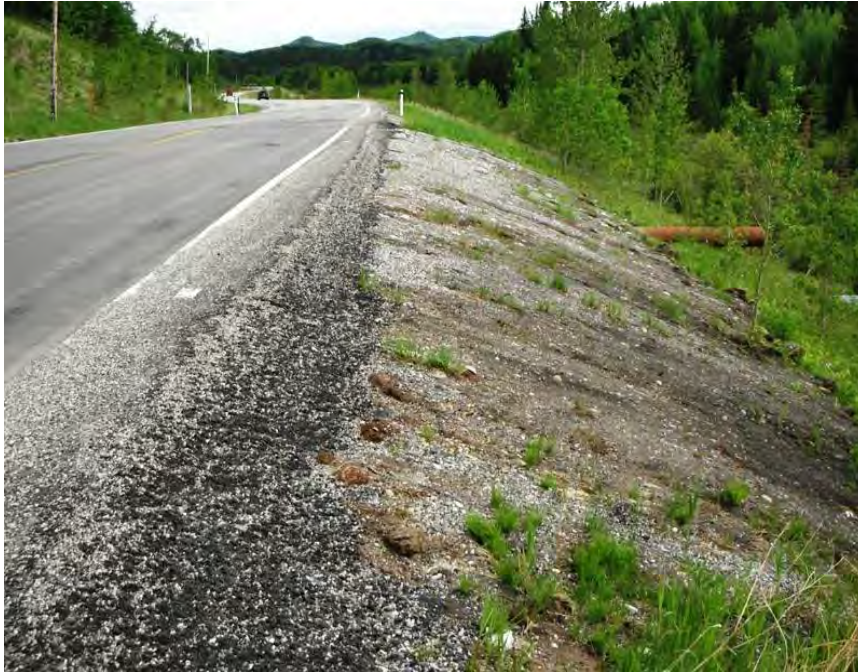
Photo S31-1 (June 2012)
Facing south from the north end of the site. This segment of the road was apparently excavated and rebuilt. A new drainage pipe was installed underneath the road. The outlet is visible on the right hand side of the photo (brown pipe). Subtle settlement was visible along this segment of the highway in previously noted areas of cracking.

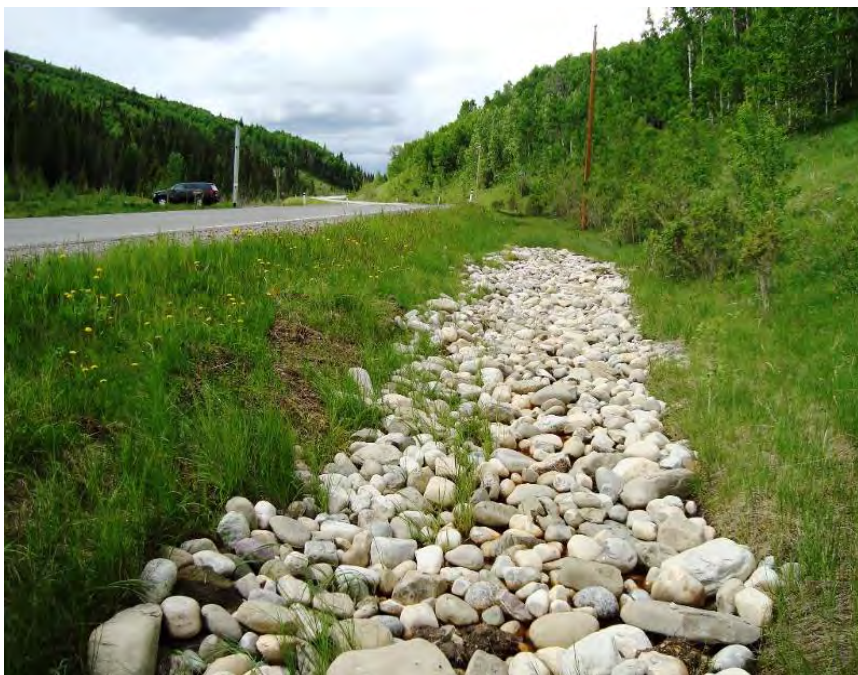
Photo S31-2 (June 2012)
Facing north from the center of the site in the east upslope ditch. Cobbles were placed in the ditch in an approximately 80 m long segment. The new drainage pipe inlet was buried beneath the cobbles.

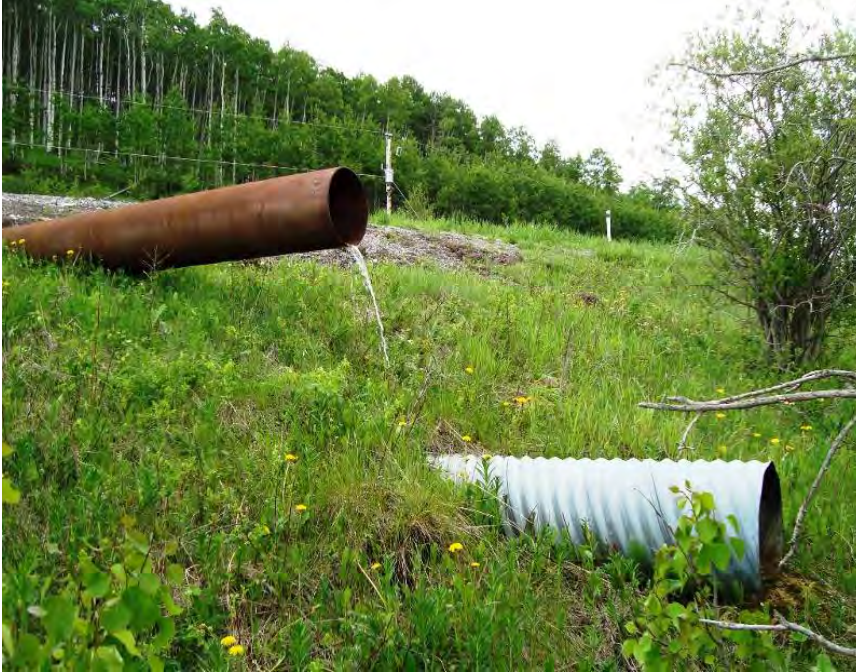
Photo S31-3 (June 2012)
Facing southeast from the bottom of the west embankment. The new drainage pipe is visible and flowing at approximately 10 L/min (brown pipe). The previous culvert is visible below it and was not flowing. The overhang of the new drainage pipe forms an obstruction hazard in the west ditch.
