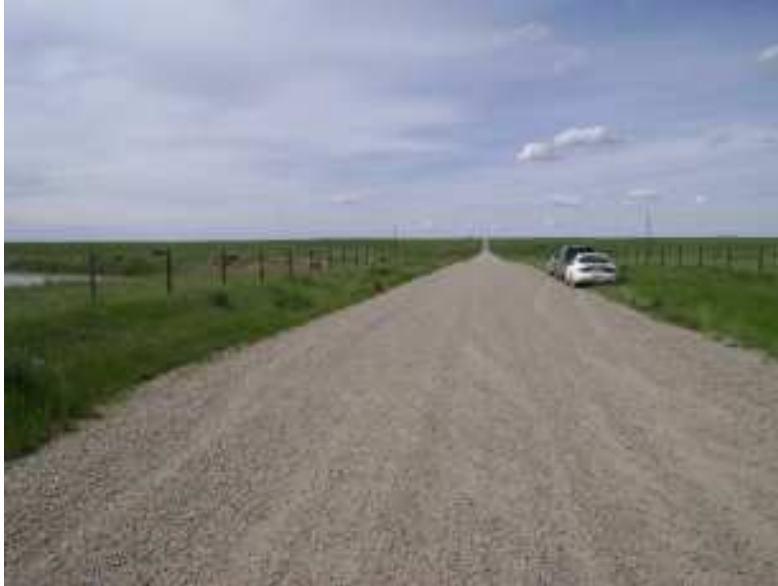
**Photo S32-1 (top) – June 2008**  
Facing north along the highway,  
adjacent to the bank erosion and slope  
instability. The Bow River channel is  
visible on the left side of the photo.

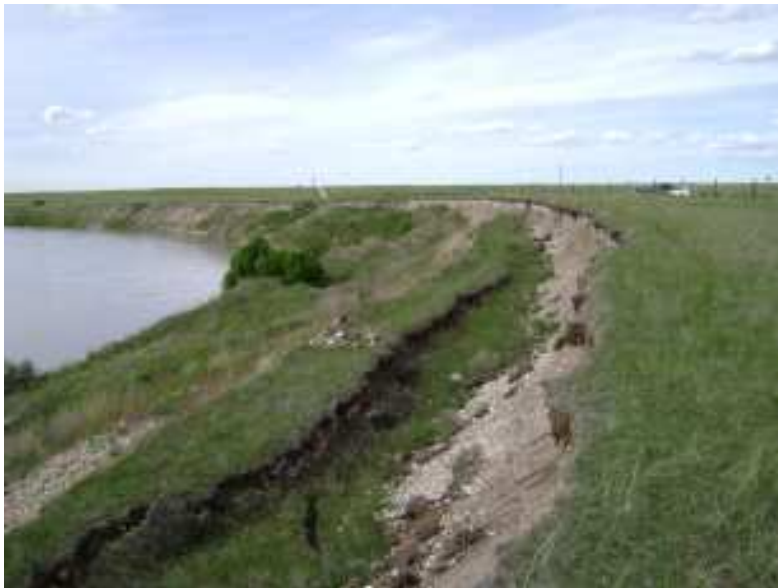
**Photo S32-2 (bottom) – June 2008**  
Facing north/upriver across the  
landsliding area along the outside of  
the meander bed in the river channel.  
The cars visible in the right background  
of this photo are parked on far side of  
the highway (Photo S32-1).

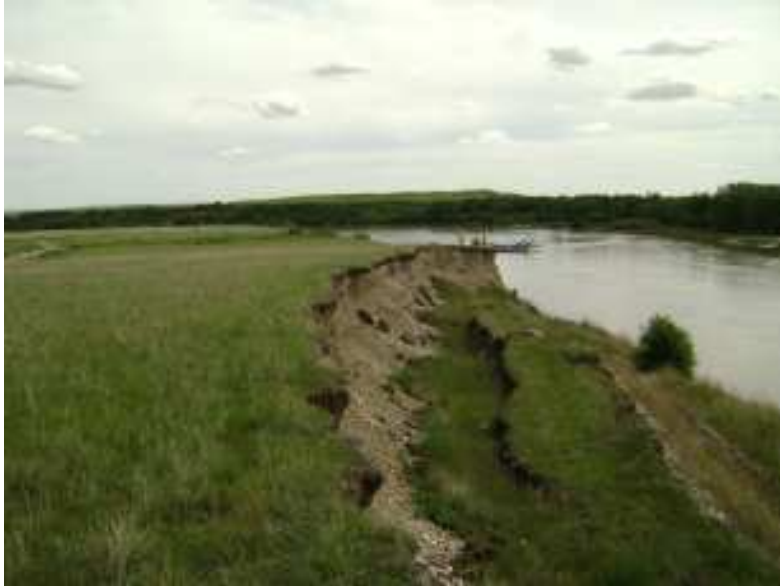
**Photo S32-3 (top) – June 2008**  
Facing south/downriver across the southern end of the bank erosion area with the corresponding southern flank of the landsliding above the river bank also visible. The Crowfoot Ferry is also visible in the centre background of the photo.

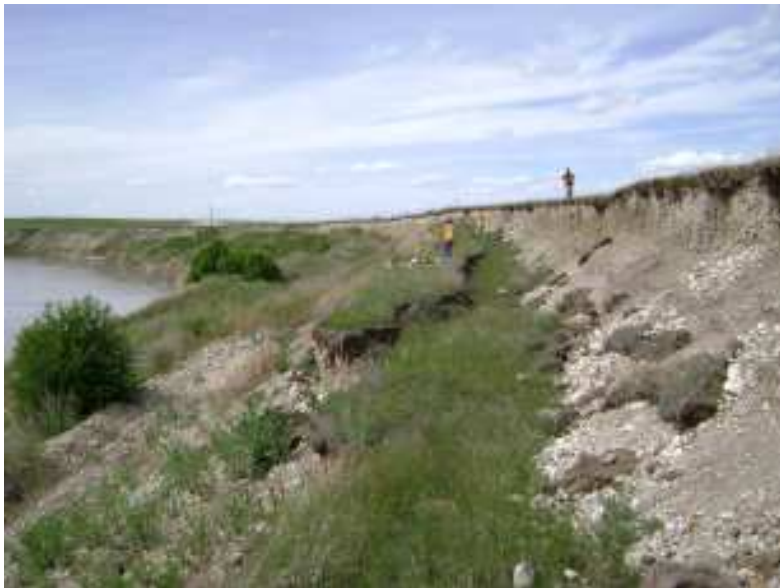
**Photo S32-4 (bottom) – June 2008**  
Closer view of the landsliding above the river bank, facing upriver.

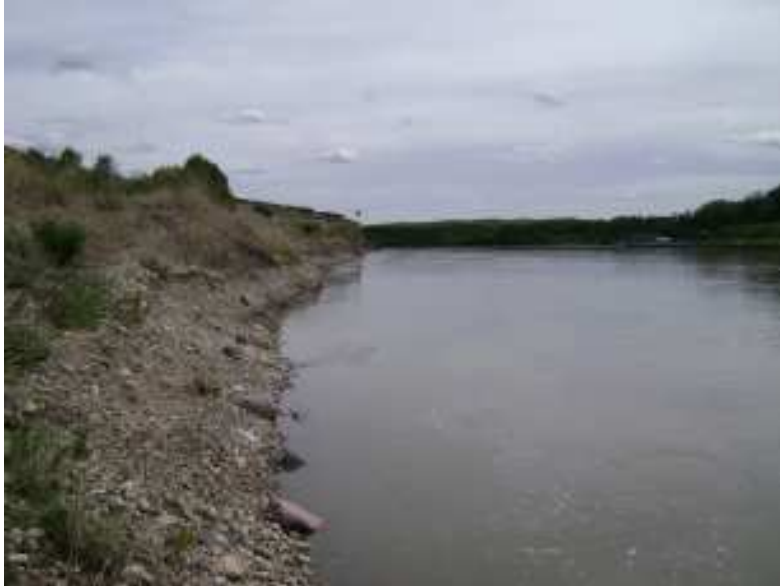
**Photo S32-5 (top) – June 2008**  
Facing downriver along the left (east)  
bank erosion area along the outside of  
the meander bend in the channel.

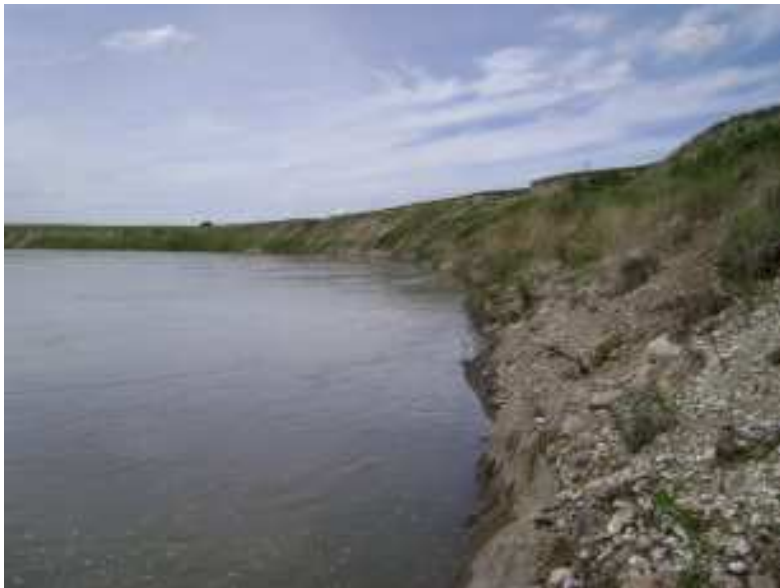
**Photo S32-6 (bottom) – June 2008**  
Facing upriver along the left (east)  
bank erosion area along the outside of  
the meander bend in the channel.
