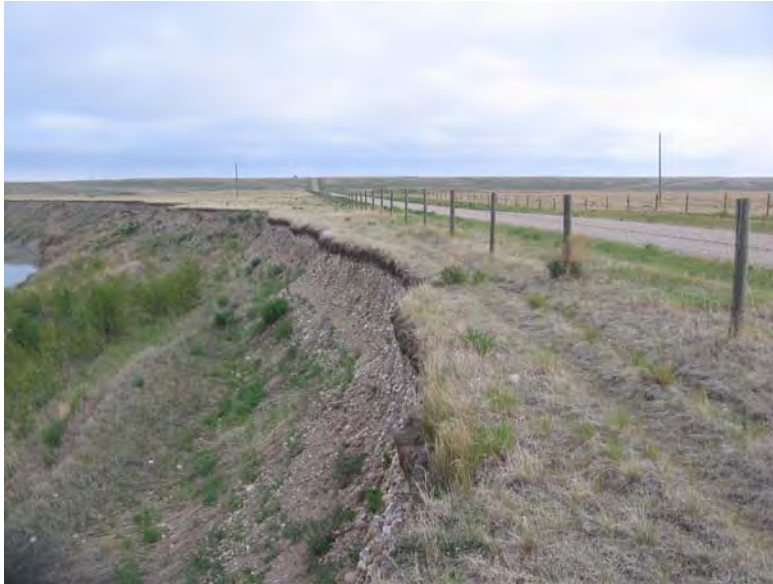
**Photo S32-1 (top) – June 2009**  
Facing north along the highway,  
adjacent to the bank erosion and slope  
instability. The Bow River channel is  
visible on the left side of the photo.

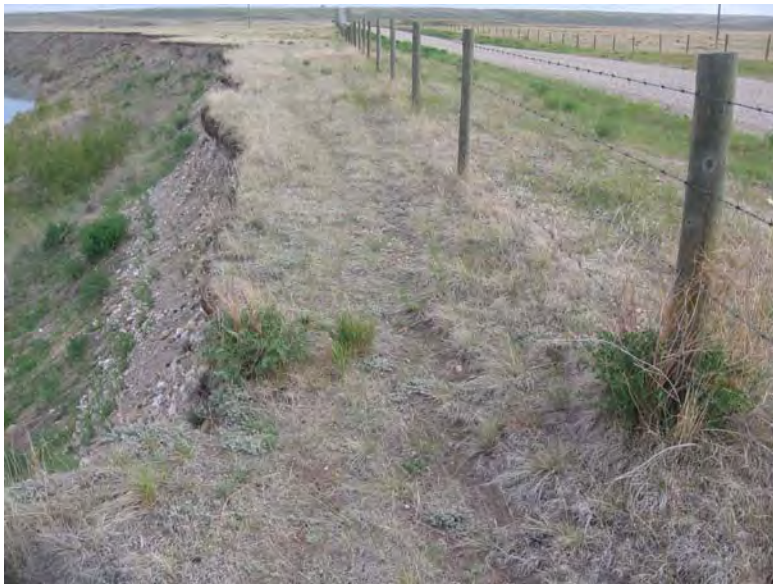
**Photo S32-2 (bottom) – June 2009**  
Closer view of the area of minimum  
offset between the slope crest in the  
landsliding area and the highway. The  
minimum offset was measured to be  
1.6 to 1.7 m in June 2009, compared  
with 1.7 m in June 2008.

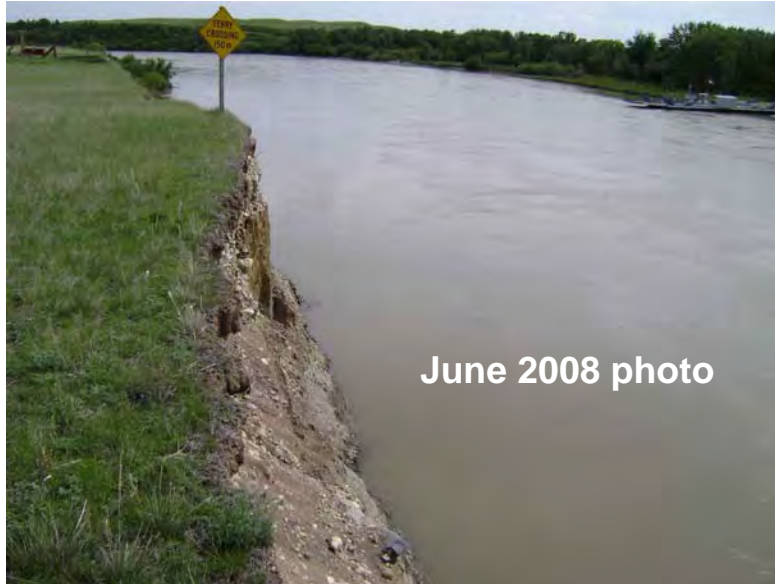
**Photo S32-3 (top) – June 2008**

Facing downstream along the oversteepened crest of the east river bank slope, as seen during the June 2008 inspection. The “Ferry Crossing, 150 m” sign visible along the crest of the slope was found to be fallen (more likely pulled down and placed on the ground near the crest) during the June 2009 inspection, indicating that the slope crest had retrogressed since the June 2008 inspection.

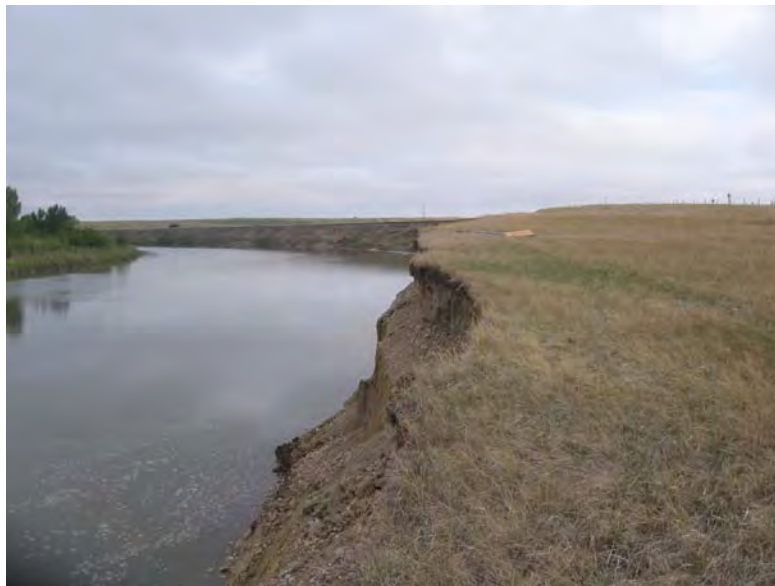
**Photo S32-4 (bottom) – June 2009**

Facing upstream along the oversteepened crest of the east river bank slope. Note the fallen sign adjacent to the slope crest. This is the “Ferry Crossing, 150 m” sign shown in the June 2008 photo (Photo S32-3, above).

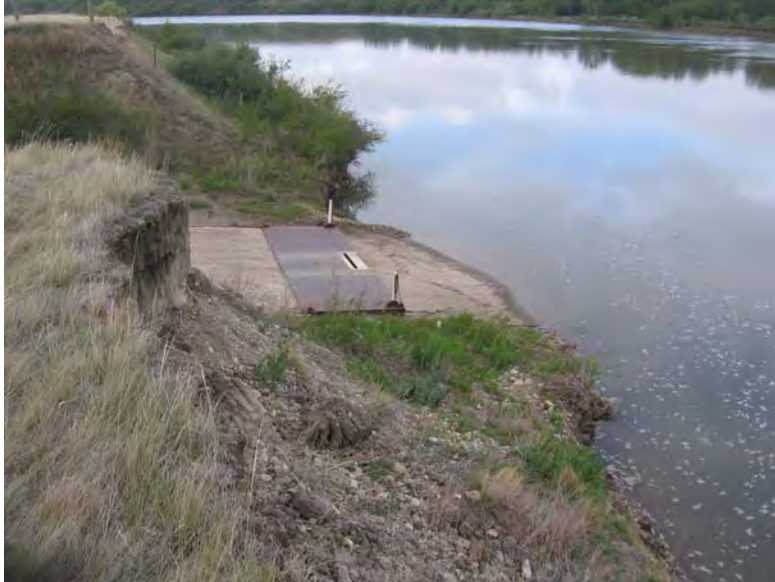
**Photo S32-5 (top) – June 2009**  
Facing upstream towards the east ferry  
ramp, located more than 100 m  
downstream of the landslide area.
