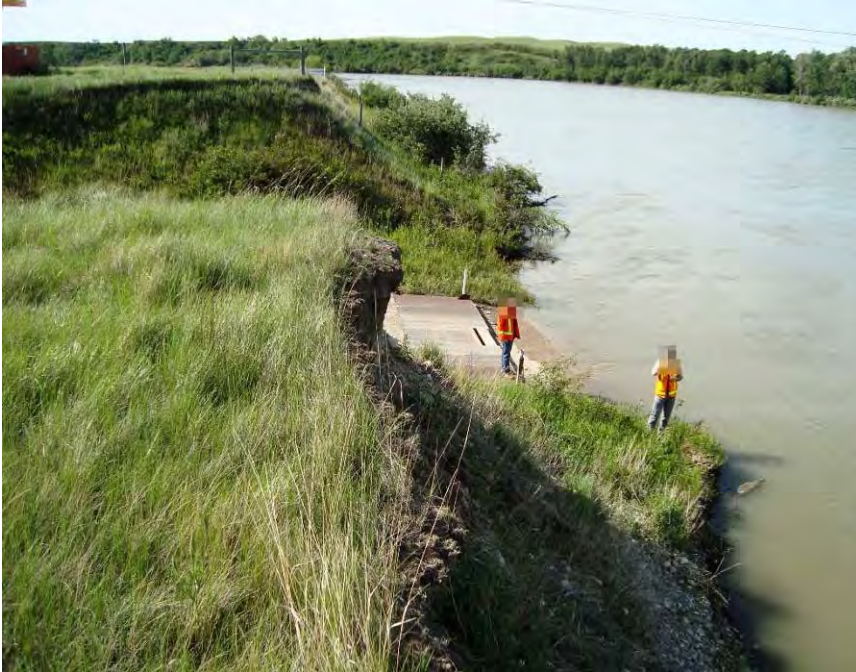
**Photo S32-1 – June 2012**  
Facing south towards the east ferry ramp. The ferry guide wire support tower is just out of the frame on the left side of the photo. This area appears mostly unchanged since the previous inspection.

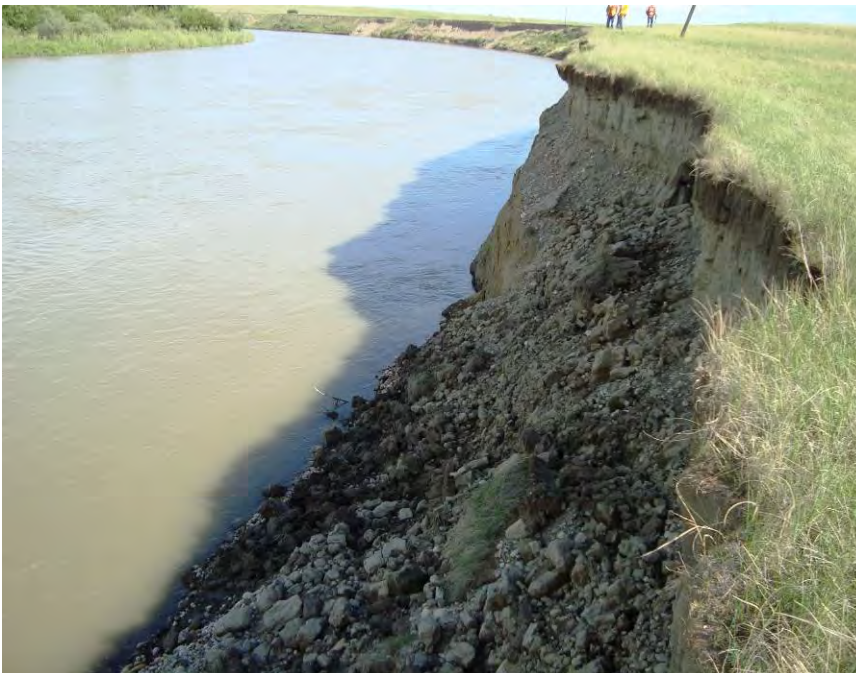
**Photo S32-2 – June 2012**  
Facing south towards the area near the ferry sign where fresh bank retrogression was observed.

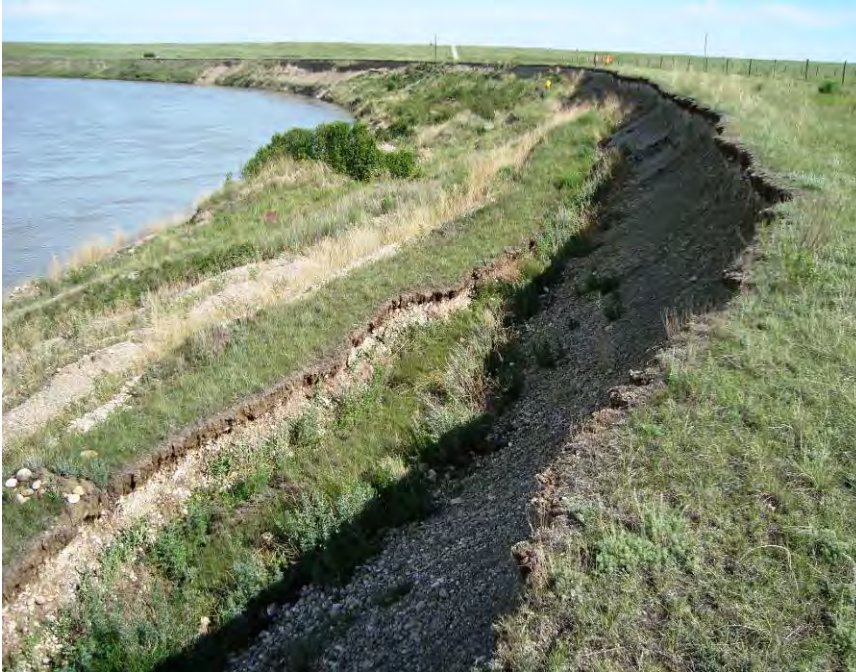
**Photo S32-3 – June 2012**  
Facing north over the main landslide area. Some evidence of fresh sliding was observed but the main crest is mainly unchanged from the 2010 inspection.
