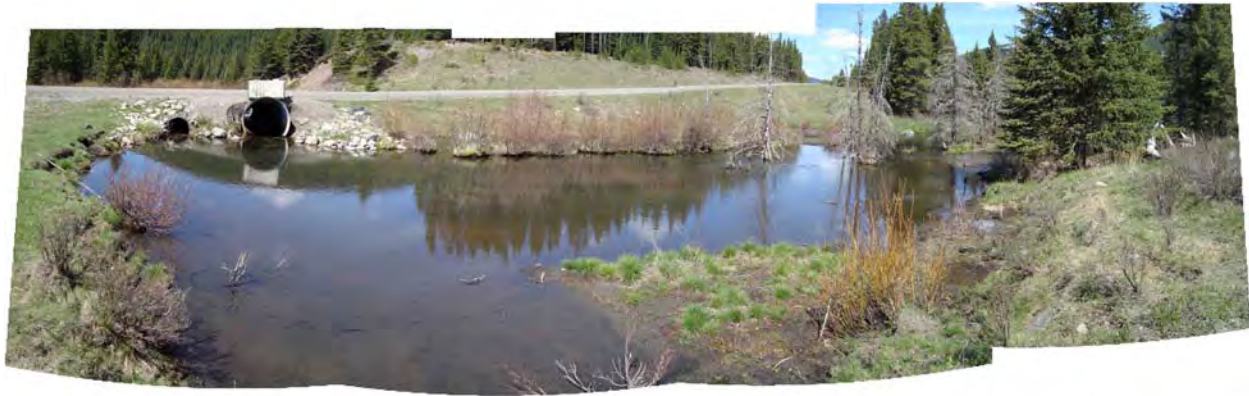
Photo 1 (top) – June 2009

The ponded water upstream of the highway culverts is at approximately the same level as was observed in the fall of 2008.

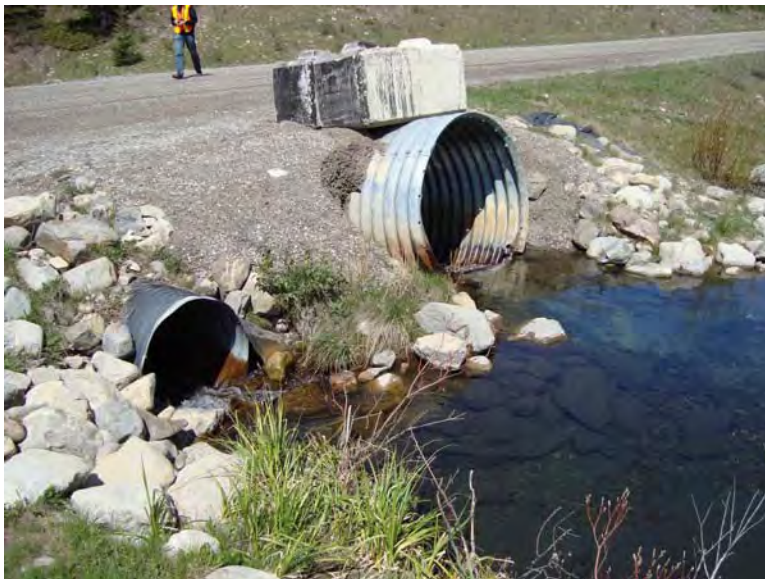
Photo 2 (left) – June 2009

The culvert inlets appear to be in the same condition as seen during the Fall 2008 inspection.

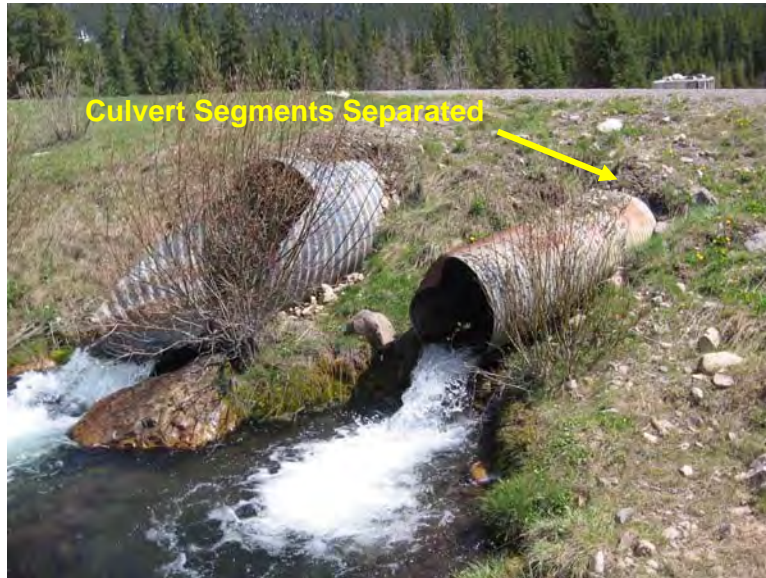
Photo 3 – June 2009

The culvert outlets were both discharging water without apparent obstruction. The 900 mm diameter culvert remains separated at the top between segments.

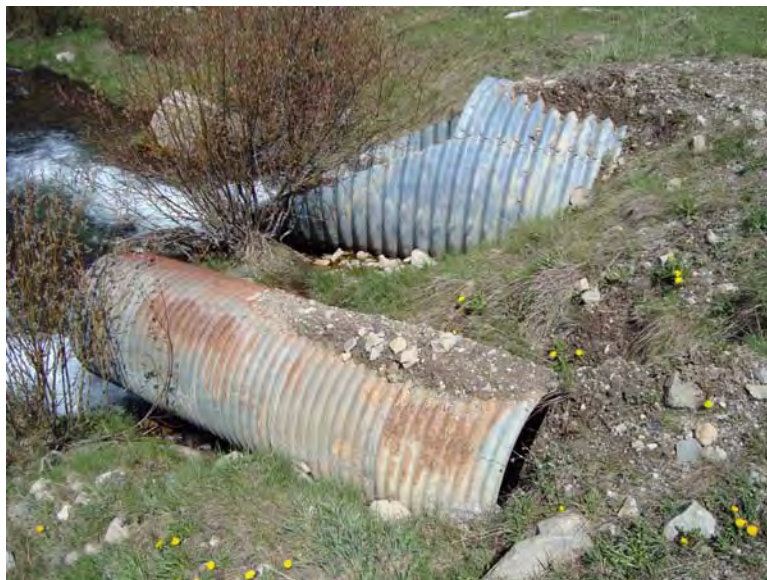
Photo 4 – June 2009

Close-up view of the separated segments of the 900 mm diameter culvert.
