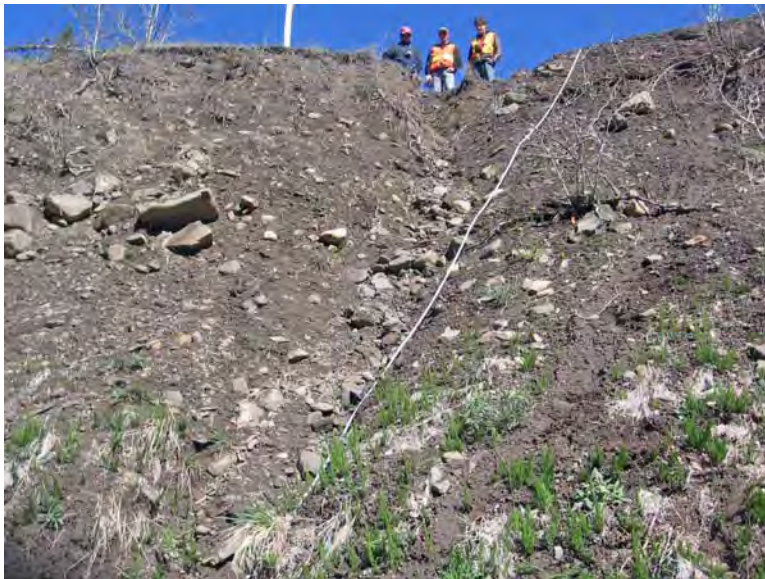
Photo 4 – June 2009
The erosion gully from near the creek level.
