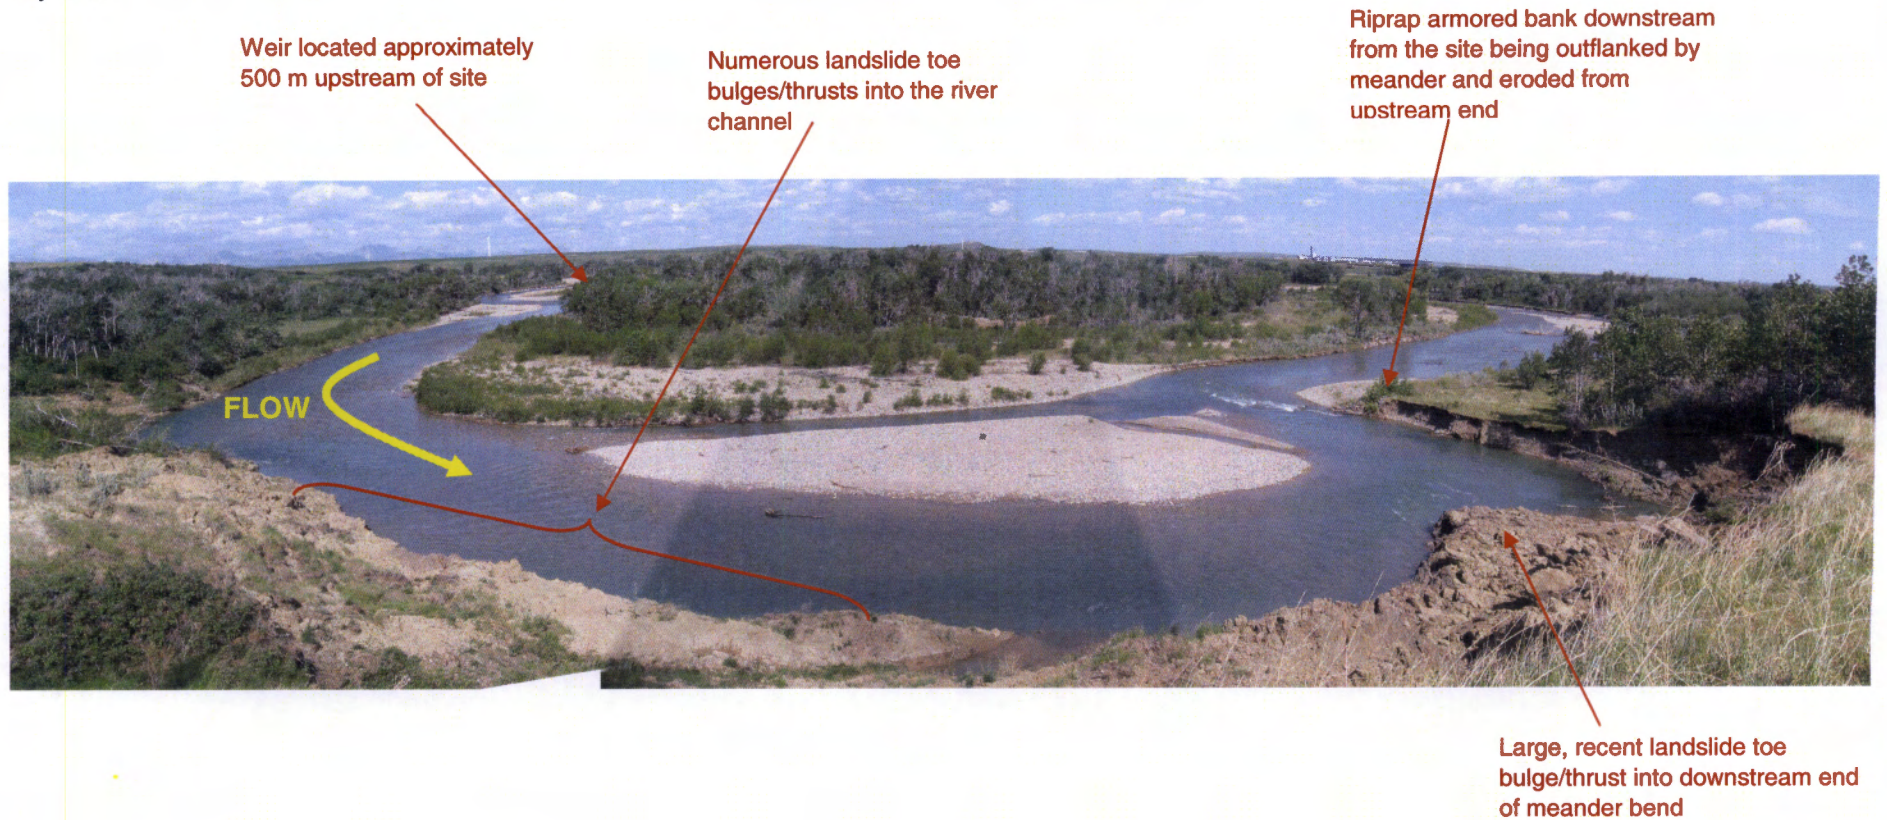
Photo 1 – View from the crest of the slope above the landslide area, a short distance south/upstream from the area of significant retrogression towards the highway in recent years. The sharp bend in the river channel immediately upstream of the site is evident, along with the meander in the channel that directly attacks the toe of the slope in the landslide area. Figure 1 contains further annotations illustrating the site features shown above.

Minimum offset of 3.4 m from
fenceline (June 26, 2009).

20 m or greater offset from
fenceline (June 26, 2009).

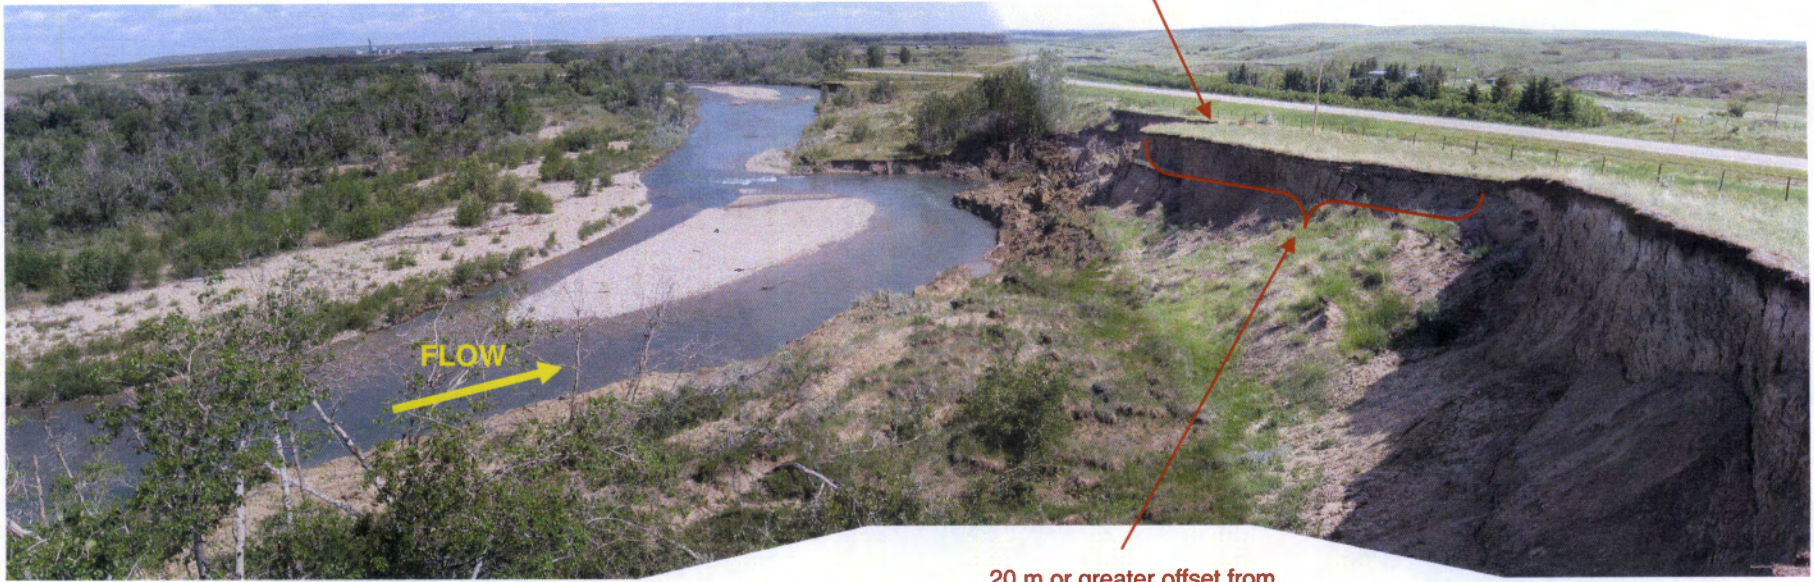
Photo 2 – View downstream/northbound towards the landslide area, with Highway 800 on the right. Note the active landsliding due to river erosion along the toe of the slope, which is located on the outside of a meander bend.

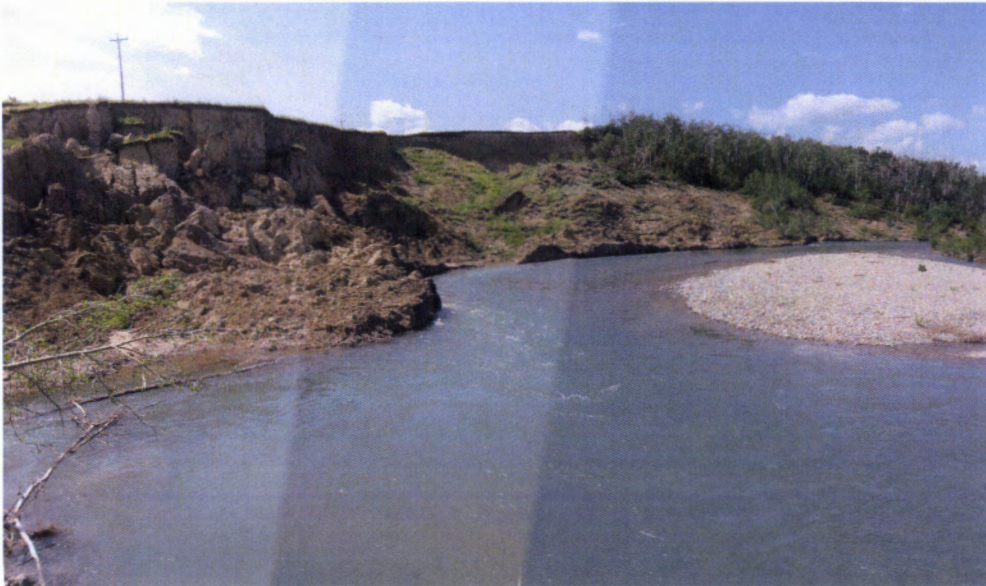
Photo 3 (top) – View upstream towards the toe of the landslide area. Photo is taken from the downstream end of the meander loop and on top of the armored right bank downstream of the landslide area that is being outflanked and eroded. Note the significant toe bulge/thrust from the recent landsliding.

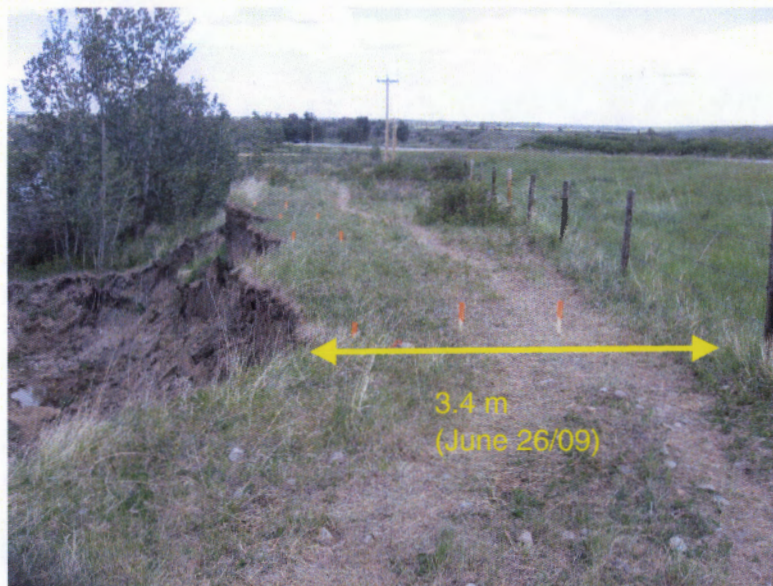
Photo 4 (bottom) – View north along the slope crest, at the point of maximum retrogression towards the highway (offset 3.4 m from the fenceline). Reference stakes were placed at selected locations along the slope crest, at 0 and 1 m offset along with a third stake at 2 m offset at the location shown.

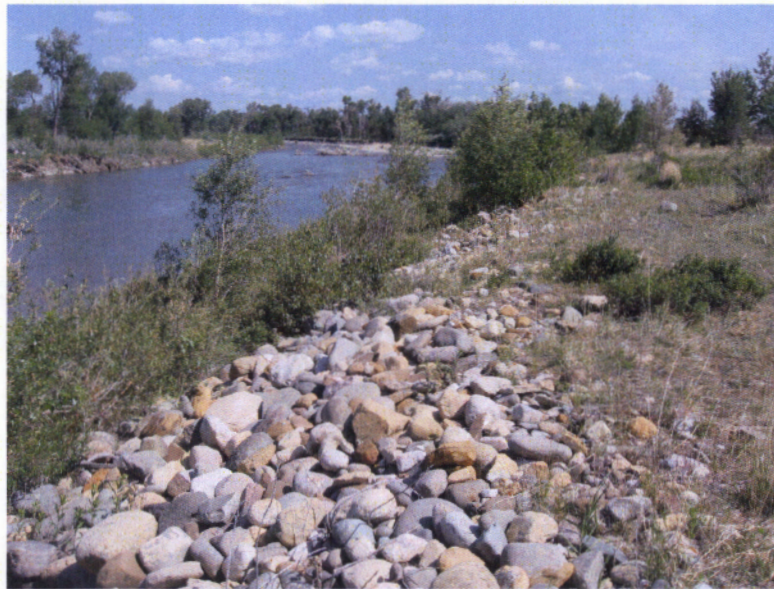
Photo 5 (top) – View downstream of the armored right bank, which is located downstream of the meander bend and landslide area. The upstream end of this armored segment of the bank is being outflanked and eroded by the meander bend.

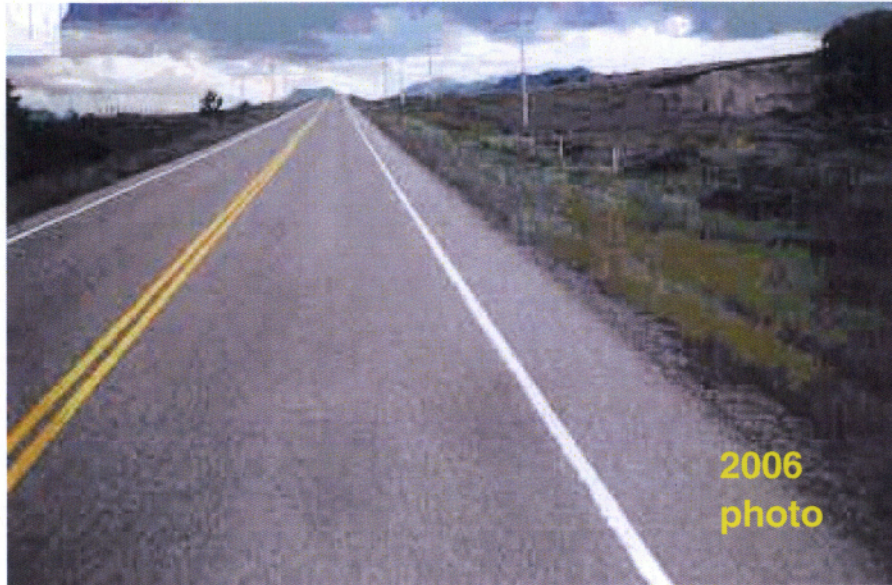
Photo 7 (top) – Photo from 2006 videolog provided by AT, facing southbound along the highway adjacent to the landslide area. Note the significantly greater offset between the crest of the slope and the highway compared to the June 2009 photos.
