**HIGHWAY 800:02 – BELLY RIVER EROSION SITE
REPORT ON JUNE 26, 2009 SITE INSPECTION**

AMEC Earth & Environmental,
a division of AMEC Americas Limited
Calgary, Alberta

July 2009

CG25309.D

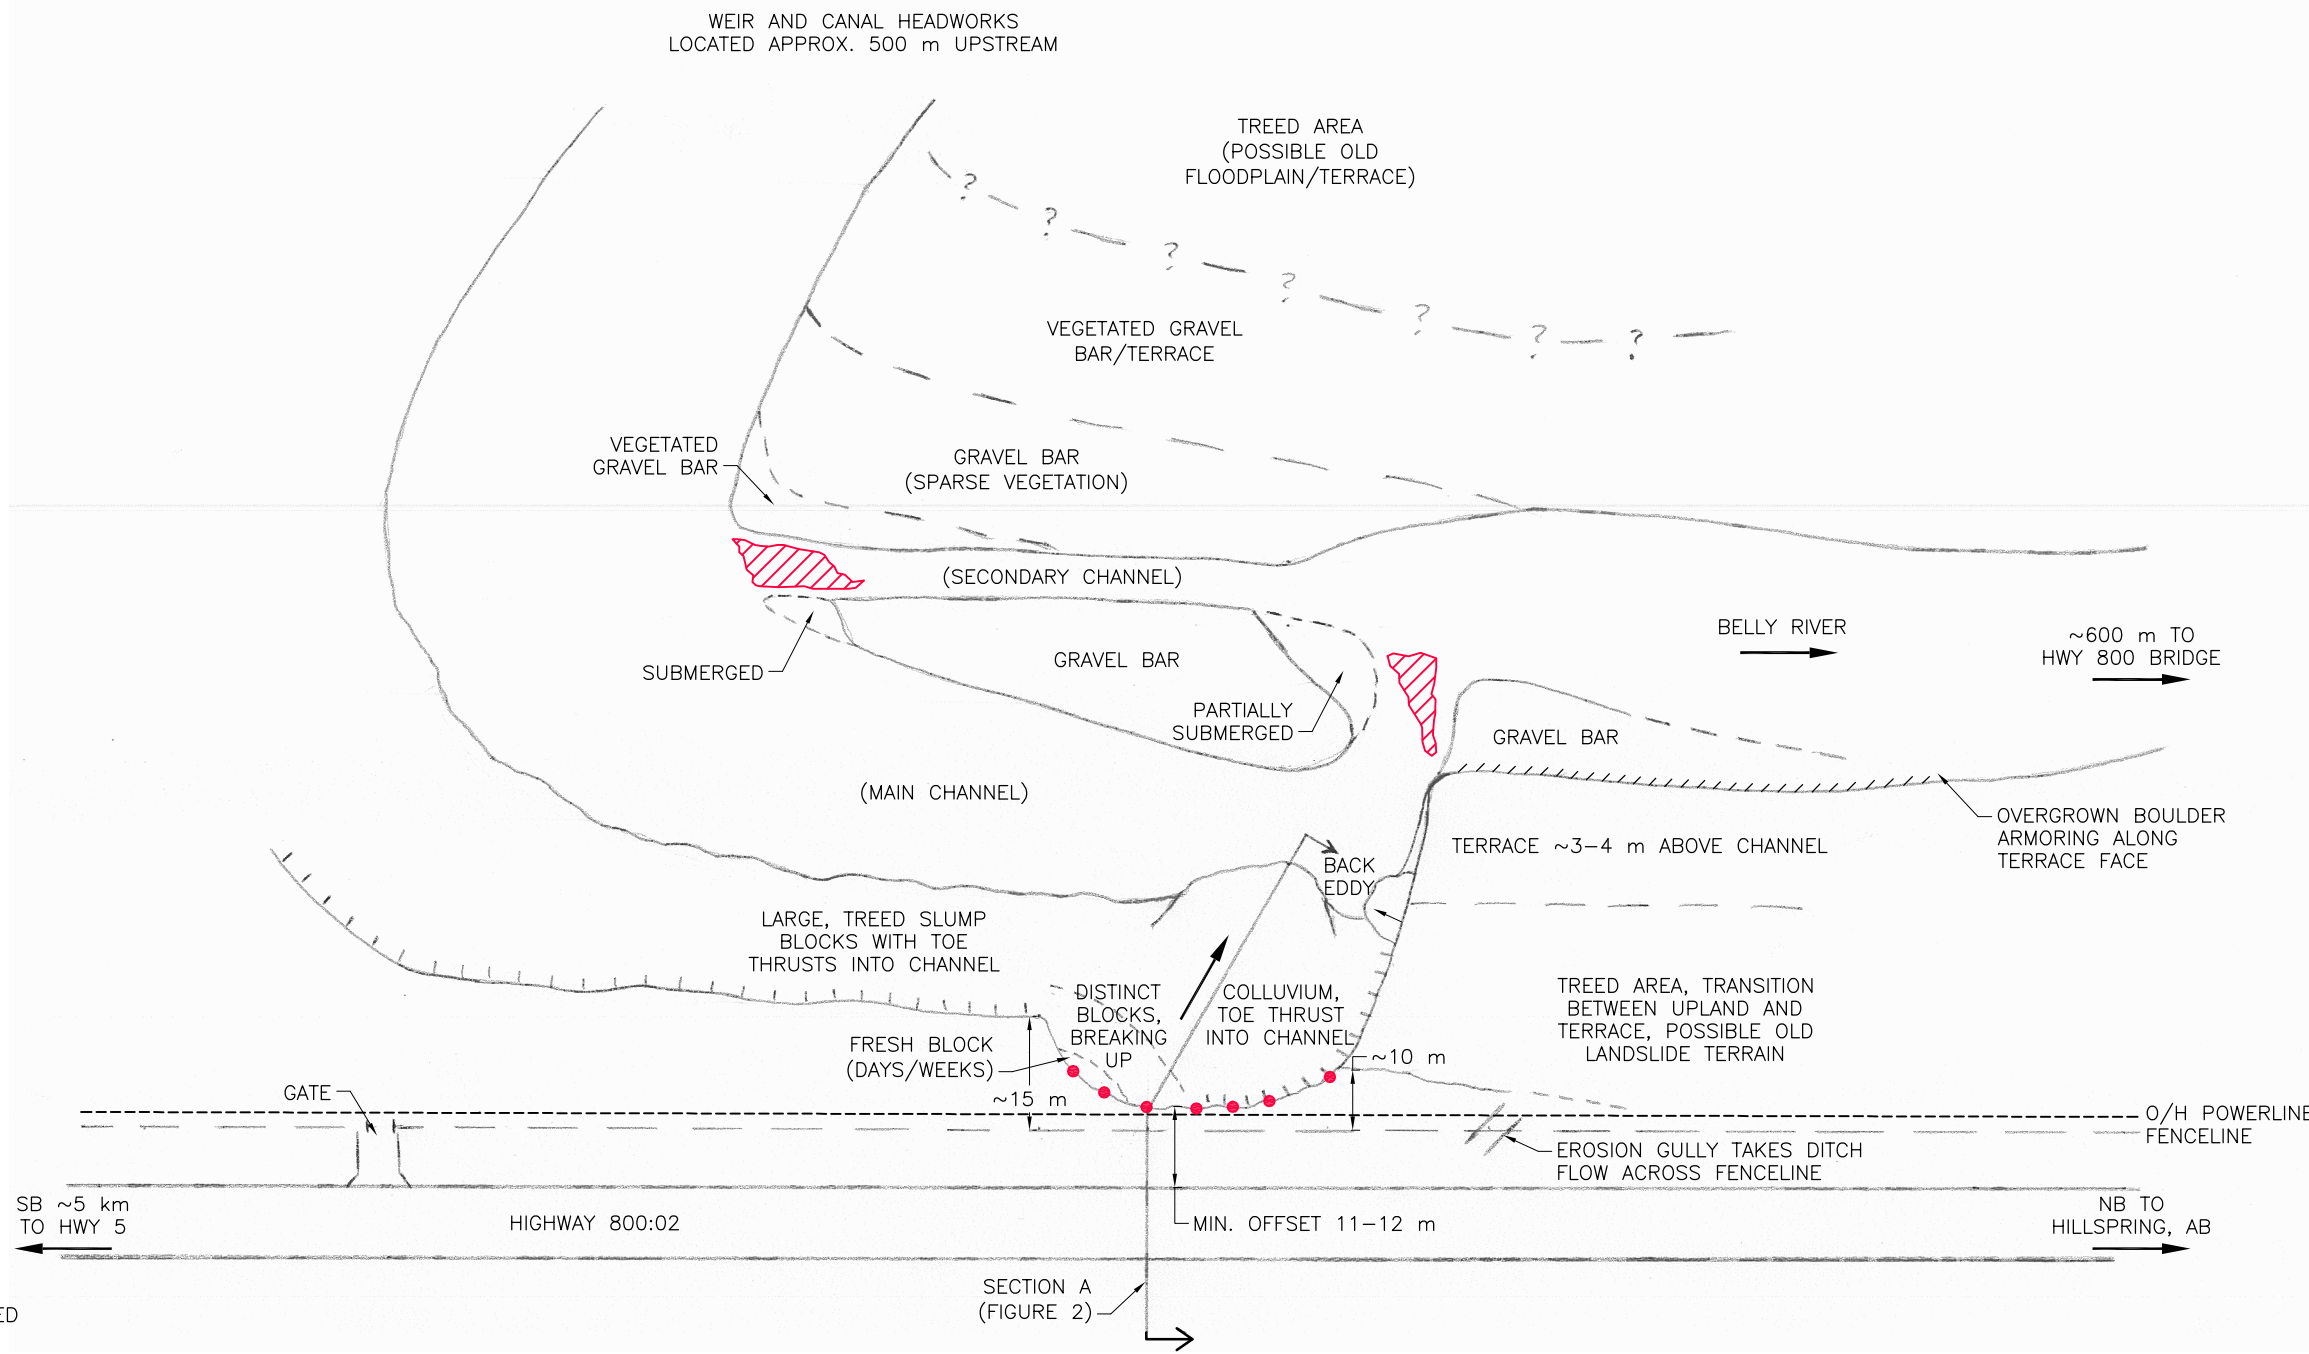
CLIENT:	PROJECT: SOUTHERN REGION GEOHAZARD ASSESSMENT				
	TITLE: HWY 800:02 BELLY RIVER EROSION SITE SITE PLAN				
DATE: JUNE 2009	JOB No.: CG25309.D	CAD FILE: 25309N20.dwg	FIGURE No.: FIGURE 1	REV. A

A site plan along with a slope cross-section through the landslide area are attached as Figures 1 and 2.

- The landsliding has caused the slope crest to retrogress eastwards towards the highway. At the time of the June 26, 2009 site inspection, the minimum offset of the slope crest from the fenceline west of the highway was 3.4 m (roughly 11 to 12 m from the edge of pavement), with an approximately 15 m segment of the slope crest offset 5 m or less from the fenceline. Photo 4 and Figures 1 and 2, attached, illustrate the minimum offset of the slope crest from the highway.

- Seven pairs of reference stakes were placed at 0 and 1 m offset from the June 26, 2009 slope crest position, at the locations shown on Figure 1 and in Photo 4. A third stake, at 2 m offset from the slope crest, was also placed at the point where the slope crest was closest to the fenceline.

- The site is located along the outside of a meander bend in the river channel and the landsliding is due to river erosion along the toe of the slope. As shown on the site plan on Figure 1, the river channel makes a sharp turn (greater than 90° change in bearing along less than approximately 200 m channel length) immediately upstream of the site, resulting in a tight meander bend along the toe of the slope adjacent to the highway. The flow along the toe of the slope was rapid and there were back-eddies present downstream of the numerous toe thrusts of landslide blocks into the channel at the time of the June 26, 2009 inspection.

- Immediately downstream of the most active landslide area, the meander bend appears to be eroding into a terrace and gravel bar along the right bank of the river as the apex of the tight meander bend shifts downriver over time. As shown on Figure 1 and Photo 5, the 2 to 3 m high face of this terrace along the right bank is armored with boulder-sized rock riprap. The armored area is largely overgrown. Where the meander bend is eroding into the gravel bar and terrace there were some rapids along the channel which suggests that several metres of the armored bank has been outflanked and recently eroded with the boulder-sized material distributed a short distance downstream.

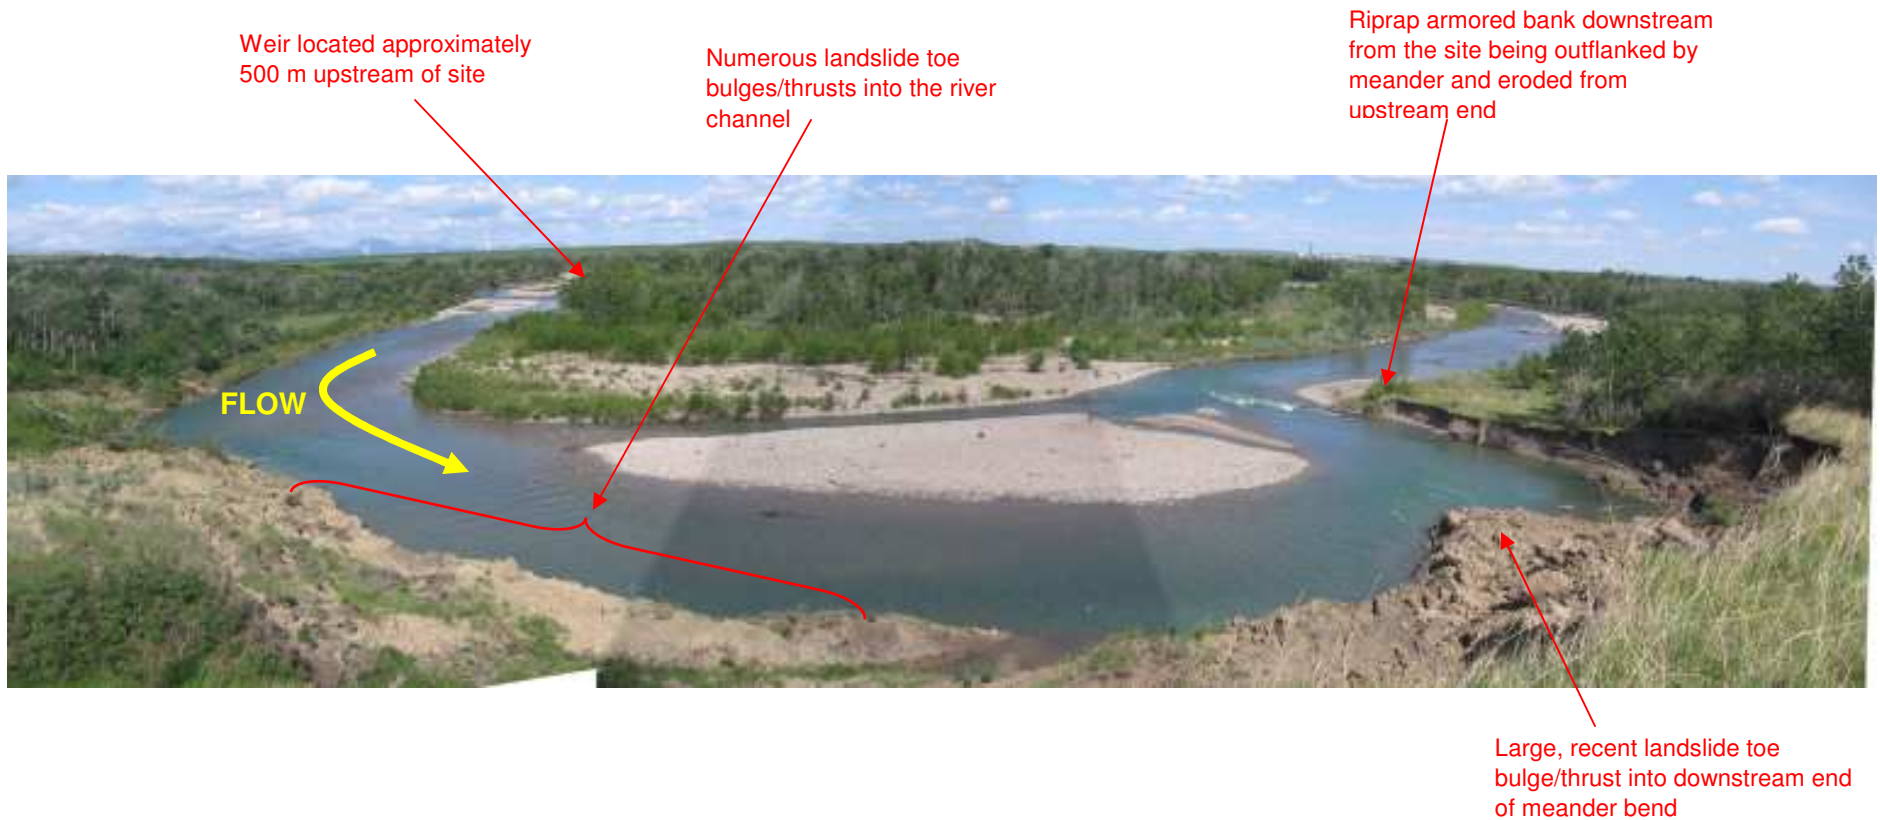
- There is active landsliding of the approximately 15 to 20 m high slope between the right bank of the river and the highway. Photos 1 to 3, attached, show views of the landsliding.

Photo 1 – View from the crest of the slope above the landslide area, a short distance south/upstream from the area of significant retrogression towards the highway in recent years. The sharp bend in the river channel immediately upstream of the site is evident, along with the meander in the channel that directly attacks the toe of the slope in the landslide area. Figure 1 contains further annotations illustrating the site features shown above.

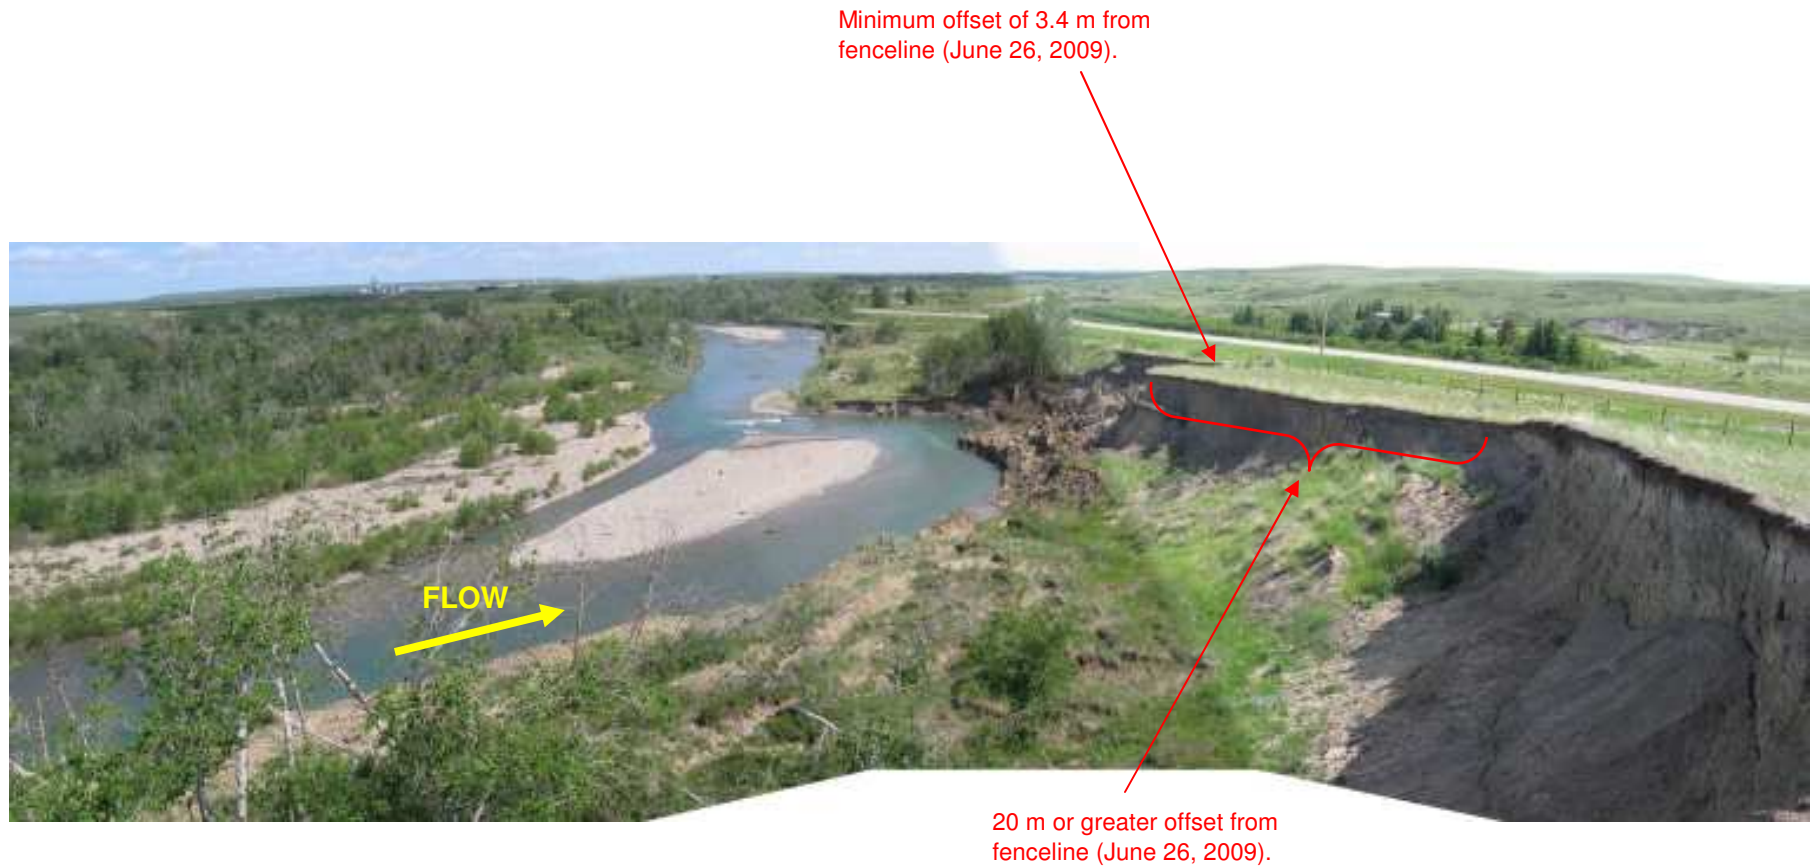
- The mode of movement appears to be slumping in the lower and mid-slope triggered by river erosion along the toe of the slope. The dropdown of the slumping areas appears to create a near-vertical soil face in the uppermost portion of the slope. This in turn leads to separation and toppling/dropdown of metre-scale blocks of soil with an intact turf cover. The surface width of currently separating and recently fallen blocks is typically around 3 to 4 m (i.e. each block that falls away causes the slope crest to retrogress in the order of 3 to 4 m.)

Photo 2 – View downstream/northbound towards the landslide area, with Highway 800 on the right. Note the active landsliding due to river erosion along the toe of the slope, which is located on the outside of a meander bend.

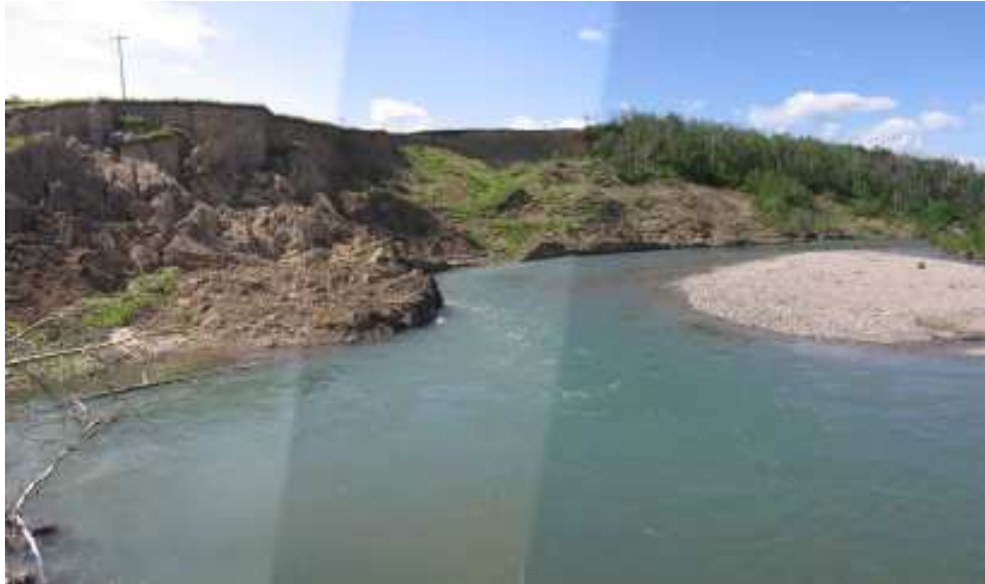
Photo 3 (top) – View upstream towards the toe of the landslide area. Photo is taken from the downstream end of the meander loop and on top of the armored right bank downstream of the landslide area that is being outflanked and eroded. Note the significant toe bulge/thrust from the recent landsliding.

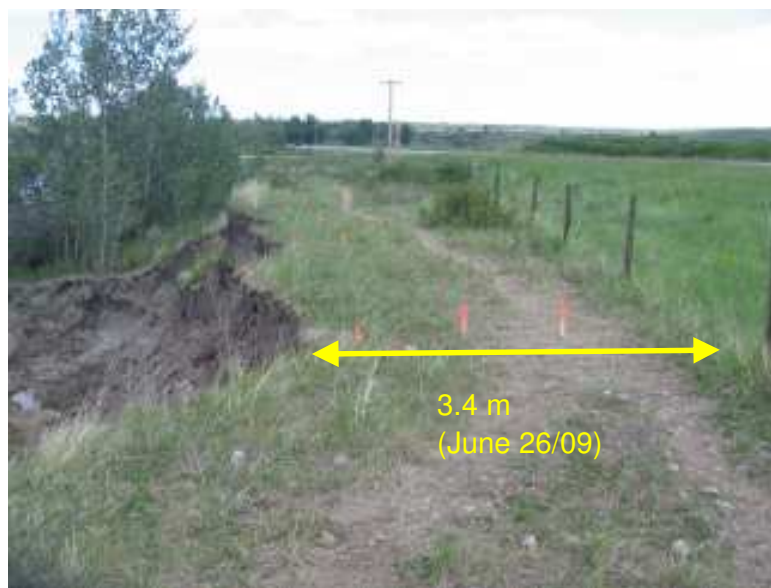
Photo 4 (bottom) – View north along the slope crest, at the point of maximum retrogression towards the highway (offset 3.4 m from the fenceline). Reference stakes were placed at selected locations along the slope crest, at 0 and 1 m offset along with a third stake at 2 m offset at the location shown.

- The offset of the slope crest from the fenceline should be checked weekly in order to provide an early indication of unexpectedly rapid crest retrogression that may trigger the need for a guardrail or possibly even the proactive construction of a detour lane on the east side of the highway. The reference stakes that were placed along the crest can be used for this monitoring. It would be most efficient and cost-effective if measurements of the offset could be taken by locally-based maintenance contractor personnel, with the data sent to AMEC for review and compilation.

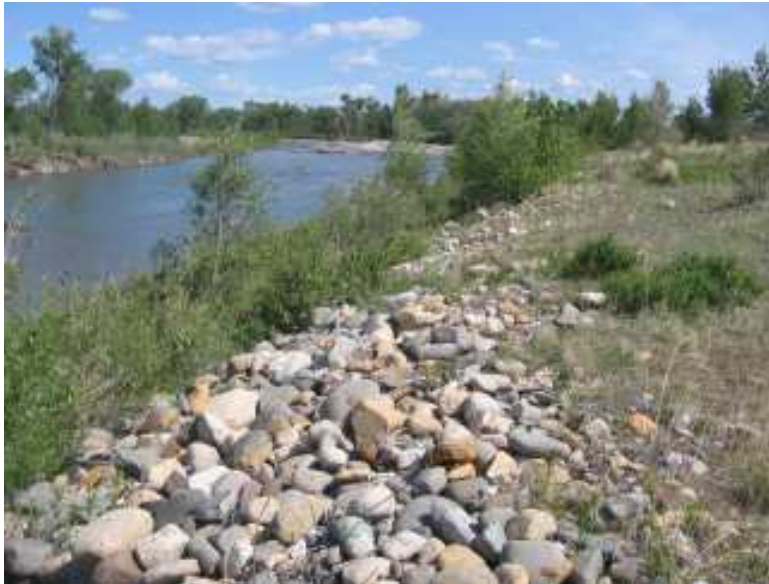
Photo 5 (top) – View downstream of the armored right bank, which is located downstream of the meander bend and landslide area. The upstream end of this armored segment of the bank is being outflanked and eroded by the meander bend.

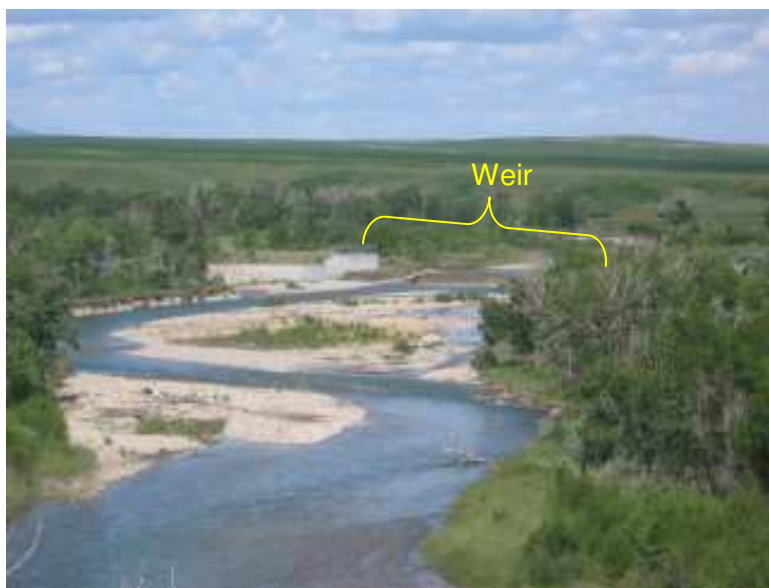
- A weir and canal headworks were noted approximately 500 m upstream from the landslide area (Photo 6).
- During the latter part of the site inspection, Mr. Ben Scout Jr. drove by the site and stopped to discuss the site conditions with the AMEC field engineer. Mr. Scout identified himself as the owner of the land at this site, and provided the following information:

- The weir and canal headworks upstream of the site were constructed approximately 15 years ago as a replacement to similar facilities around the same location. Mr. Scout contends that the current weir has altered the flow pattern of the river channel which has led to the current landsliding and encroachment towards the highway.

Photo 6 (bottom) – View upstream from the site towards the weir and canal headworks (approximately 500 m upstream from the site).

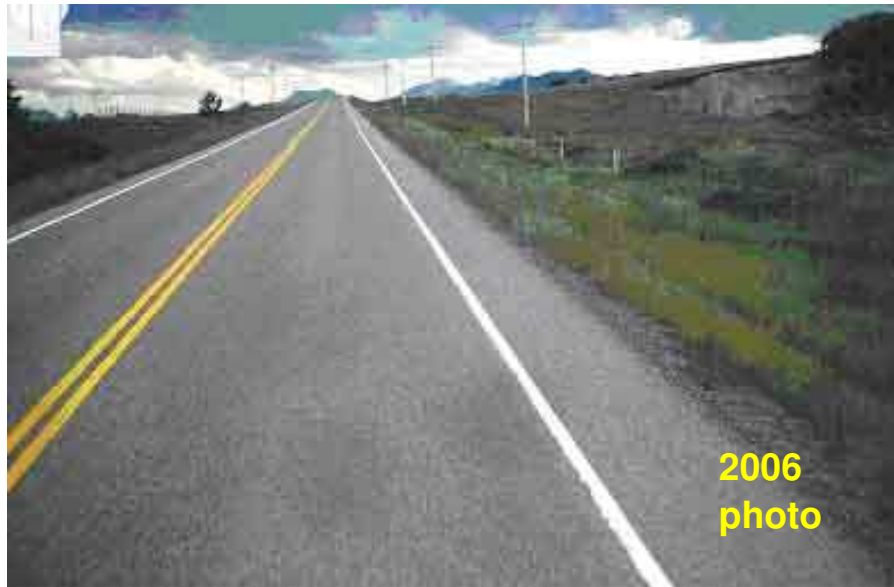
A comparison of the site photo from the 2006 videolog of this segment of Highway 800 to the observations from the June 26, 2009 inspection shows that a significant length of the slope crest has retrogressed several metres towards the highway since 2006. There are no measurements of the offset of the slope crest from the fenceline along the west side of the right-of-way, therefore the following items are approximations at this time:

Photo 7 (top) – Photo from 2006 videolog provided by AT, facing southbound along the highway adjacent to the landslide area. Note the significantly greater offset between the crest of the slope and the highway compared to the June 2009 photos.
