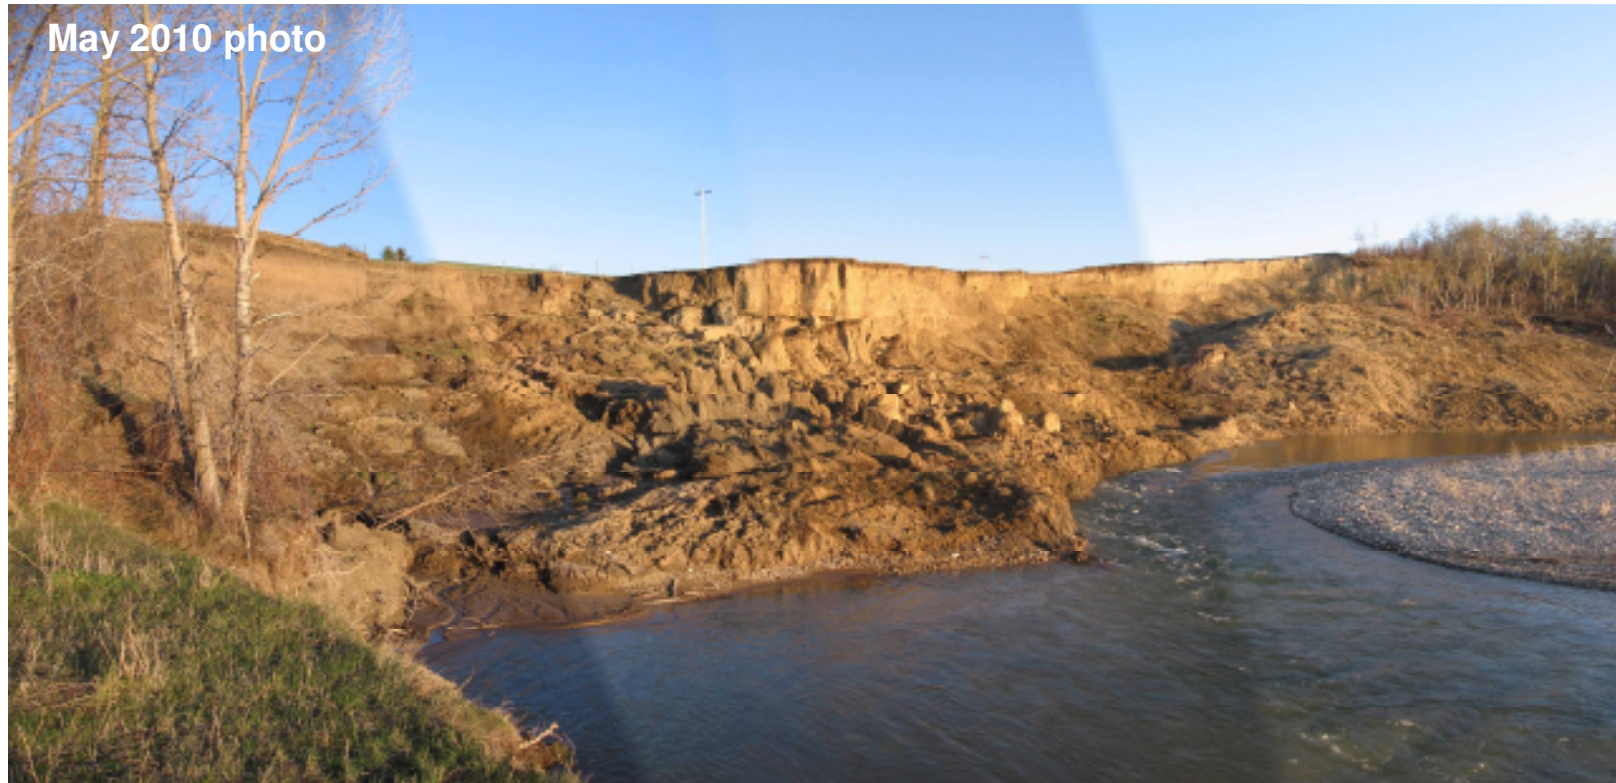
**Photo 1 - May 2010**

Looking south/upriver towards the main slide area from the river edge. The slide mass is partially obstructing the river flow. The upper scarp topples onto the slide mass in blocks, which then continue to slide down the slope as a rotational failure or soil flow. The blocks can be seen in the slide mass. The scarps to the south of the main slide area have active landsliding but are at a greater offset from the road.

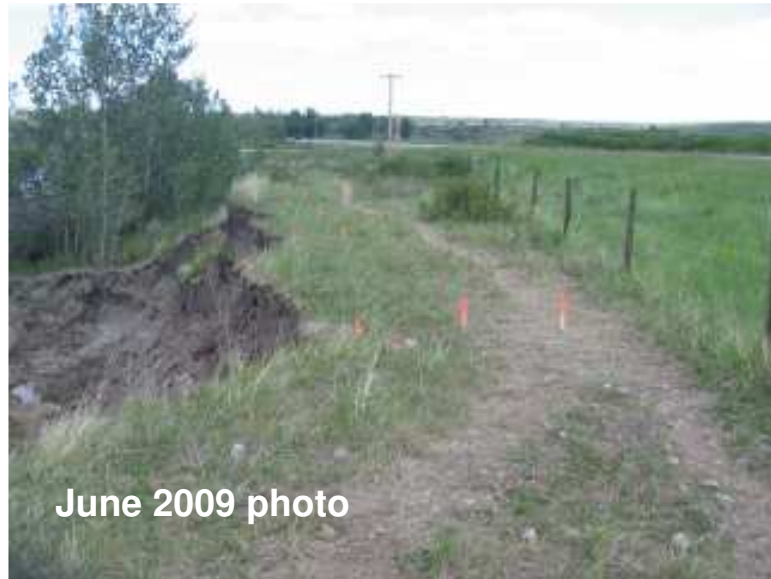
**Photo 2 (top) – June 2009**

Looking north at the headscarp of the main slide area in 2009. The headscarp is offset 3 to 4 m from the fenceline.

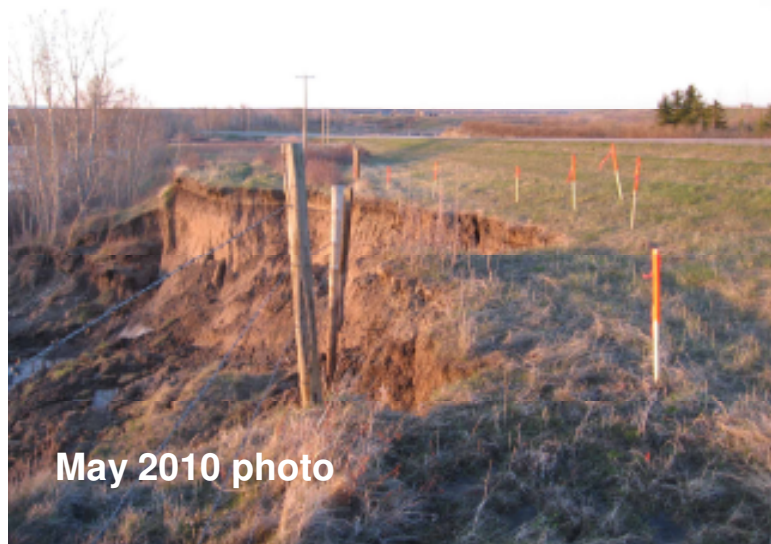
**Photo 3 (bottom) – May 2010**

Taken from the same location and direction as Photo 2, for comparison. Note the large increment of slope crest retrogression. The ditch has been intercepted in 2010 and now drains onto the slide mass.

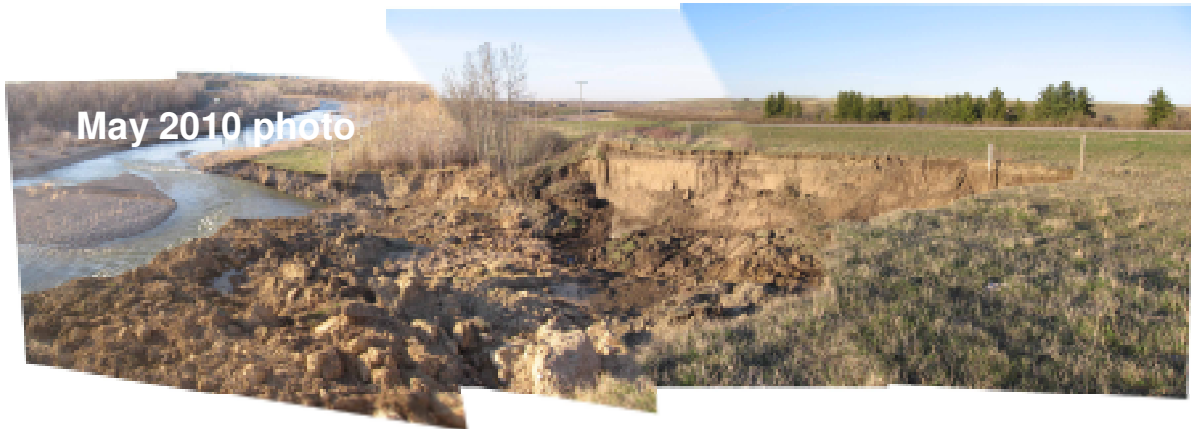
**Photo 4 (top) - May 2010**

Looking north towards the main slide area from the slope crest before the temporary repair work.

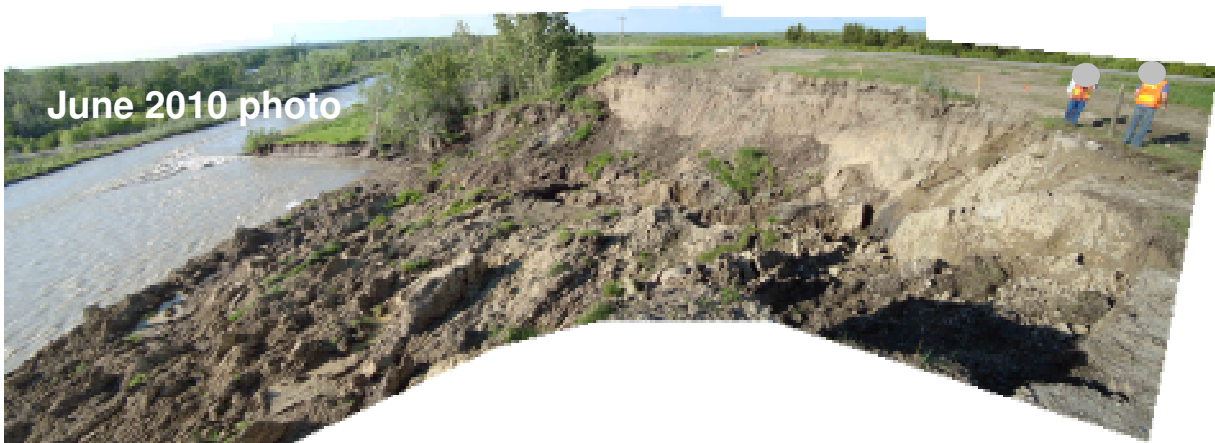
**Photo 5 (bottom) - June 2010**

Taken after the temporary repair work in June 2010 from near the same point as Photo 3. Note that the headscarp has been graded to a 1H:1V angle, and that soil nails are visible protruding from the slope. Also note the high river level.

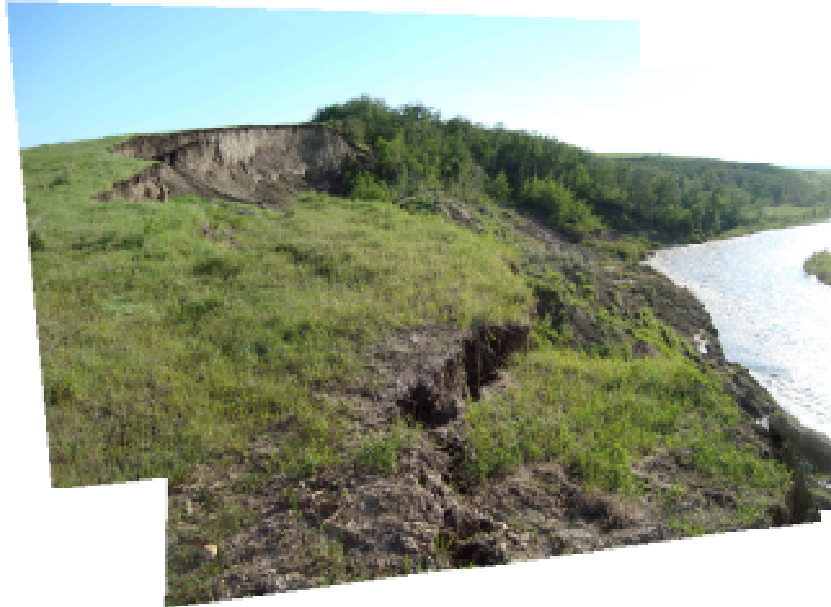
**Photo 6 (top) – June 2010**

Looking south from the same location as Photos 3 and 4 towards the scarp to the south of the main encroachment. Tension cracks indicate that the scarp is retrogressing. This area is offset 20 m or more from the highway.

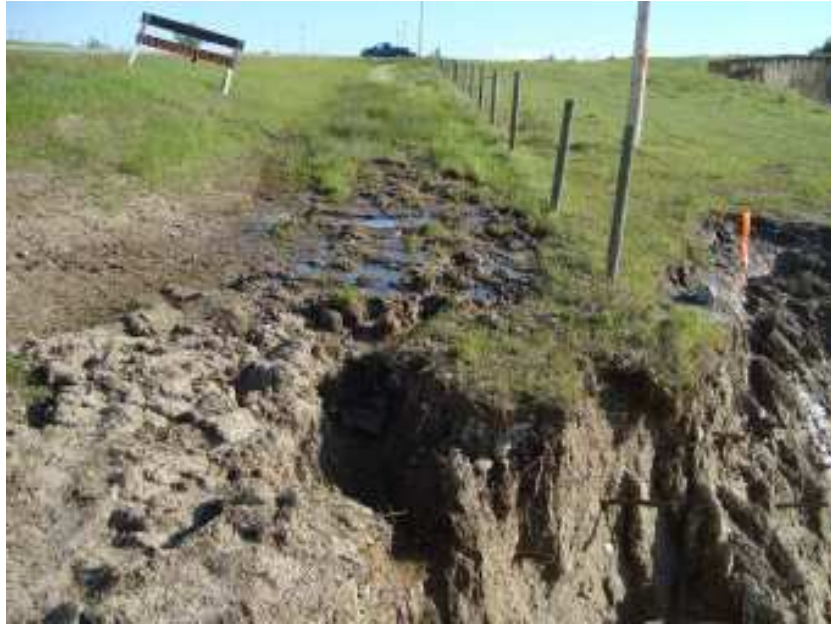
**Photo 8 (top) – June 2010**

The headscarp has retrogressed to intercept the ditch invert causing ditch flow to be directed onto the slide mass. The flowing water in the ditch was draining onto the upper portion of the slide area at the time of the inspection.

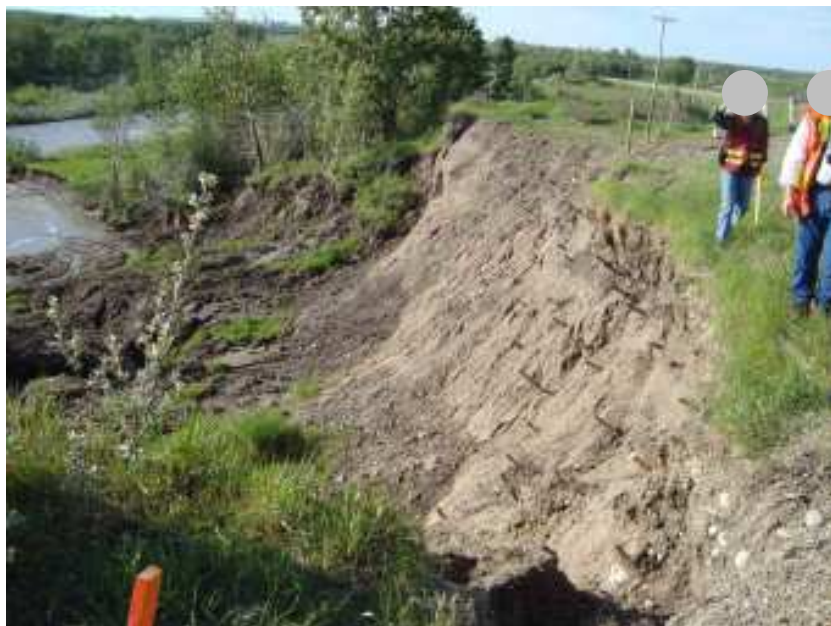
**Photo 9 (bottom) – June 2010**

Looking north towards the soil nails in the scarp of the main slide area.
