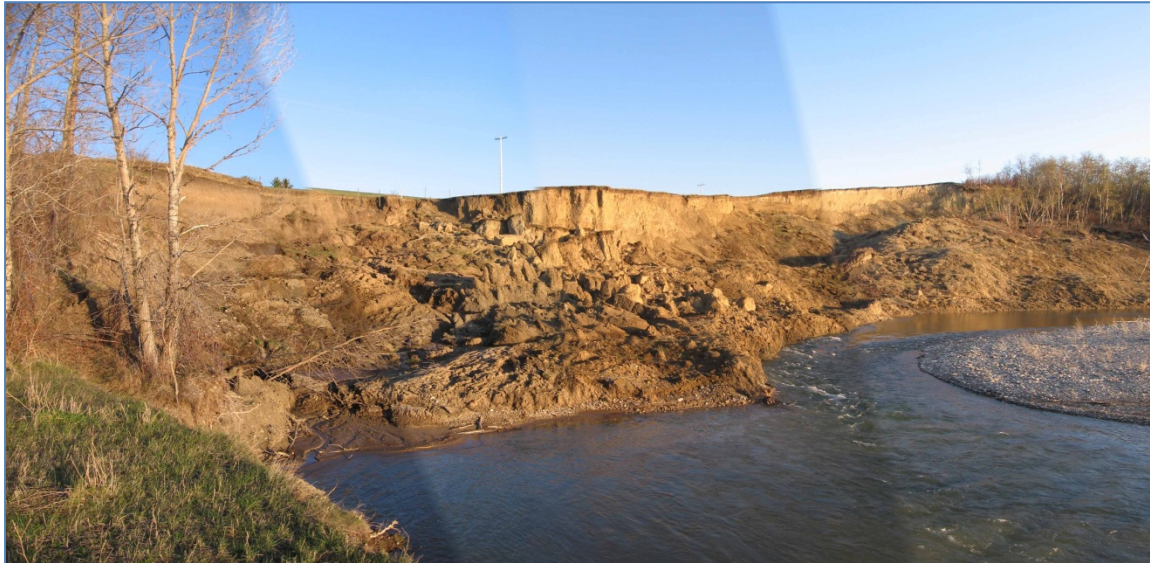
**Photo S36-1 (May 2010) – top –**  
Facing southwest and upstream towards the slide area.

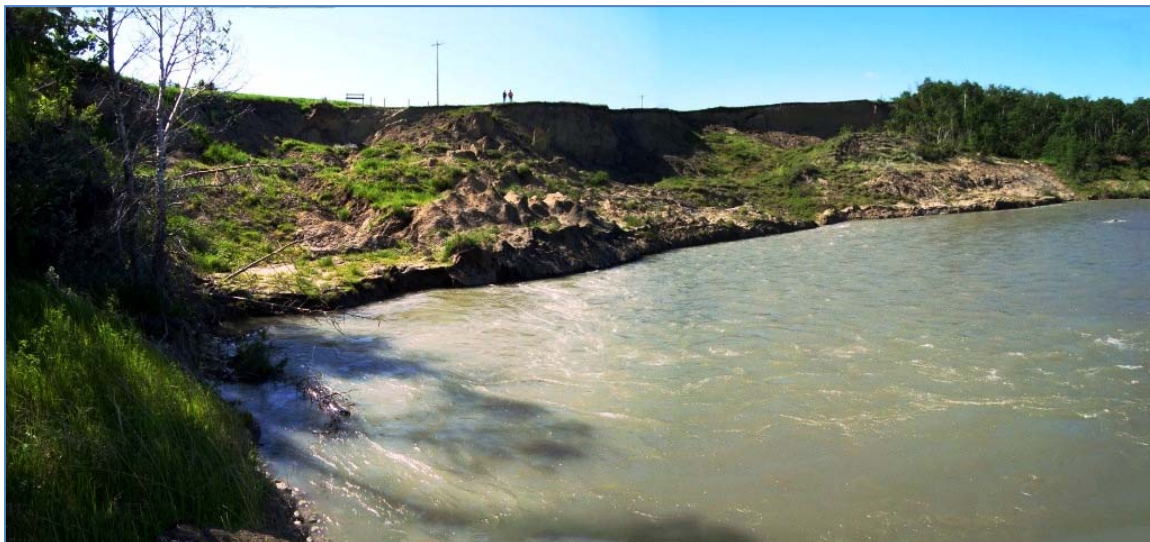
**Photo S36-2 (June 2011) – bottom –**  
Photo of the slide area taken from the same location as Photo S36-1. The slide mass that encroached into the river in early 2010 has been largely removed by river erosion. The blocky appearance of the slide mass has become somewhat subdued by erosion and some natural revegetation has taken hold. It appears that the landslide has not moved significantly since May 2010.

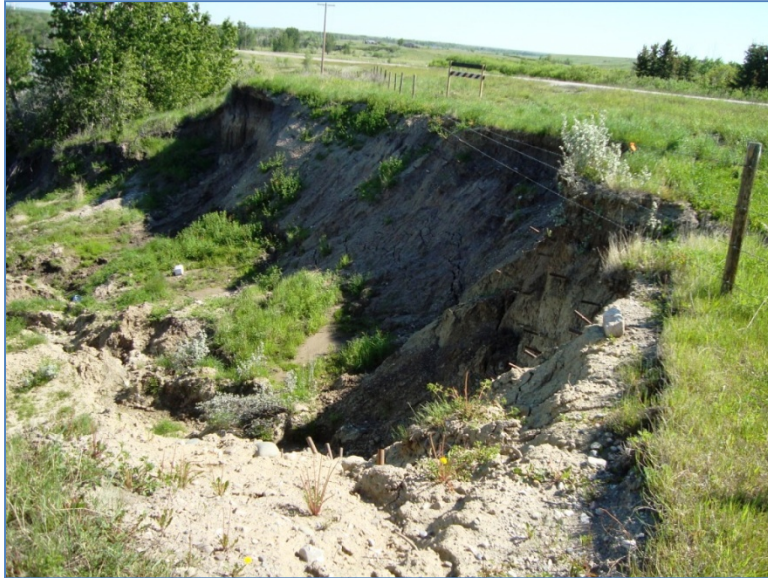
**Photo S36-3 (June 2011)**  
Facing northwest towards the main encroachment area with the 2010 regrading and soil nail repair. The landslide does not appear to have retrogressed closer to the road since the June 2010 inspection. The soil nail repair was in good condition.

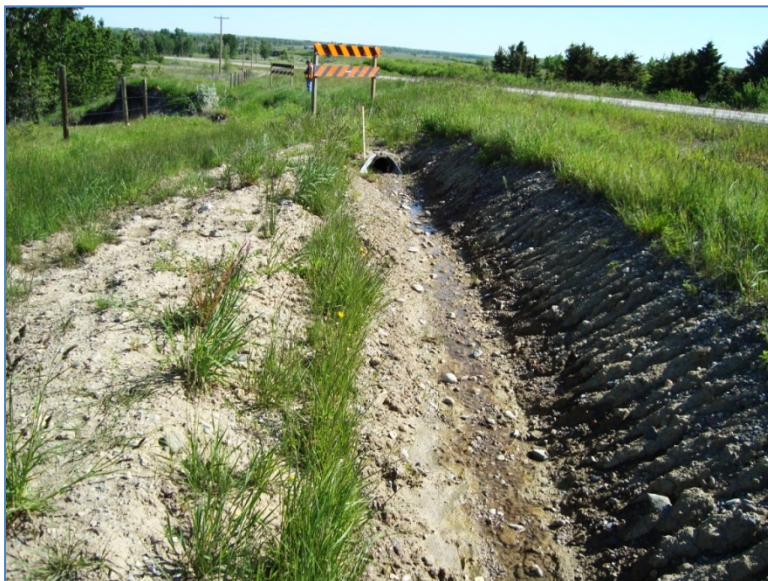
**Photo S36-4 (June 2011)**  
Facing north at the main encroachment area and the temporary pipe that has been installed to convey ditch flow across the headscarp area to an armoured outlet north of the site. The ditch and pipe were working effectively.

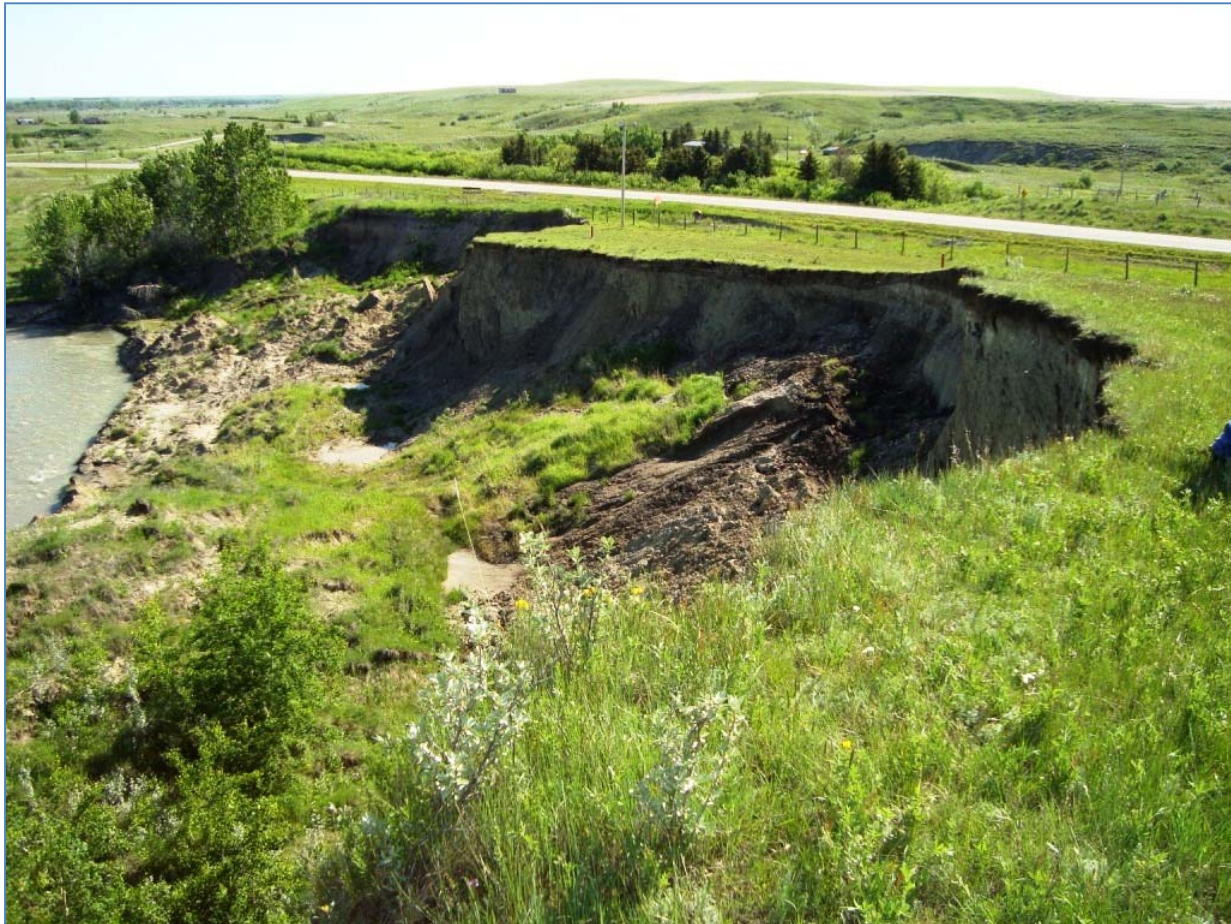
**Photo S36-5 (June 2011)**

Facing northwest towards the landslide area. Ponded water on the slide mass may indicate seepage discharge areas. The slide mass has become partially vegetated since the 2010 inspection, indicating that slide mass has experienced relatively lesser movement over the past year. Some areas of freshly disturbed, flowed, soil were noted where the slide mass has continued to move.
