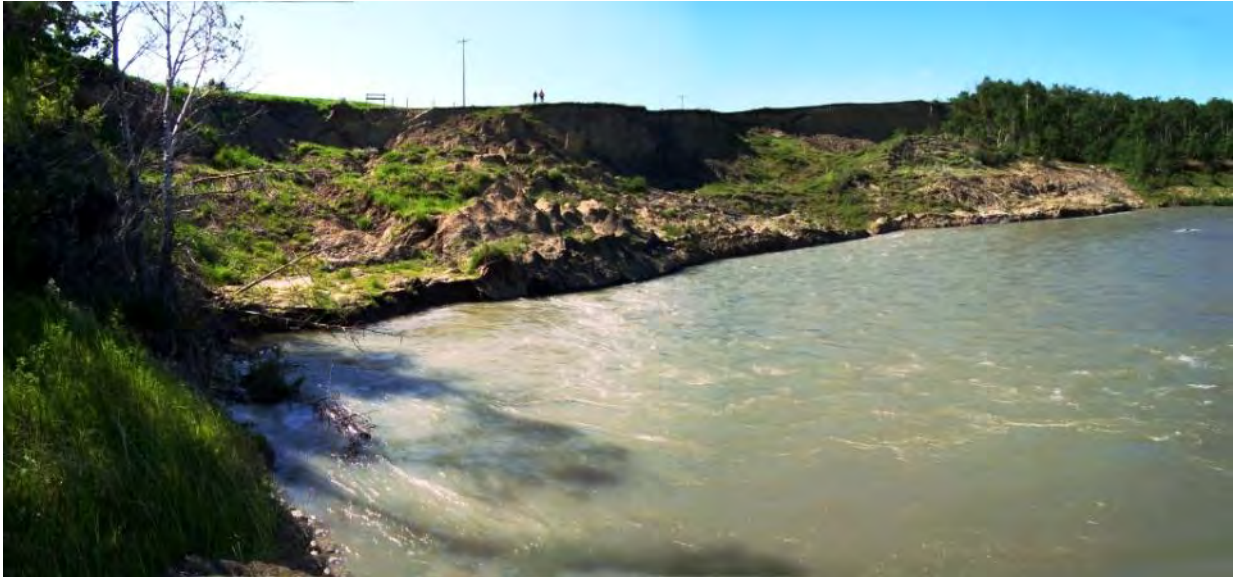
**Photo S36-1 - (June 2011)**

Facing southwest and upstream towards the slide area during the June 2011 inspection prior to repair work.

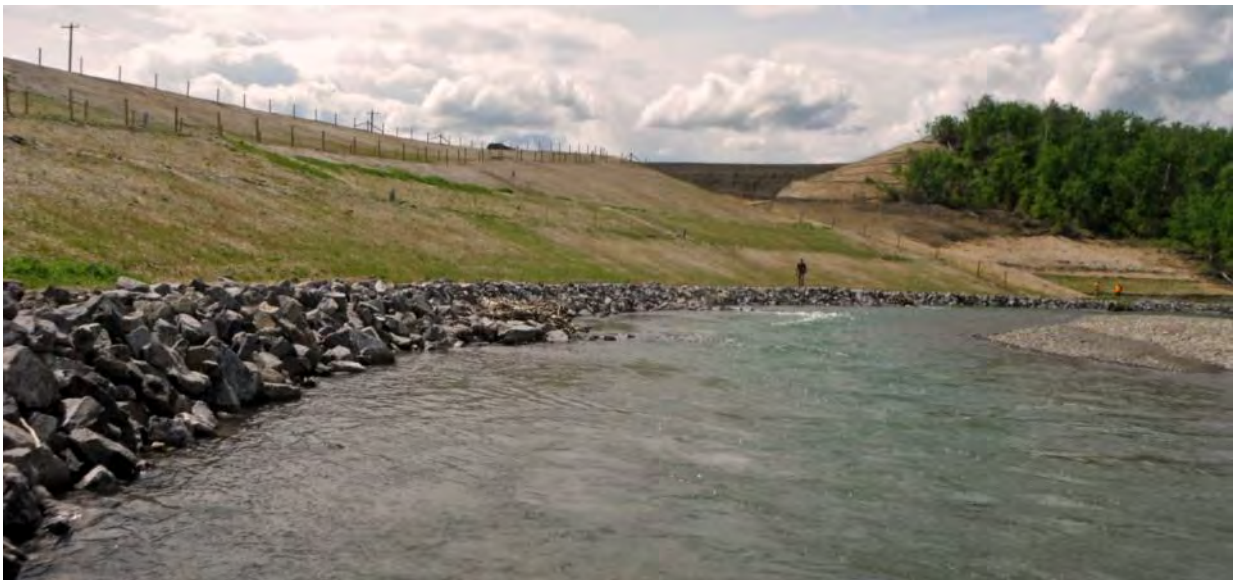
**Photo S36-2 - (May 2013)**

Standing at a similar location as Photo S36-1, facing southwest and upstream at the repaired slide area.

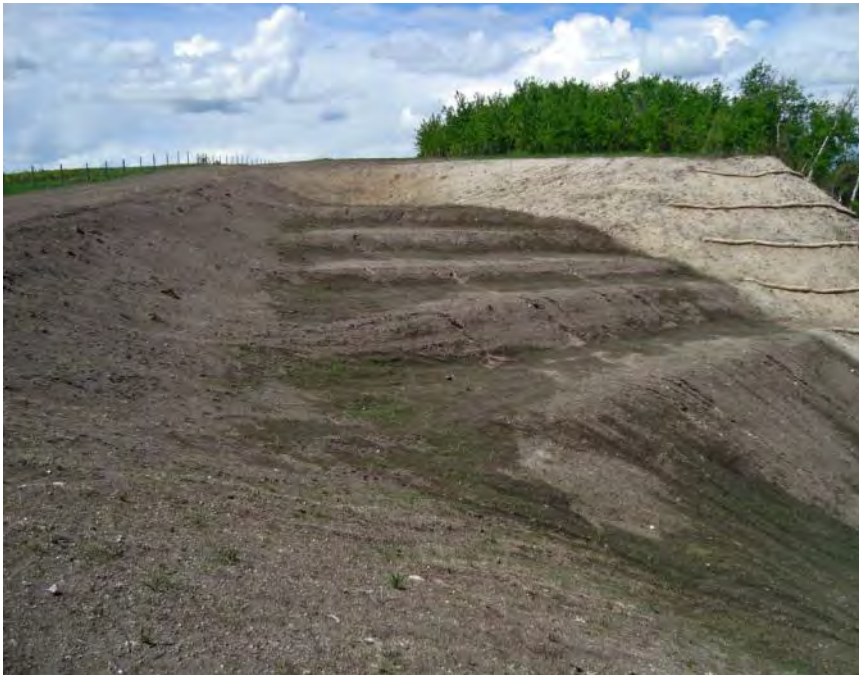
**Photo S36-3 - (May 2013)**  
Standing near the top of the graded slope looking towards the south at the borrow area. Minor vegetation growth and rilling on the benches was visible.

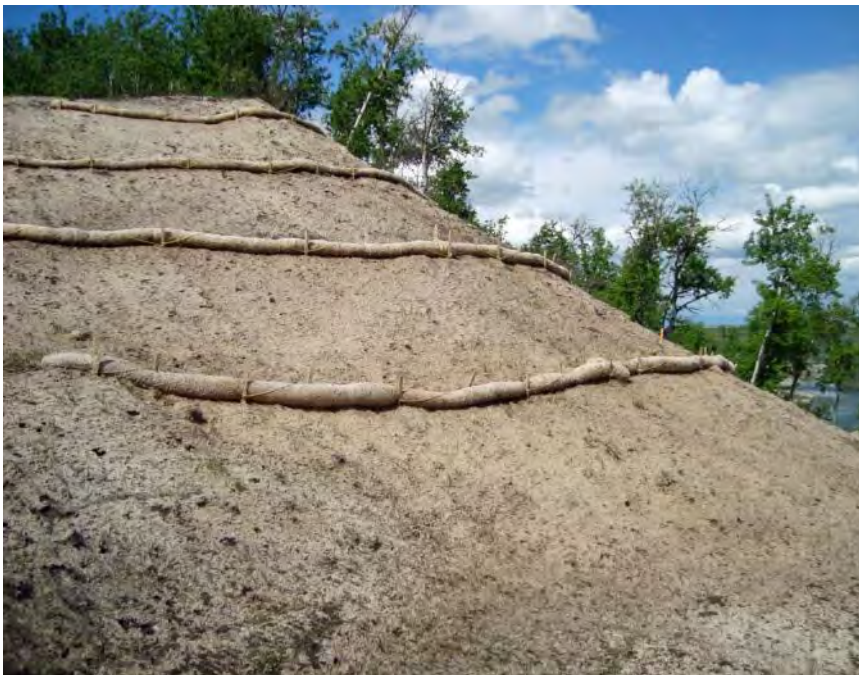
**Photo S36-4 - (May 2013)**  
Looking towards the southwest near the bottom of the southwest ridge at the borrow area.

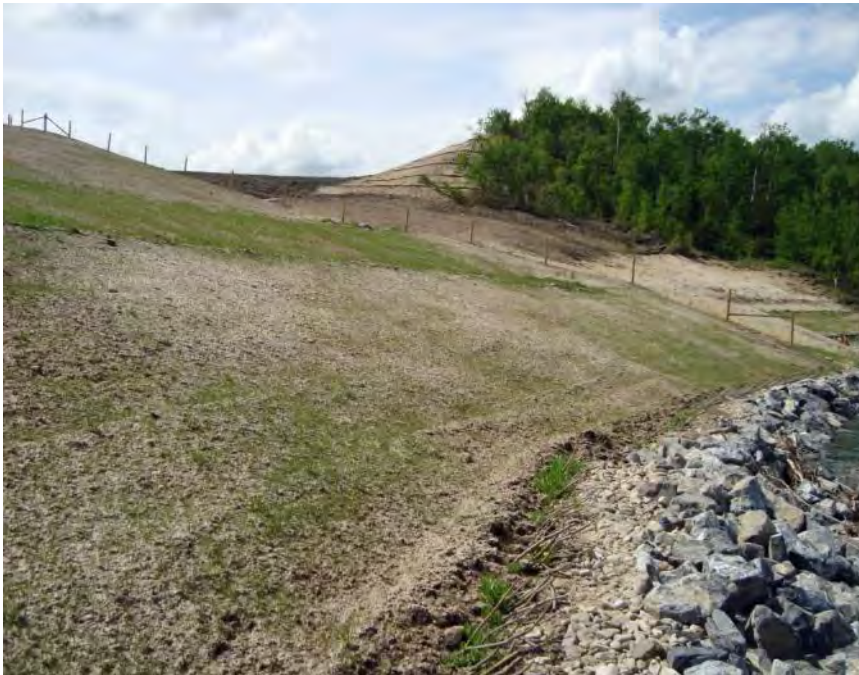
**Photo S36-5 - (May 2013)**  
Standing at the toe of the main slide area looking towards the south across the lowestmost bench face.

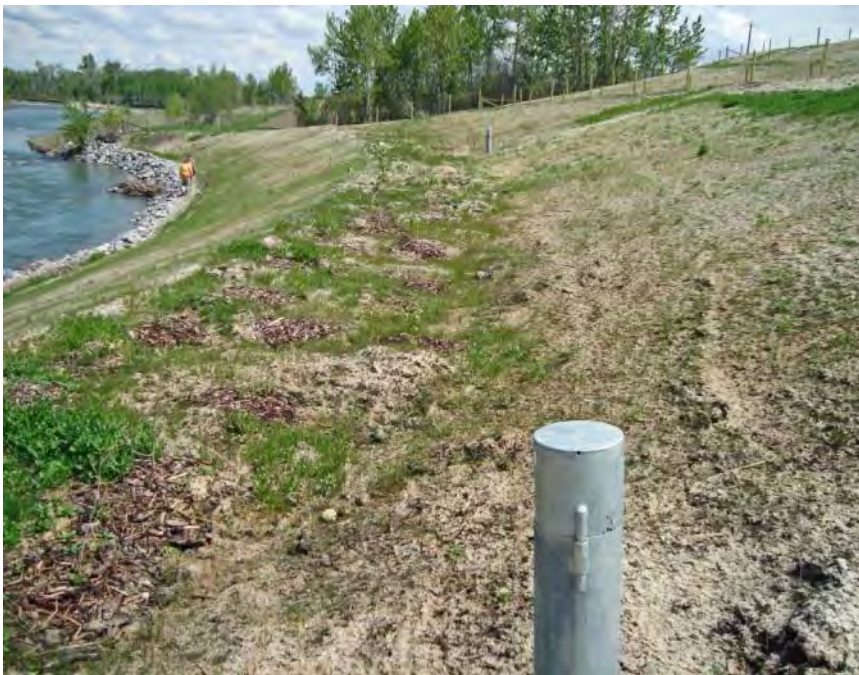
**Photo S36-6 - (May 2013)**  
Standing at the southern edge of the main slide area looking towards the north across the lowermost bench.

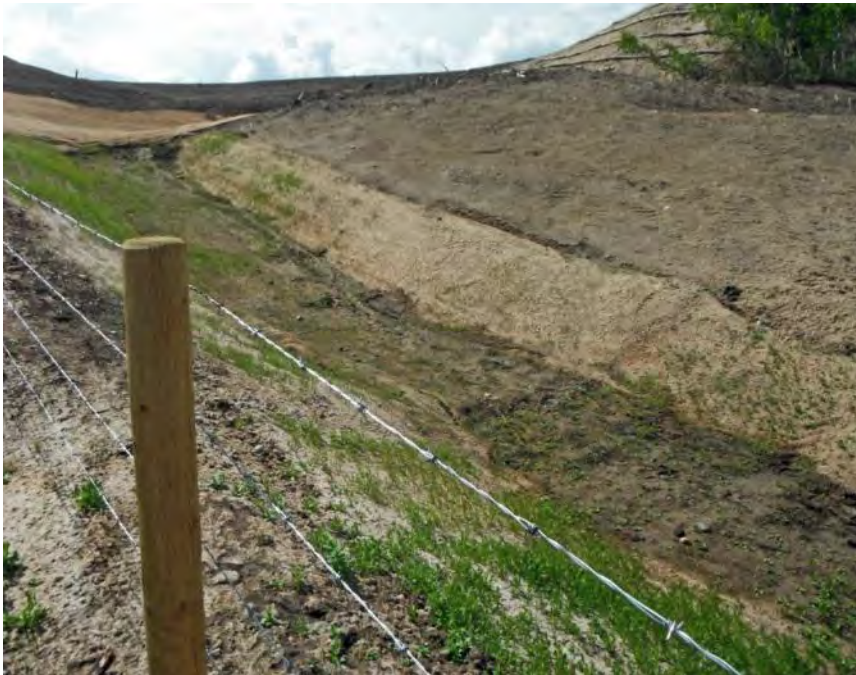
**Photo S36-7 - (May 2013)**  
Looking upslope towards the southeast at the south collection ditch. The ditch was wet and vegetation growth was visible.

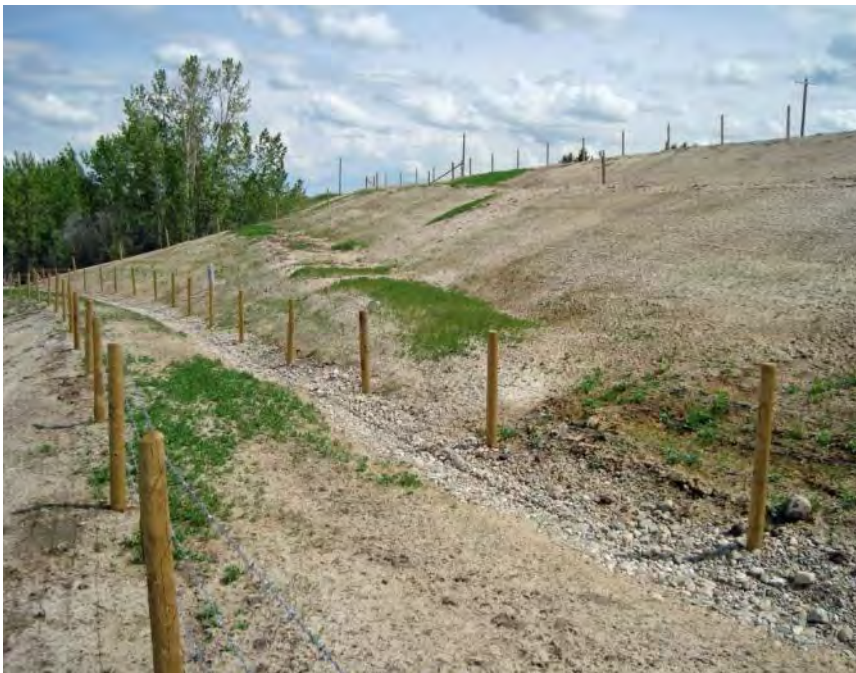
**Photo S36-8 - (May 2013)**  
Standing at mid-slope within the main slide area looking towards the north at the fenced access road and upper slope benches.

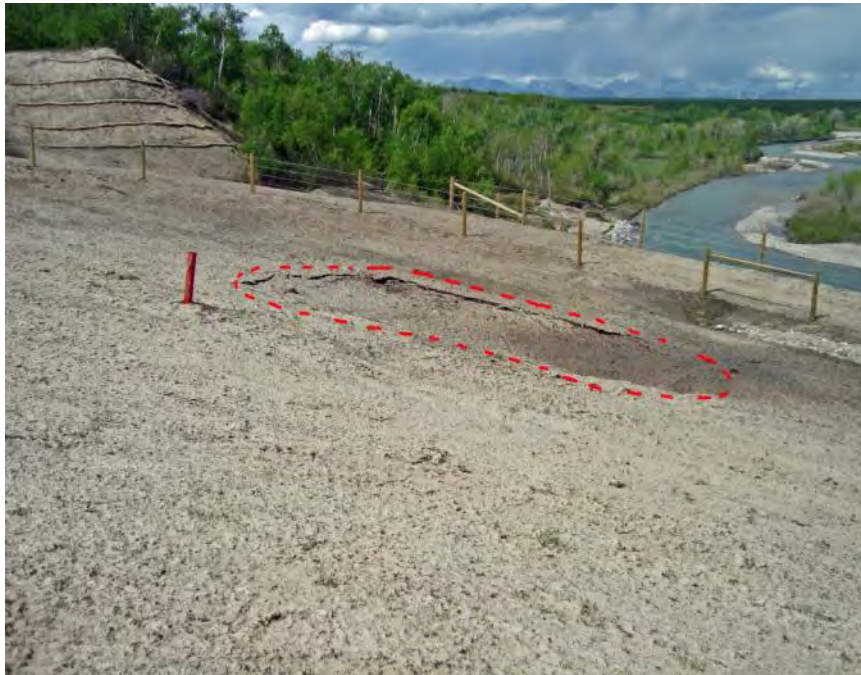
**Photo S36-9 - (May 2013)**  
Standing on a bench upslope of the access road within the main slide area looking towards the west at a settlement area around an old piezometer installation. The extent of the settlement is outlined in red.

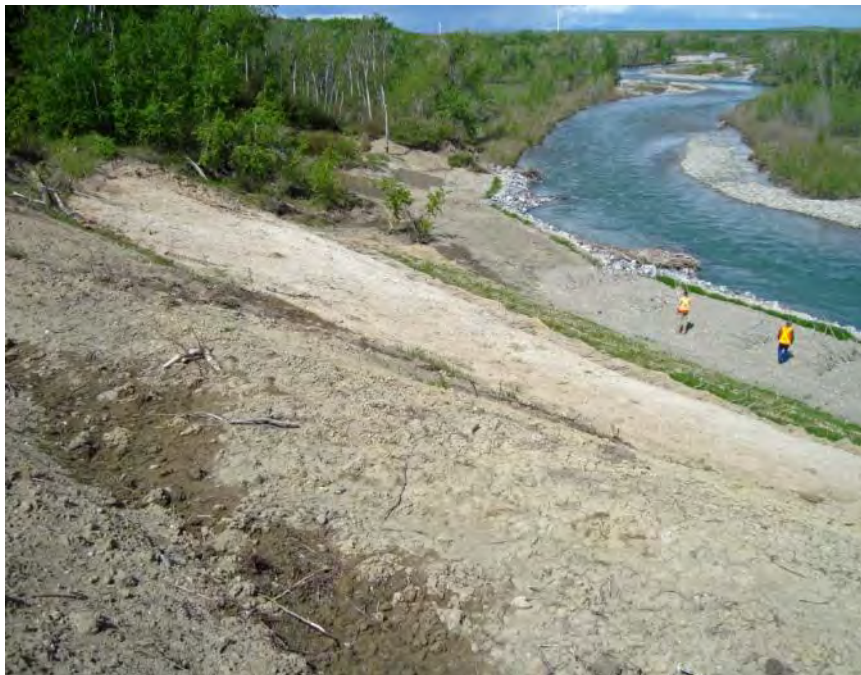
**Photo S36-10 - (May 2013)**  
Looking downslope towards the southwest from mid-slope at the area containing bio-engineering repairs.

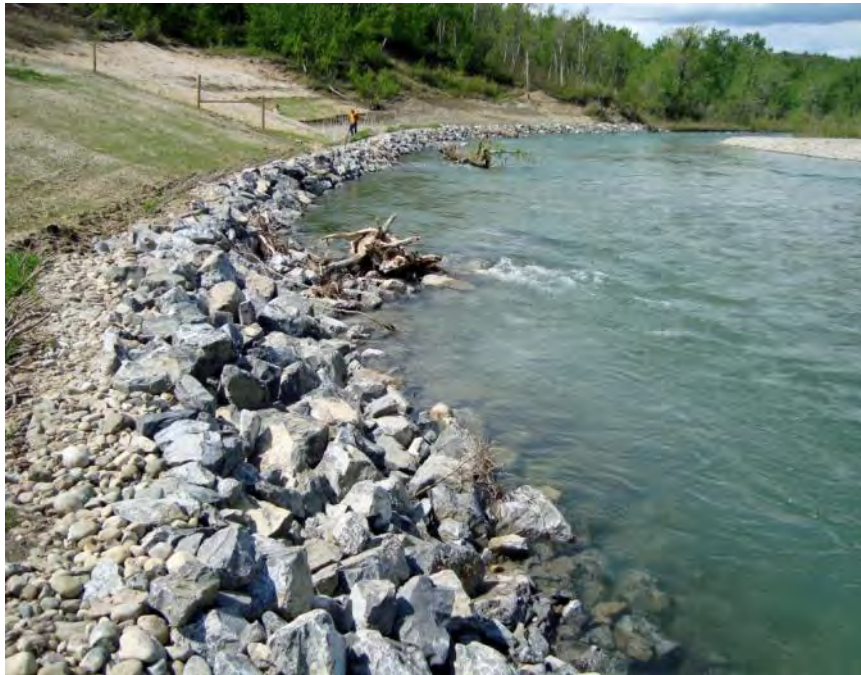
**Photo S36-11 - (May 2013)**  
Standing at the east edge of the river bank, at approximately the center of the site, looking towards the south at the LPSTP and vanes. Wood debris had collected in the vanes.

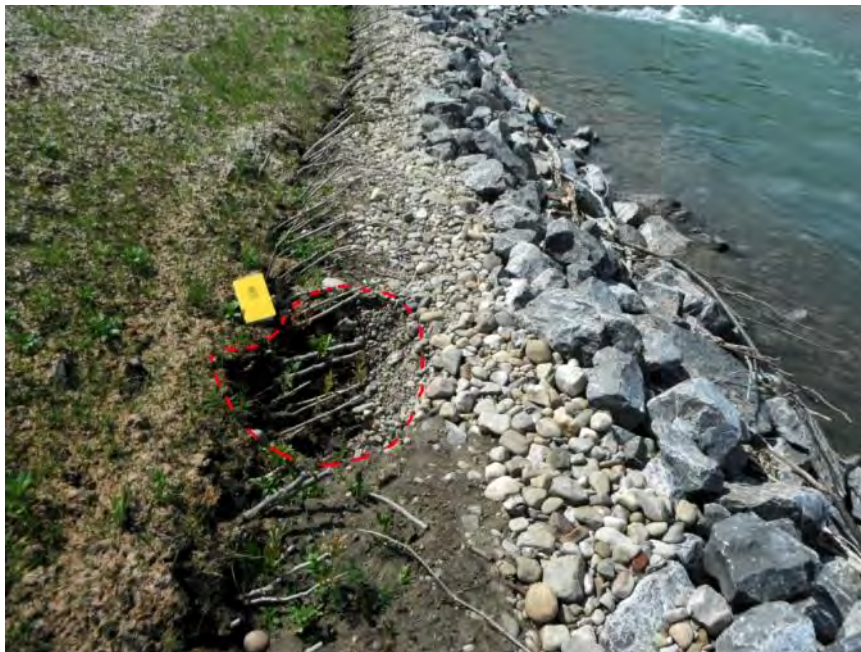
**Photo S36-12 - (May 2013)**  
Standing at the east edge of the river bank at the north end of the site. An erosion / settlement area was noted between the rip-rap and willow plantings at the toe of the slope.

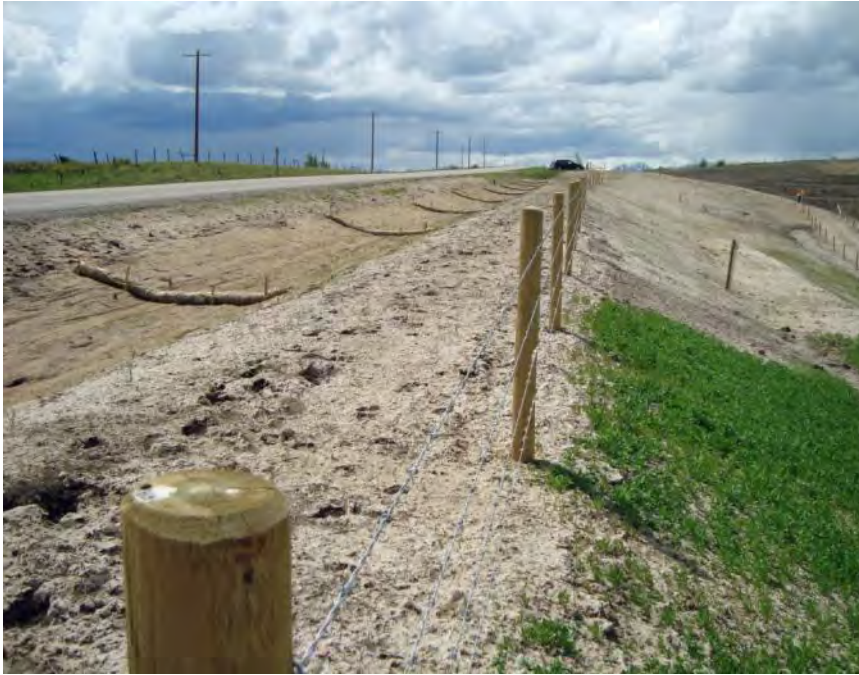
**Photo S36-13 - (May 2013)**  
Standing at the fenceline along the slope crest within the main slide area looking south across the west highway ditch and upper bench face.
