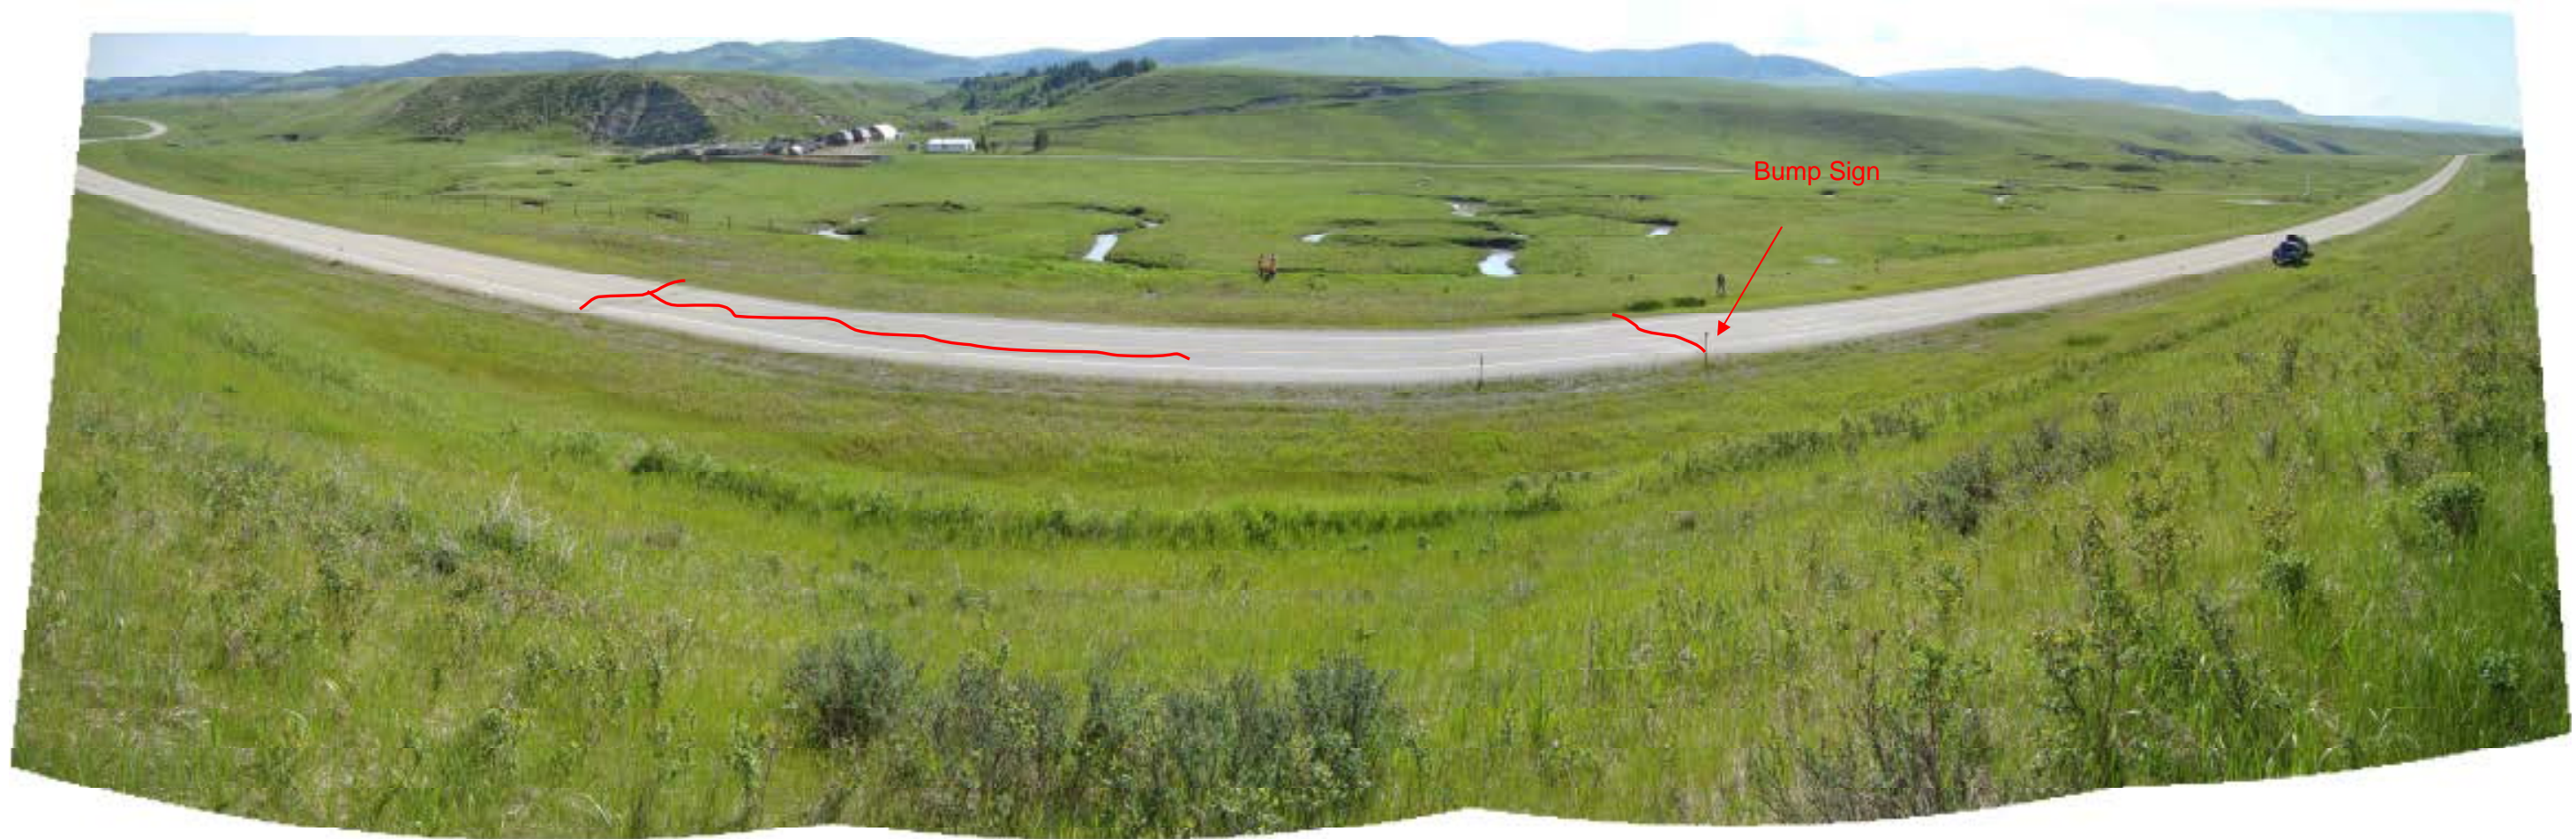
**Photograph 1 – Stitched panorama of Km 15.8 Site taken from the slope above (west of) the site. The cracks in the road surface are marked for clarity. The apparent curvature of the road is due to the photograph stitching software and is not realistic.**

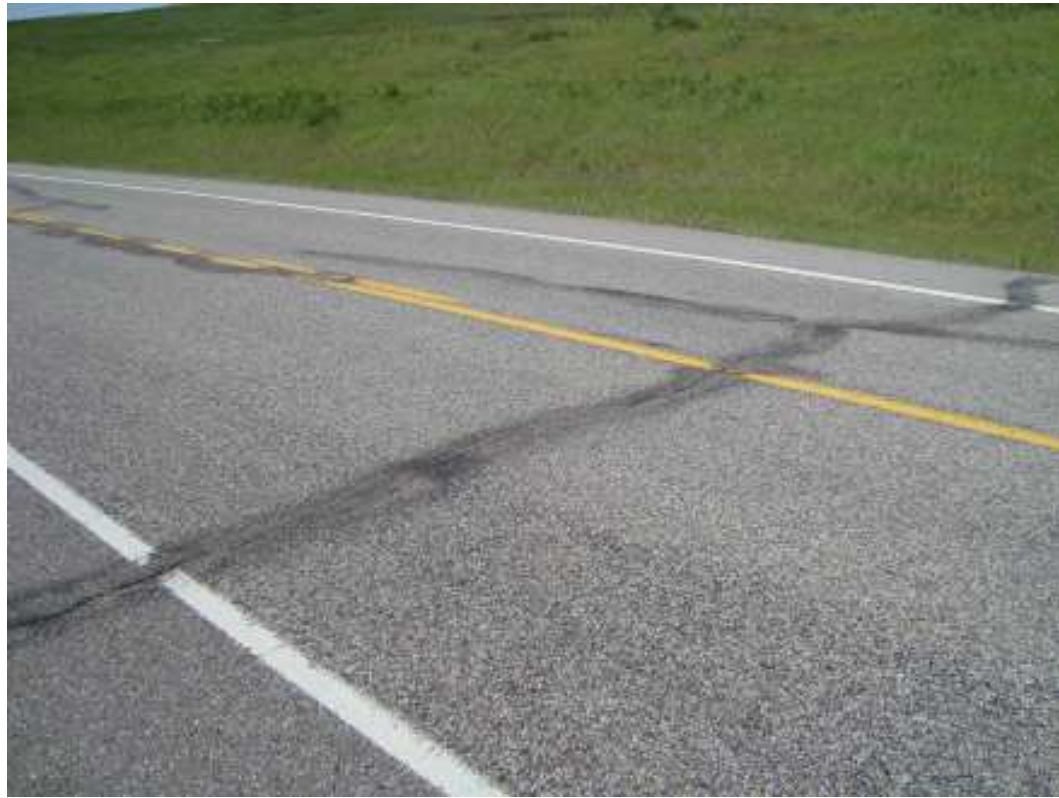
**Photograph 2 – Top Left – Cracks in the road surface at Km 15.8 Site.**

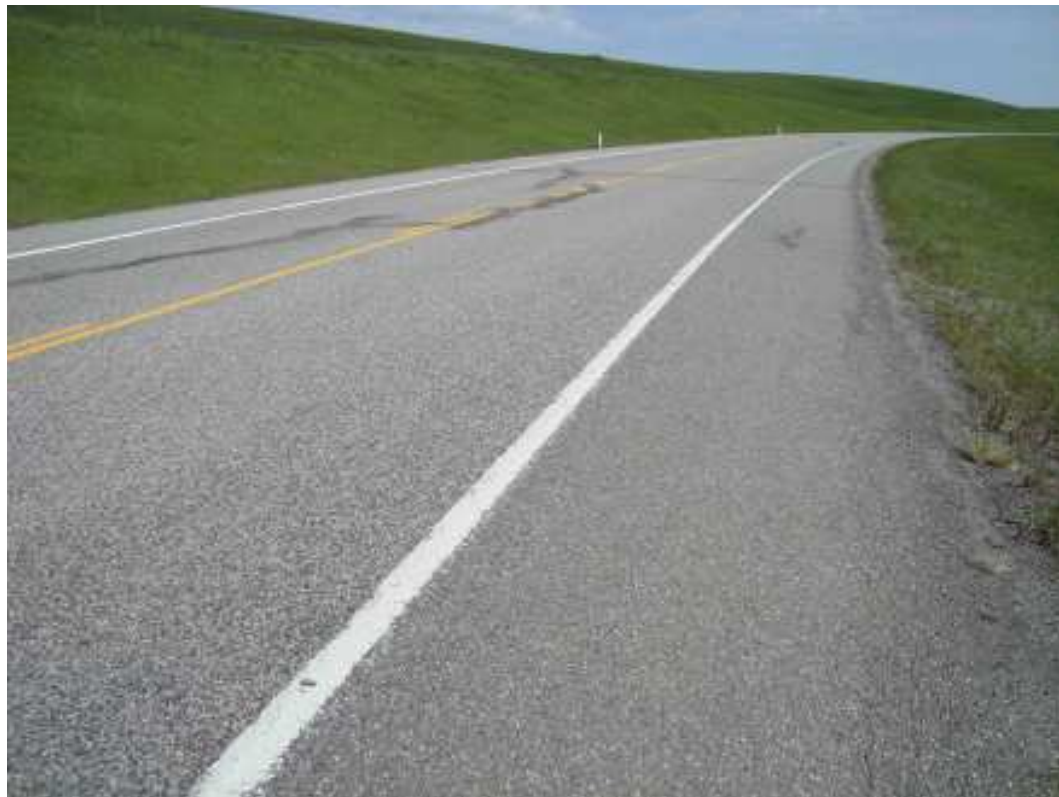
**Photograph 3 – Bottom Left – Looking northbound at cracks in the road surface at Km 15.8 Site.**

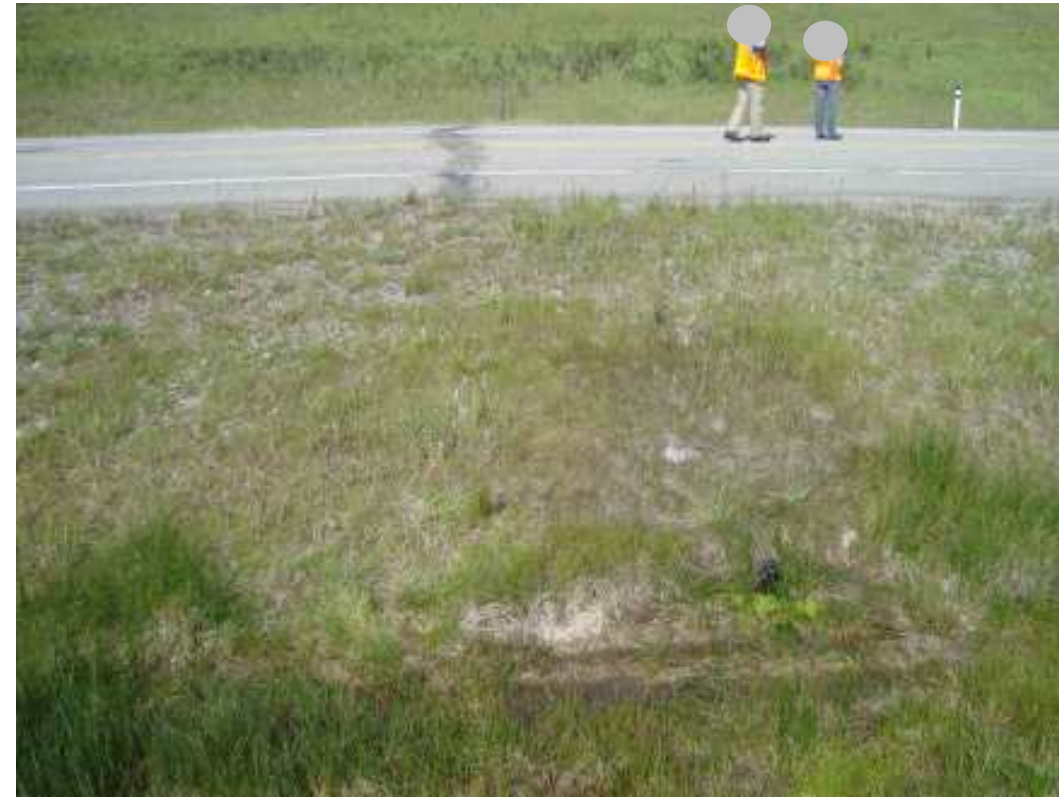
**Photograph 4 – Top Right – Perforated drainage pipe outlet in the east ditch at Km 15.8 Site.**

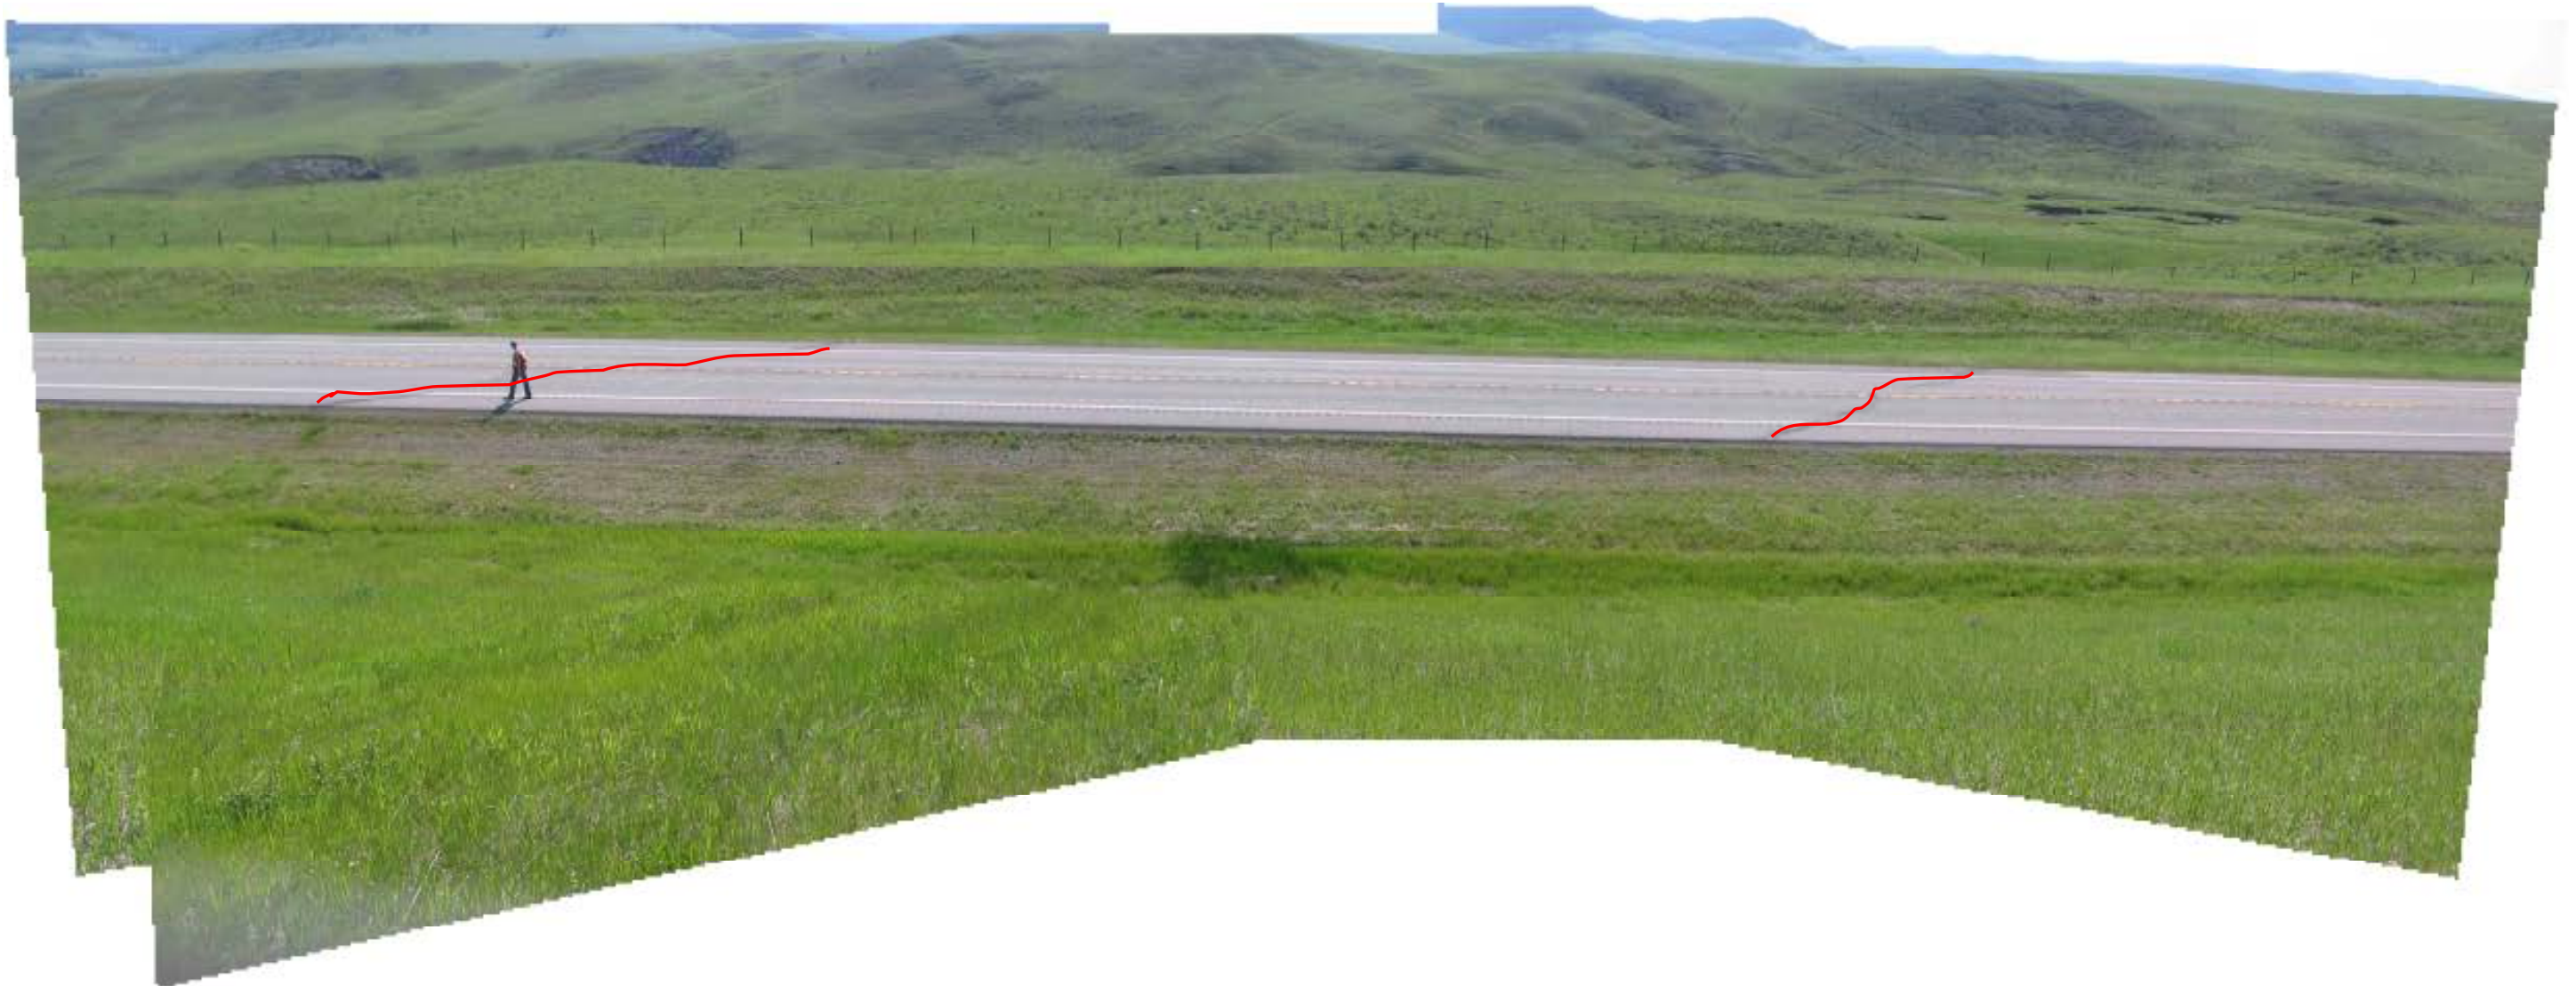
**Photograph 5 – Stitched panoramic of Km 15.8 Site taken from the slope above the site. The cracks in the road surface are marked for clarity.**
