Client	<b>Alberta Transportation</b>		<b>Figure 1</b>	
Project	<b>Southern Region Geohazard Assessment</b> <b>S38 - Hwy 22:08 - Callum Creek - Site Plan and Instrumentation Detail</b>		Date:	Revision
			<b>Sep-11</b>	
			Job No.	<b>CG25352.200</b>
			Figure 1.xls

**From:** Clay, Tyler  
**Sent:** Monday, July 18, 2011 5:31 PM  
**To:** Ross Dickson  
**Cc:** Bidwell, Andrew; Bale, Bryan  
**Subject:** S38 - Callum Creek, Hwy 22 Site Conditions (July 2011)  
**Attachments:** July2011\_CallumCk\_Figures.pdf

This email is intended to serve as a summary of the recent instrument data and observations from the July 14, 2011 visit to the S38 - Callum Creek site on Highway 22.

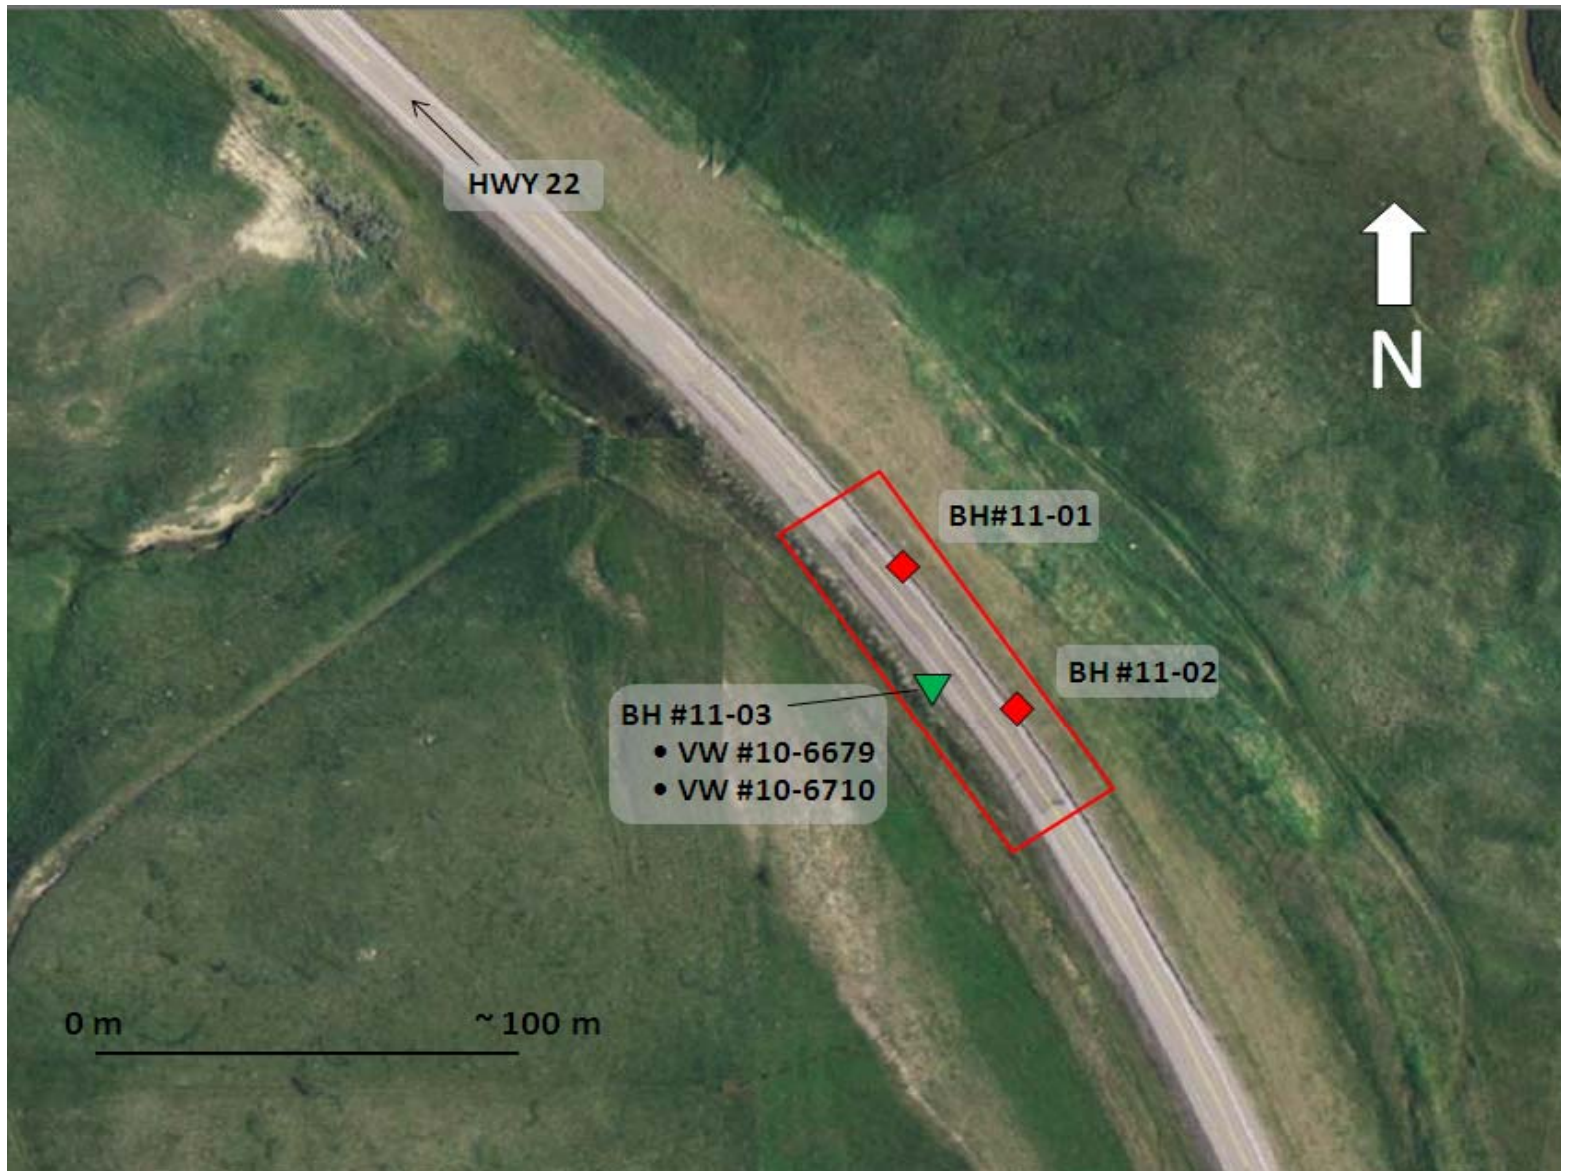
Area of cracking / settlement

The highway appeared to have a recent overlay patch (within the last month or so) along the section where settlement and cracking had been previously observed (approximately 70 – 100 m length). There were some fresh cracks through the new overlay on the west side of the highway shoulder, approximately 20 m in length with aperture less than 50 mm (see attached photos). There was also roughly 10 mm or less of settlement of a portion of the road within the overlay area (see attached photos). The shape and position of the settled area was consistent with past observations of arc-shaped cracks and settlement. There was also some cracking visible on the east side of the road near SI 11-02 for approximately 10 -15 m and with an aperture less than 20 mm.

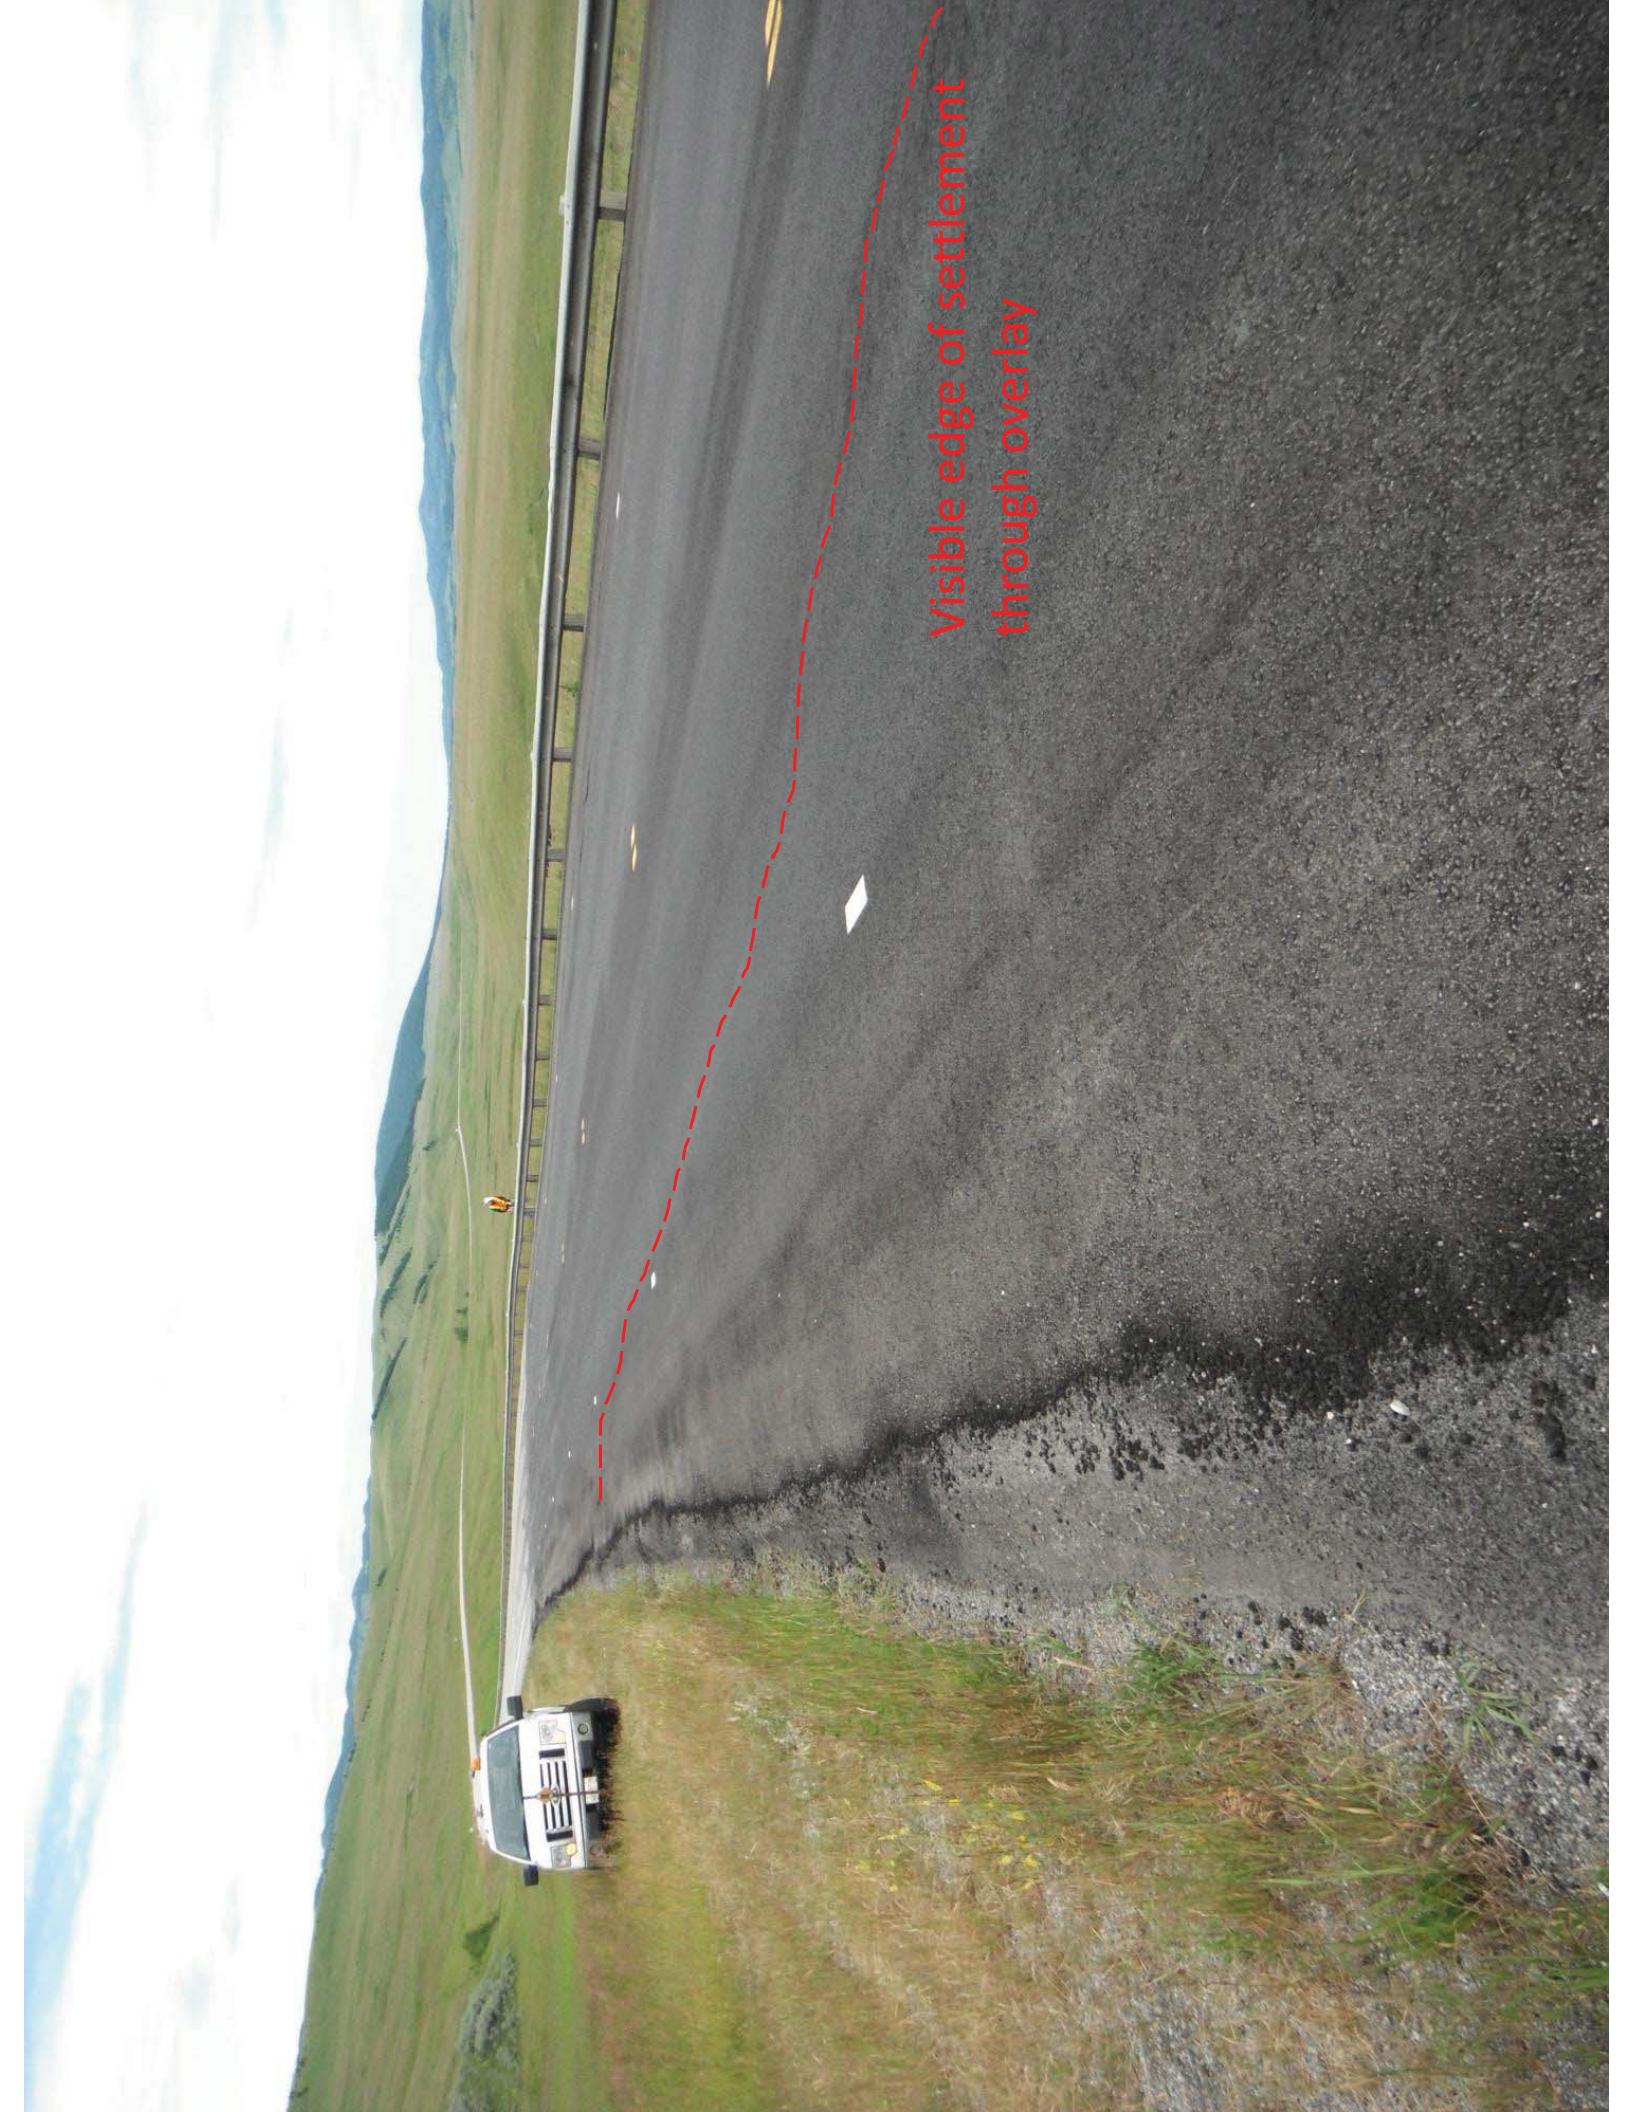
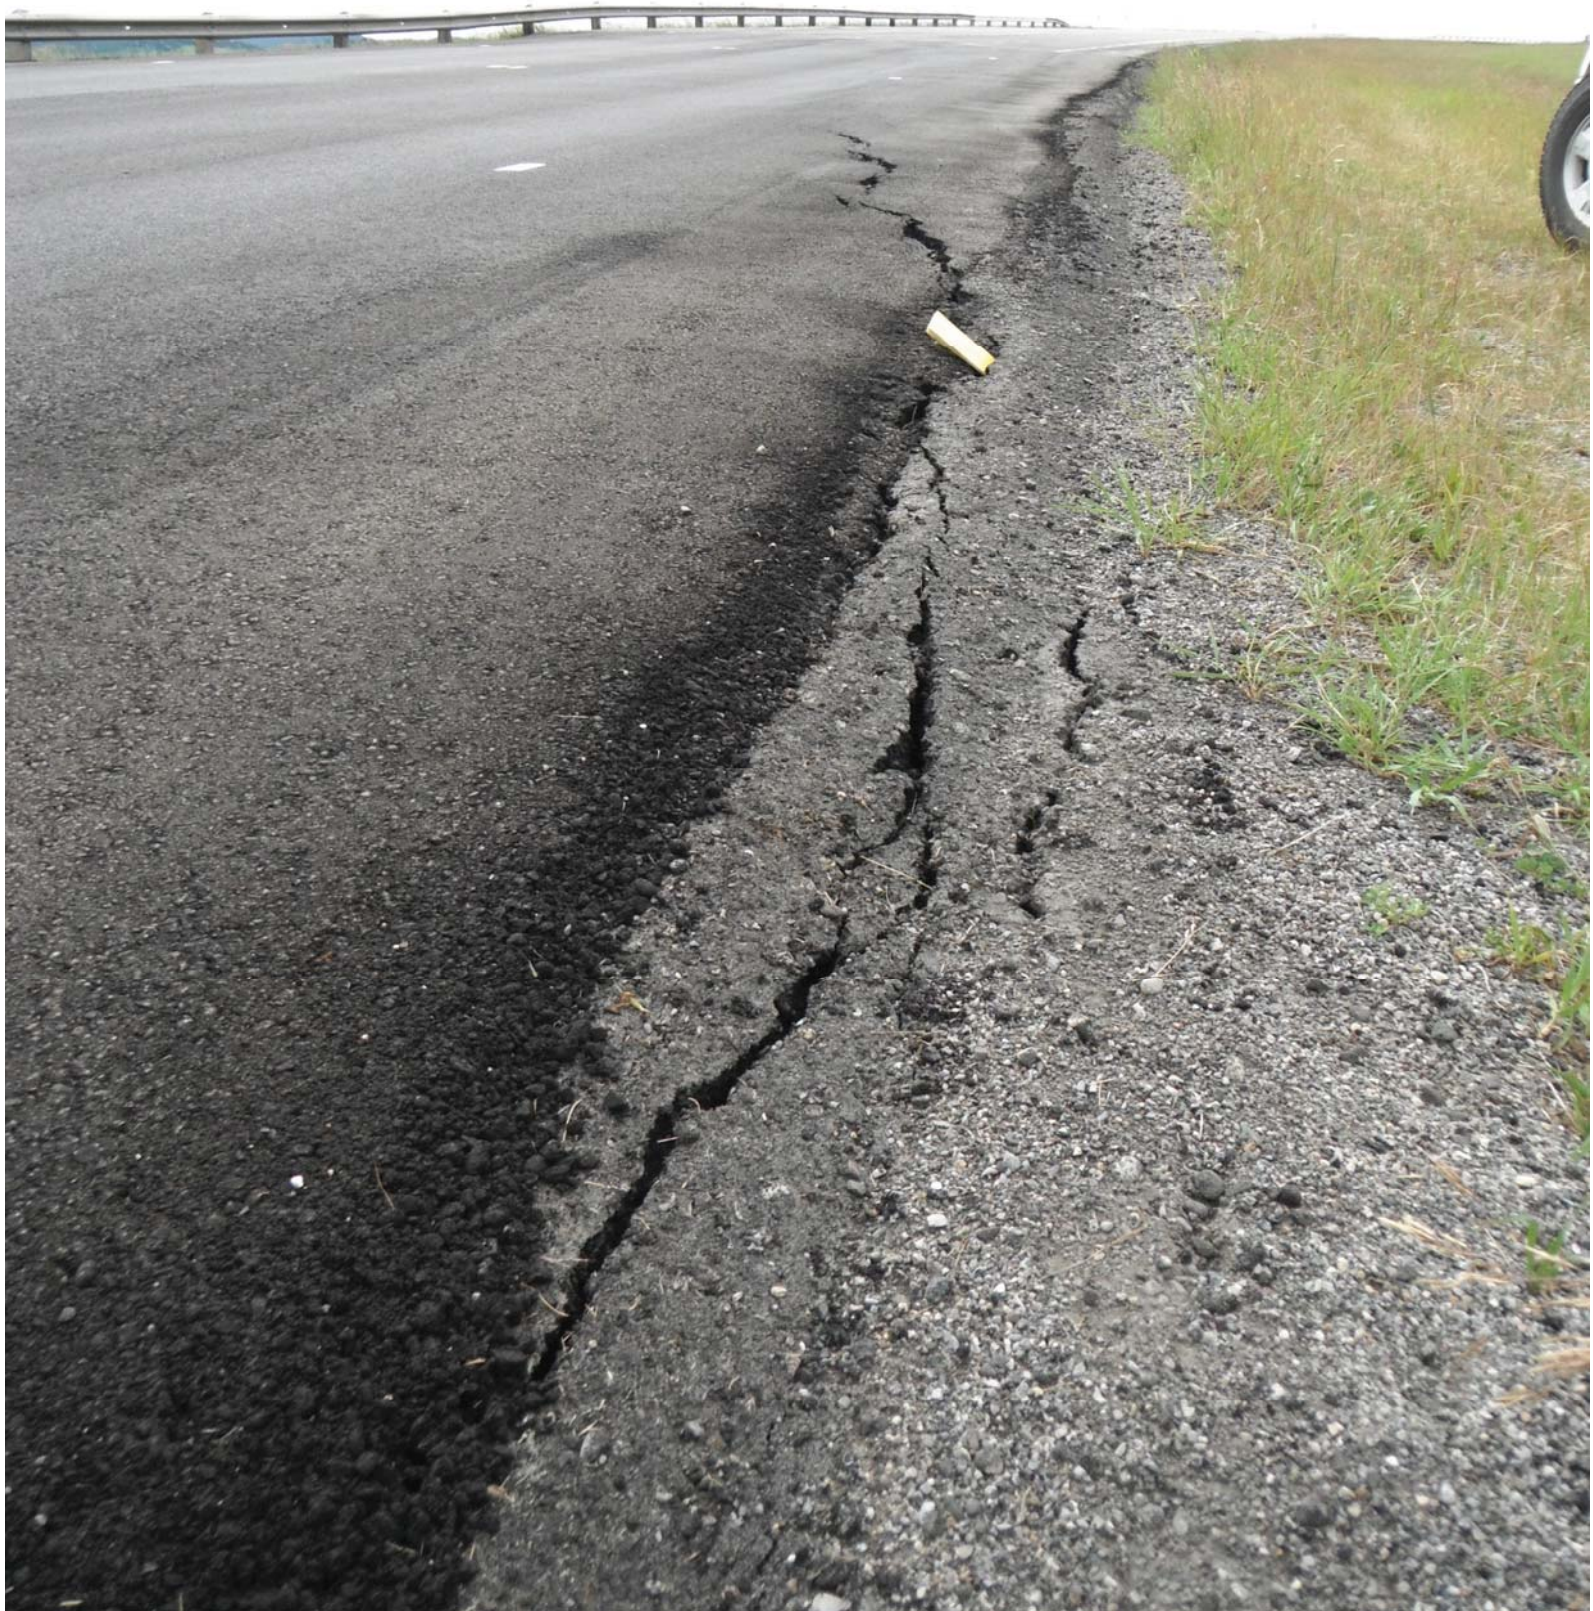
Visible edge of settlement  
through overlay

- Continue placing overlays and/or milling down and resurfacing the asphalt to maintain a trafficable surface through the slide area but without accumulating an excessive load from repeated overlays (i.e. loading the upper portion of the landslide area).
- Maintain signage (e.g. "Bump Ahead") along with reduced speed limit as appropriate for the road surface conditions.
- There is a possibility that additional or accelerated landslide movement could lead to the loss of one of both lanes of the highway and the construction of a temporary detour lane in the upslope road ditch may be required.

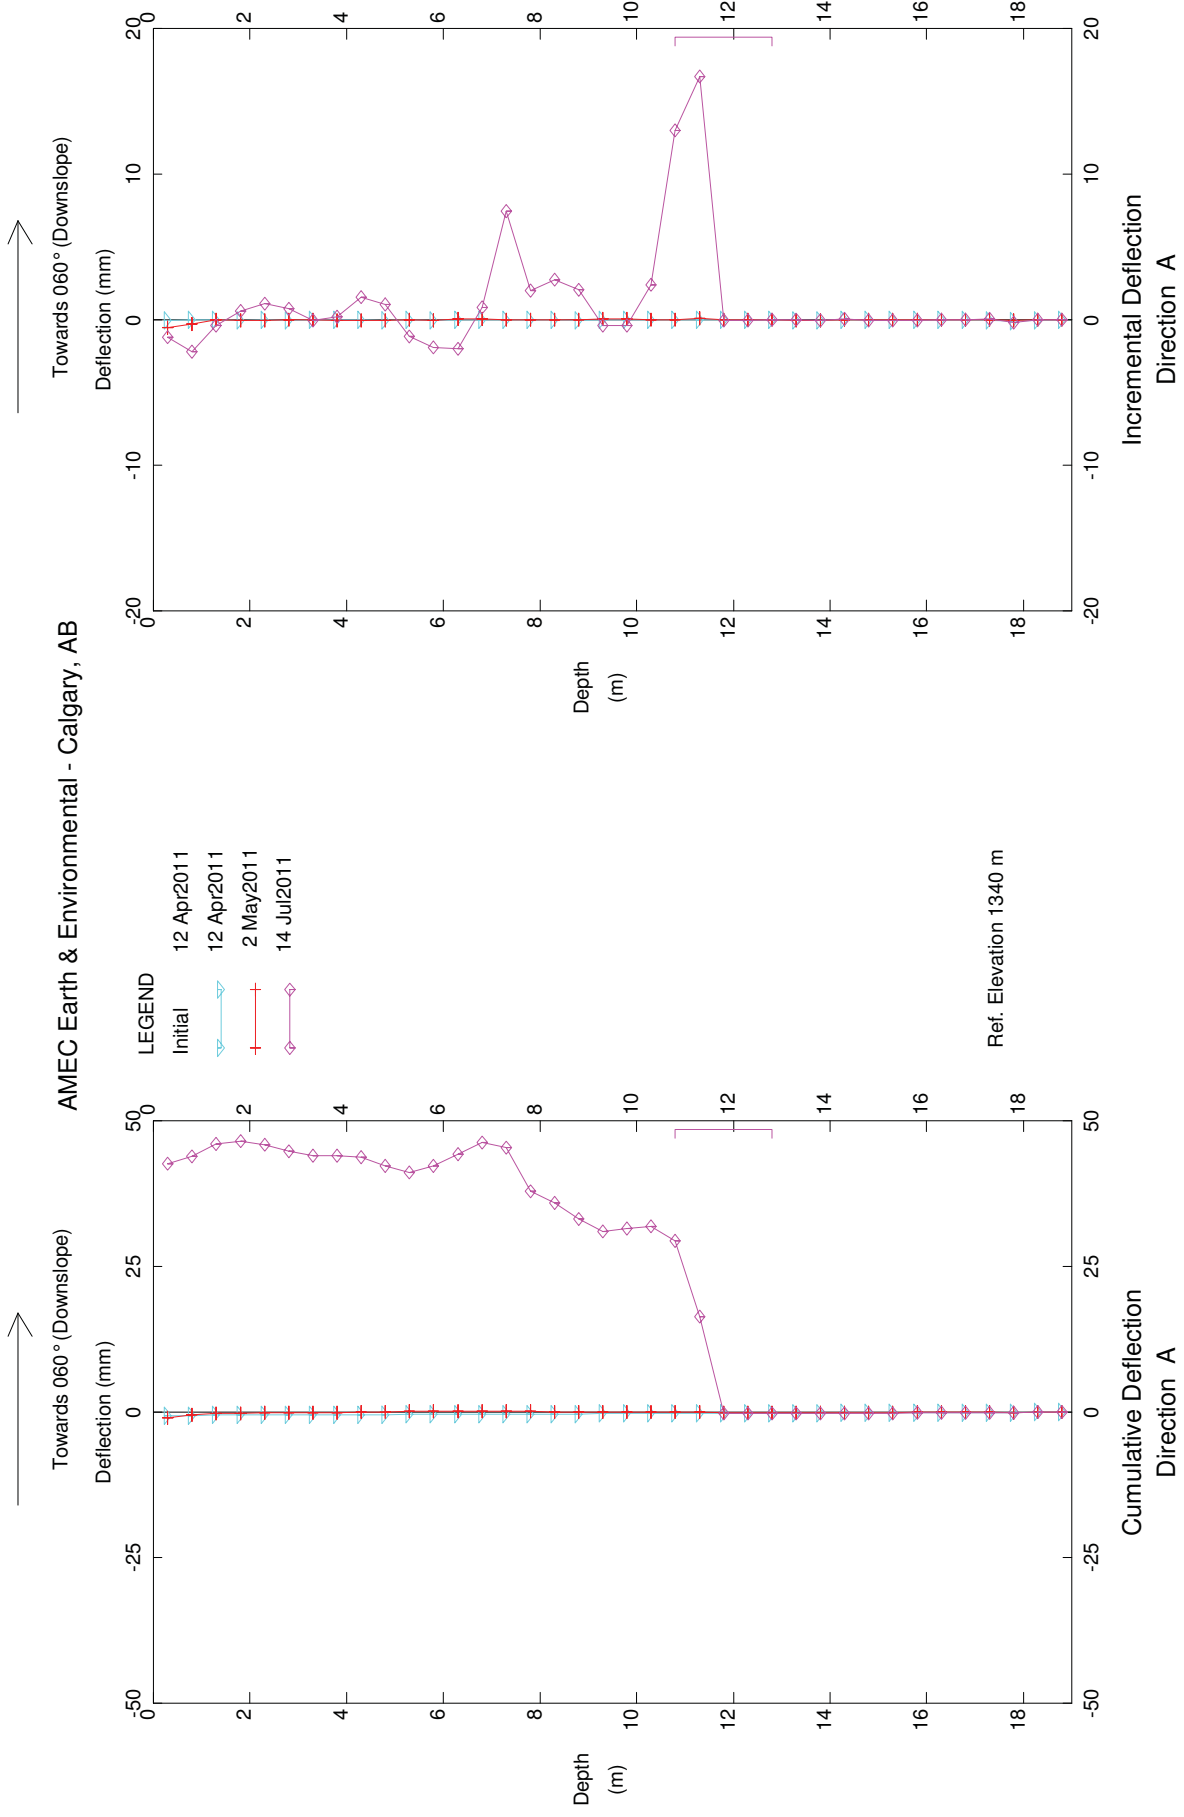
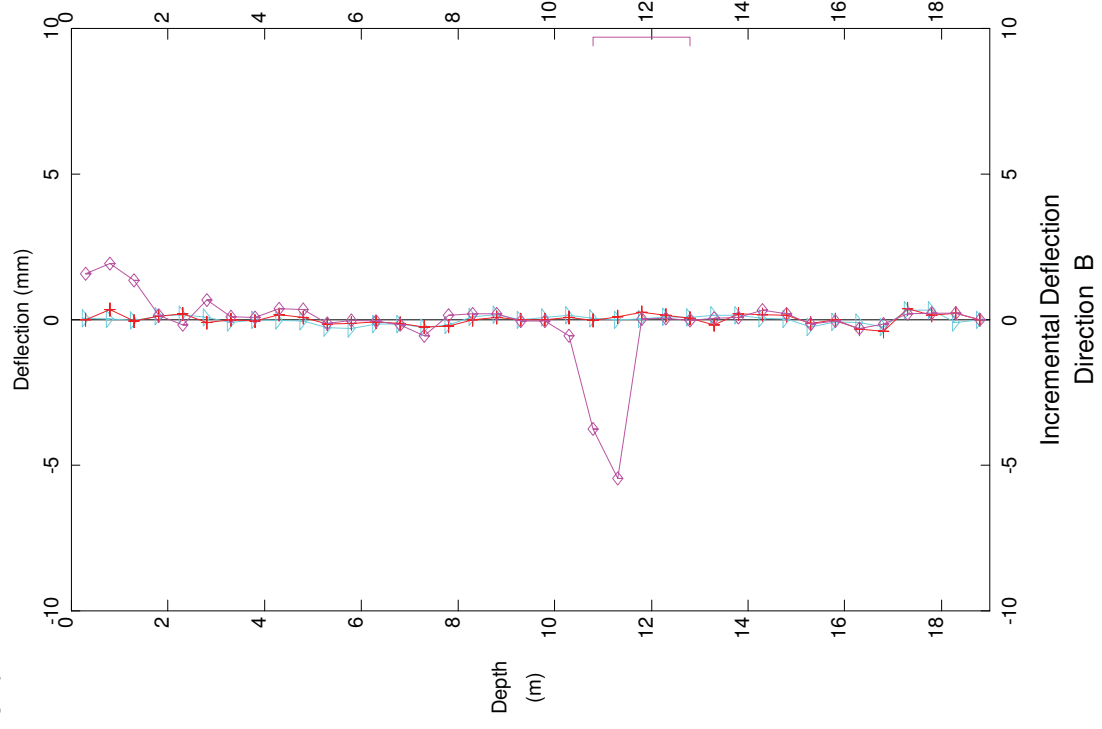
Figure S38-2

- **SI 11-01:** Since the April 12, 2011 initialization this SI has been read twice (May 2<sup>nd</sup>, July 14<sup>th</sup>). Prior to the July 14<sup>th</sup> readings there were no confirmed movement zones. The July 14<sup>th</sup> data shows a confirmed downslope movement zone at approximately 12 m depth with 31 mm displacement at 43° bearing.

This site has active and significant landslide movement, based on the continued settlement and cracking visible in the road surface through recent overlay patches and the SI data. The depth of the movement zones in the SI's roughly corresponds to a layer of higher plastic clay with possible slickensides that was identified during the instrument installation drilling. The data from the vibrating wire piezometers indicates that there are potentially zones of higher water pressure within the slope. These water pressures could be a contributing factor that is driving the active movement at this site.

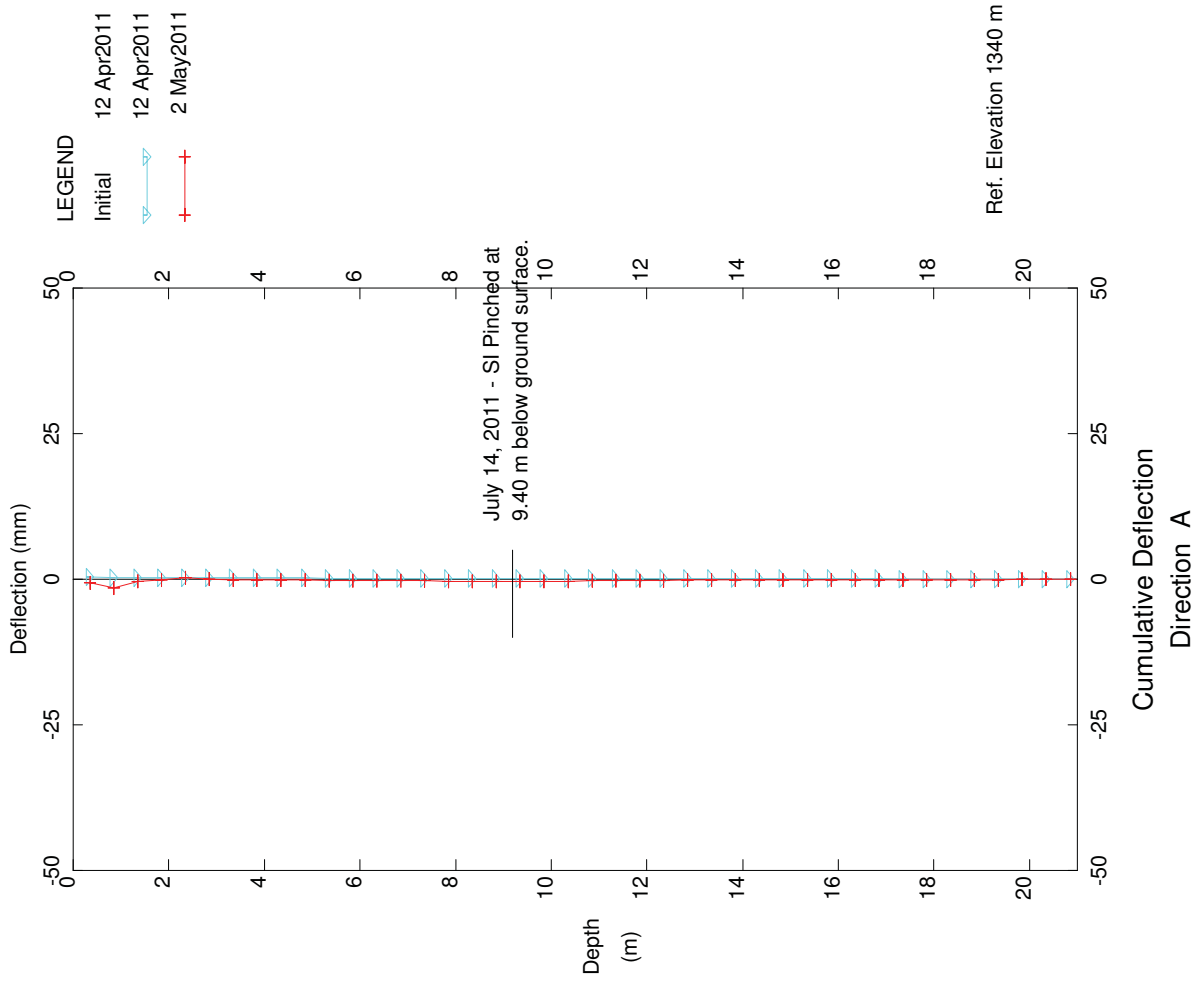
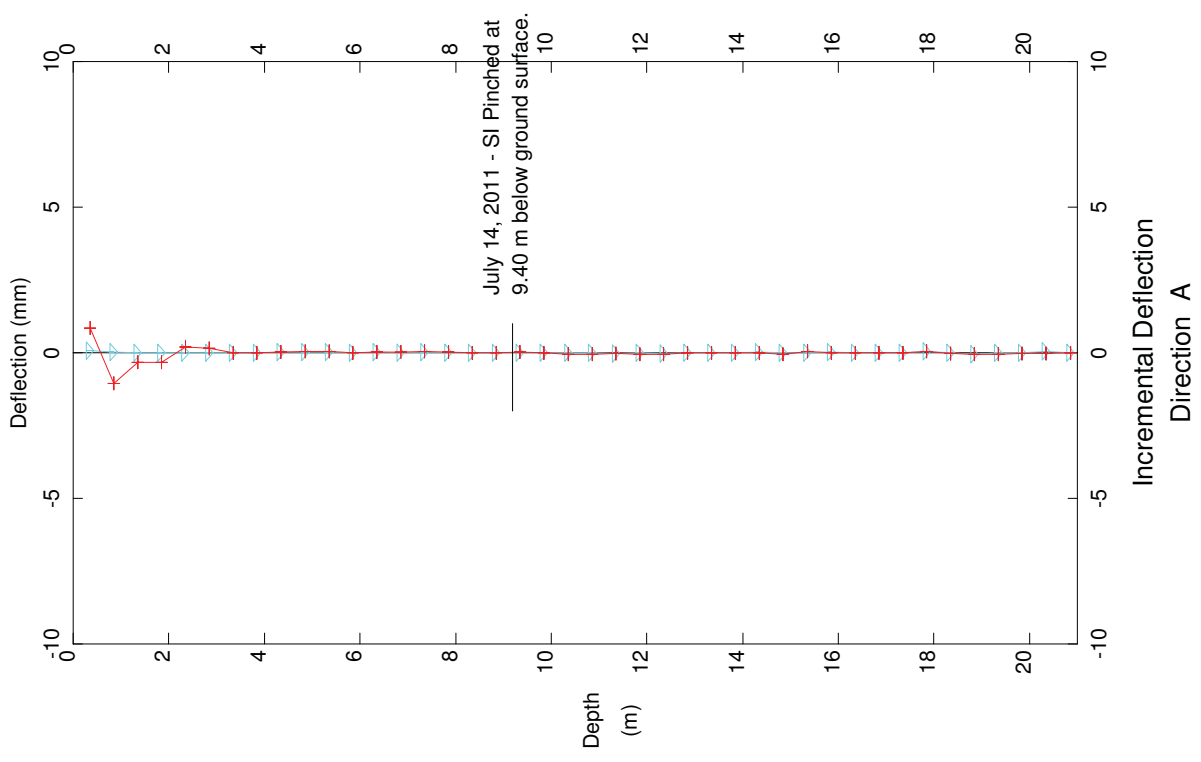
Figure S38-4

- **SI 11-02:** Since the April 12, 2011 initialization this SI has been twice (May 2<sup>nd</sup>, July 14<sup>th</sup>). Prior to the July 14<sup>th</sup> readings there were no confirmed movement zones. On July 14<sup>th</sup>, this SI was found to be pinched off at approximately 9.40 m below ground surface.

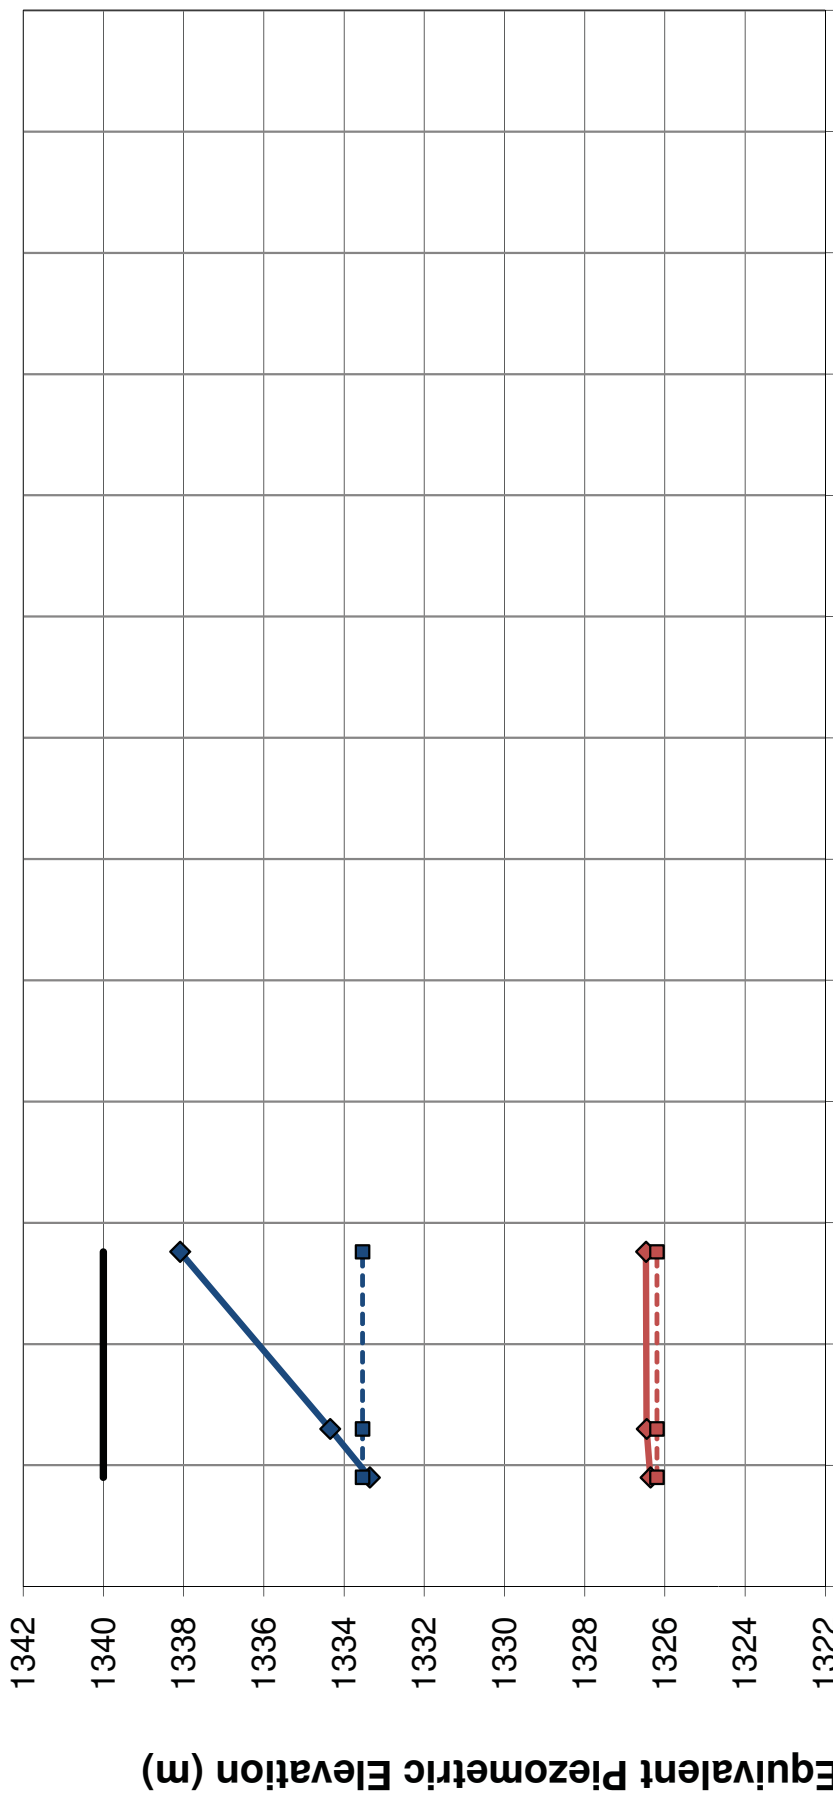
- **VW 10-6697:** This piezometer tip is installed approximately 14 m BGS (below ground surface). This instrument has recorded small pressures since it was installed, i.e. the equivalent groundwater table would be only slightly above the piezometer tip.

- **VW 10-6710:** This piezometer tip is installed approximately 6 m BGS. This instrument has recorded a pressure approximately 37 kPa higher than the previous reading in May 2011. This current pressure corresponds to an equivalent piezometric elevation 4.55 m above the tip elevation, i.e. roughly 1.5 m BGS.

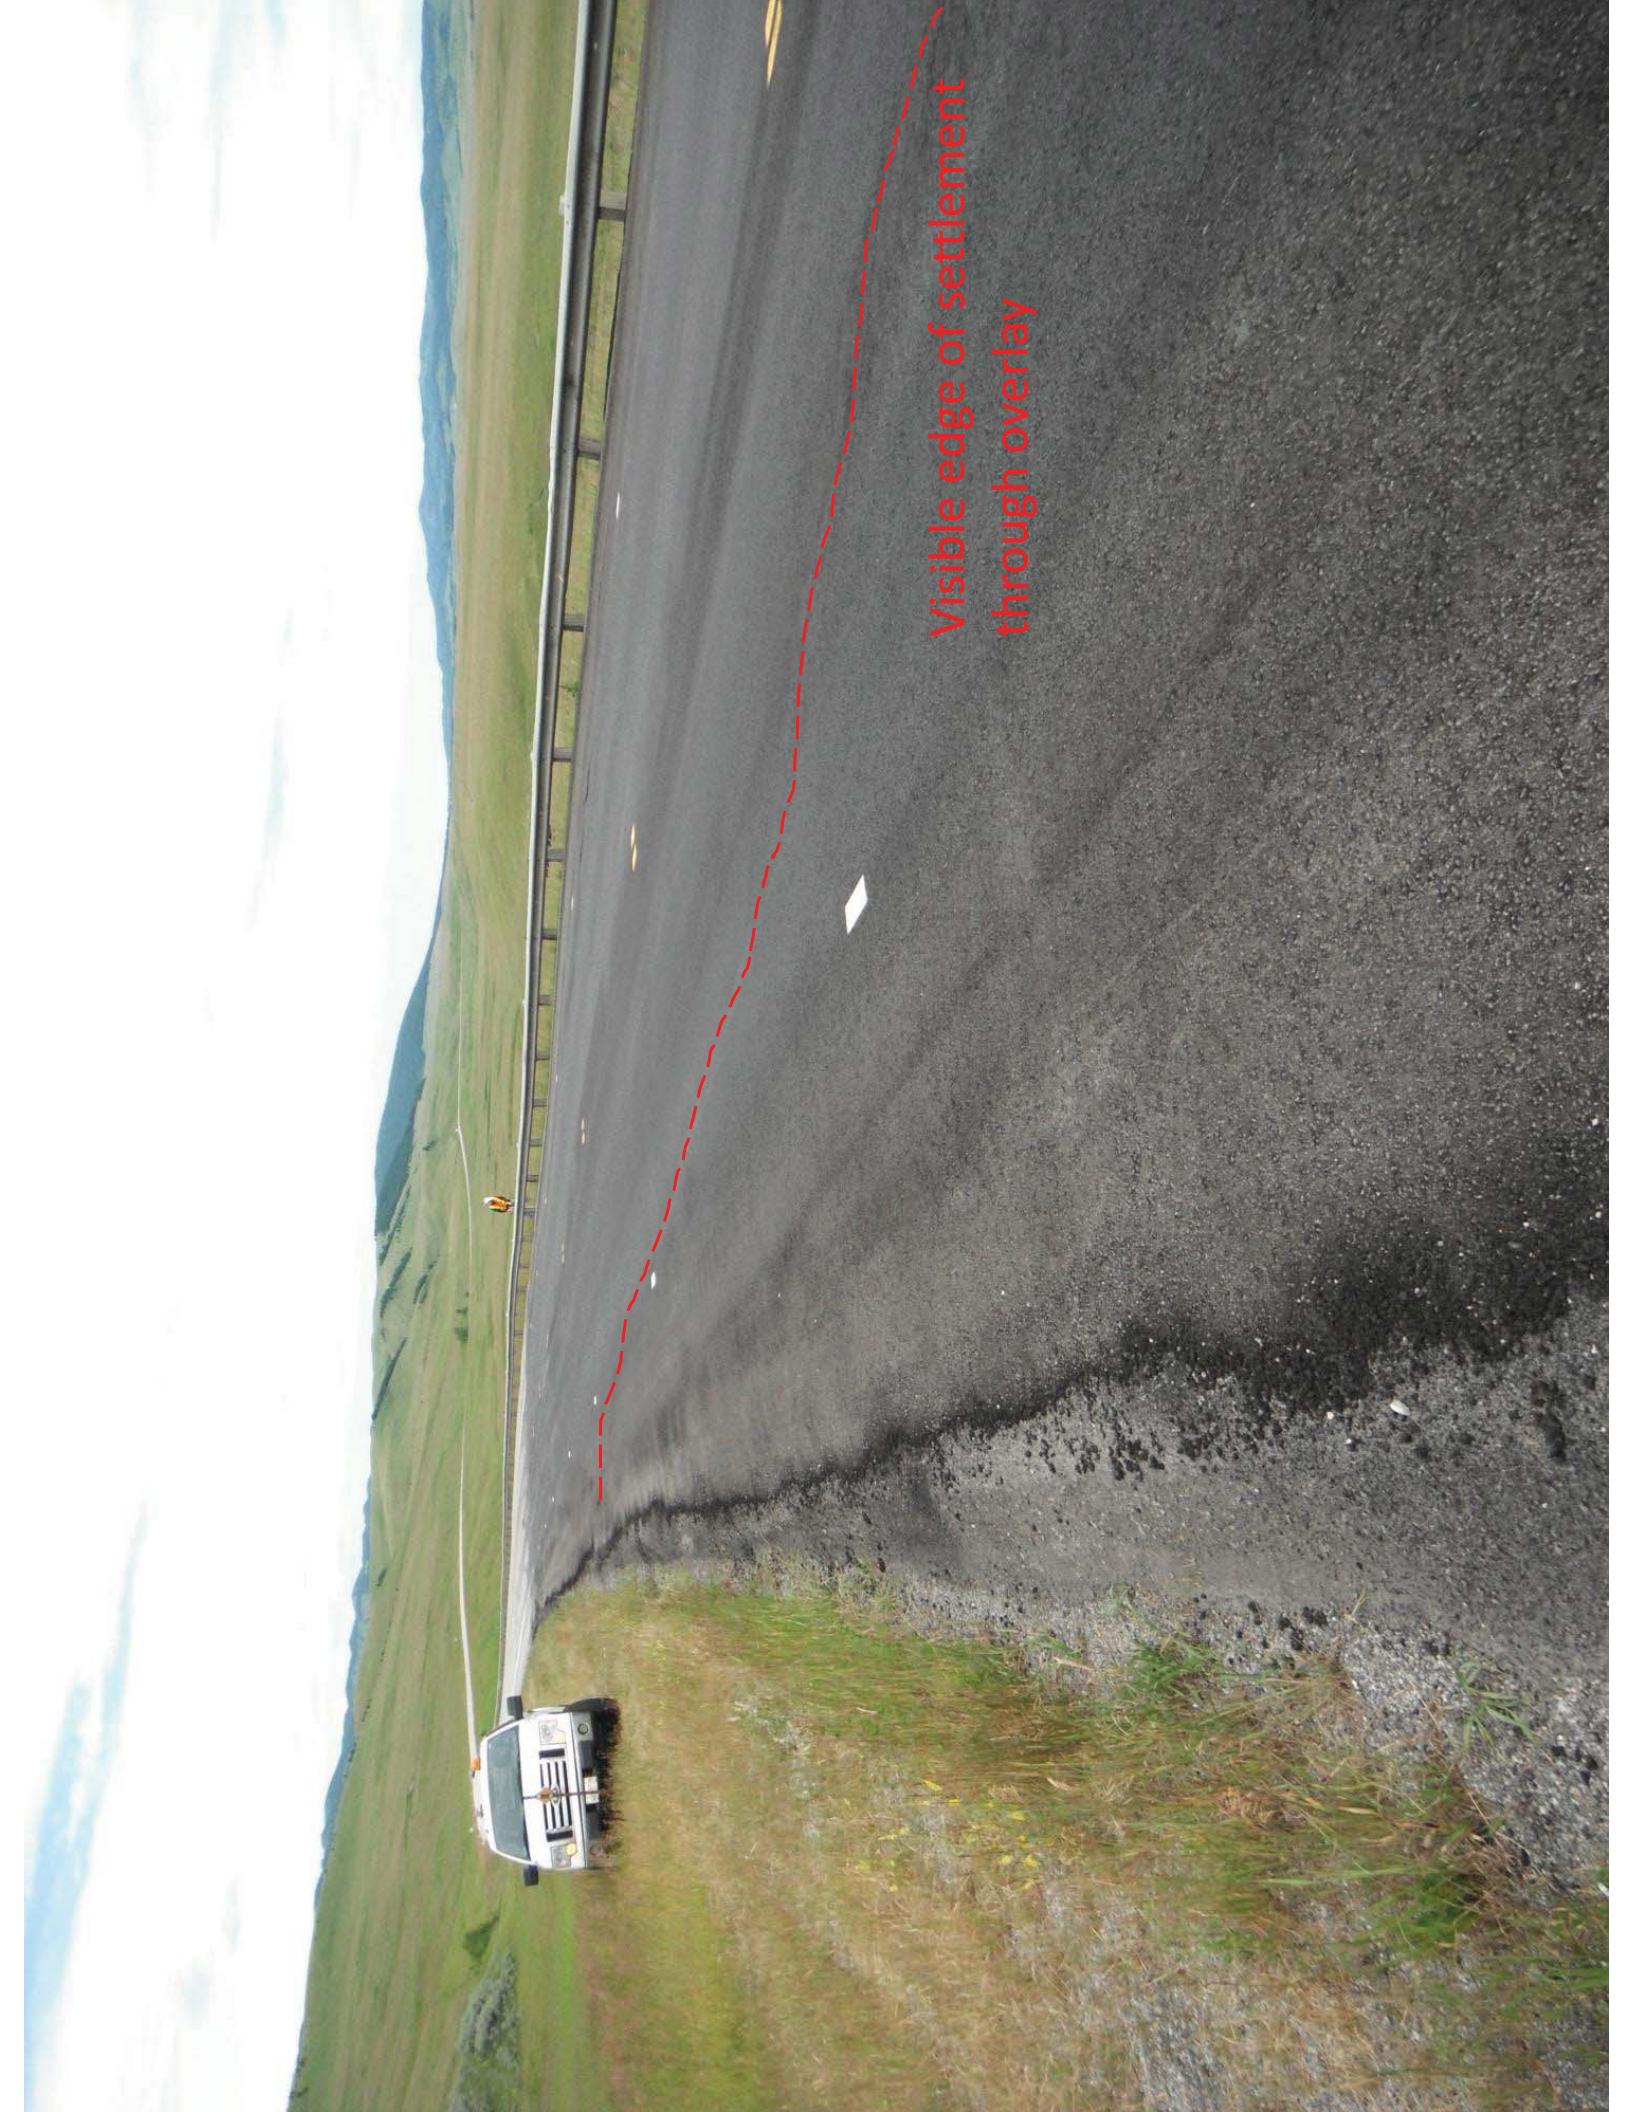
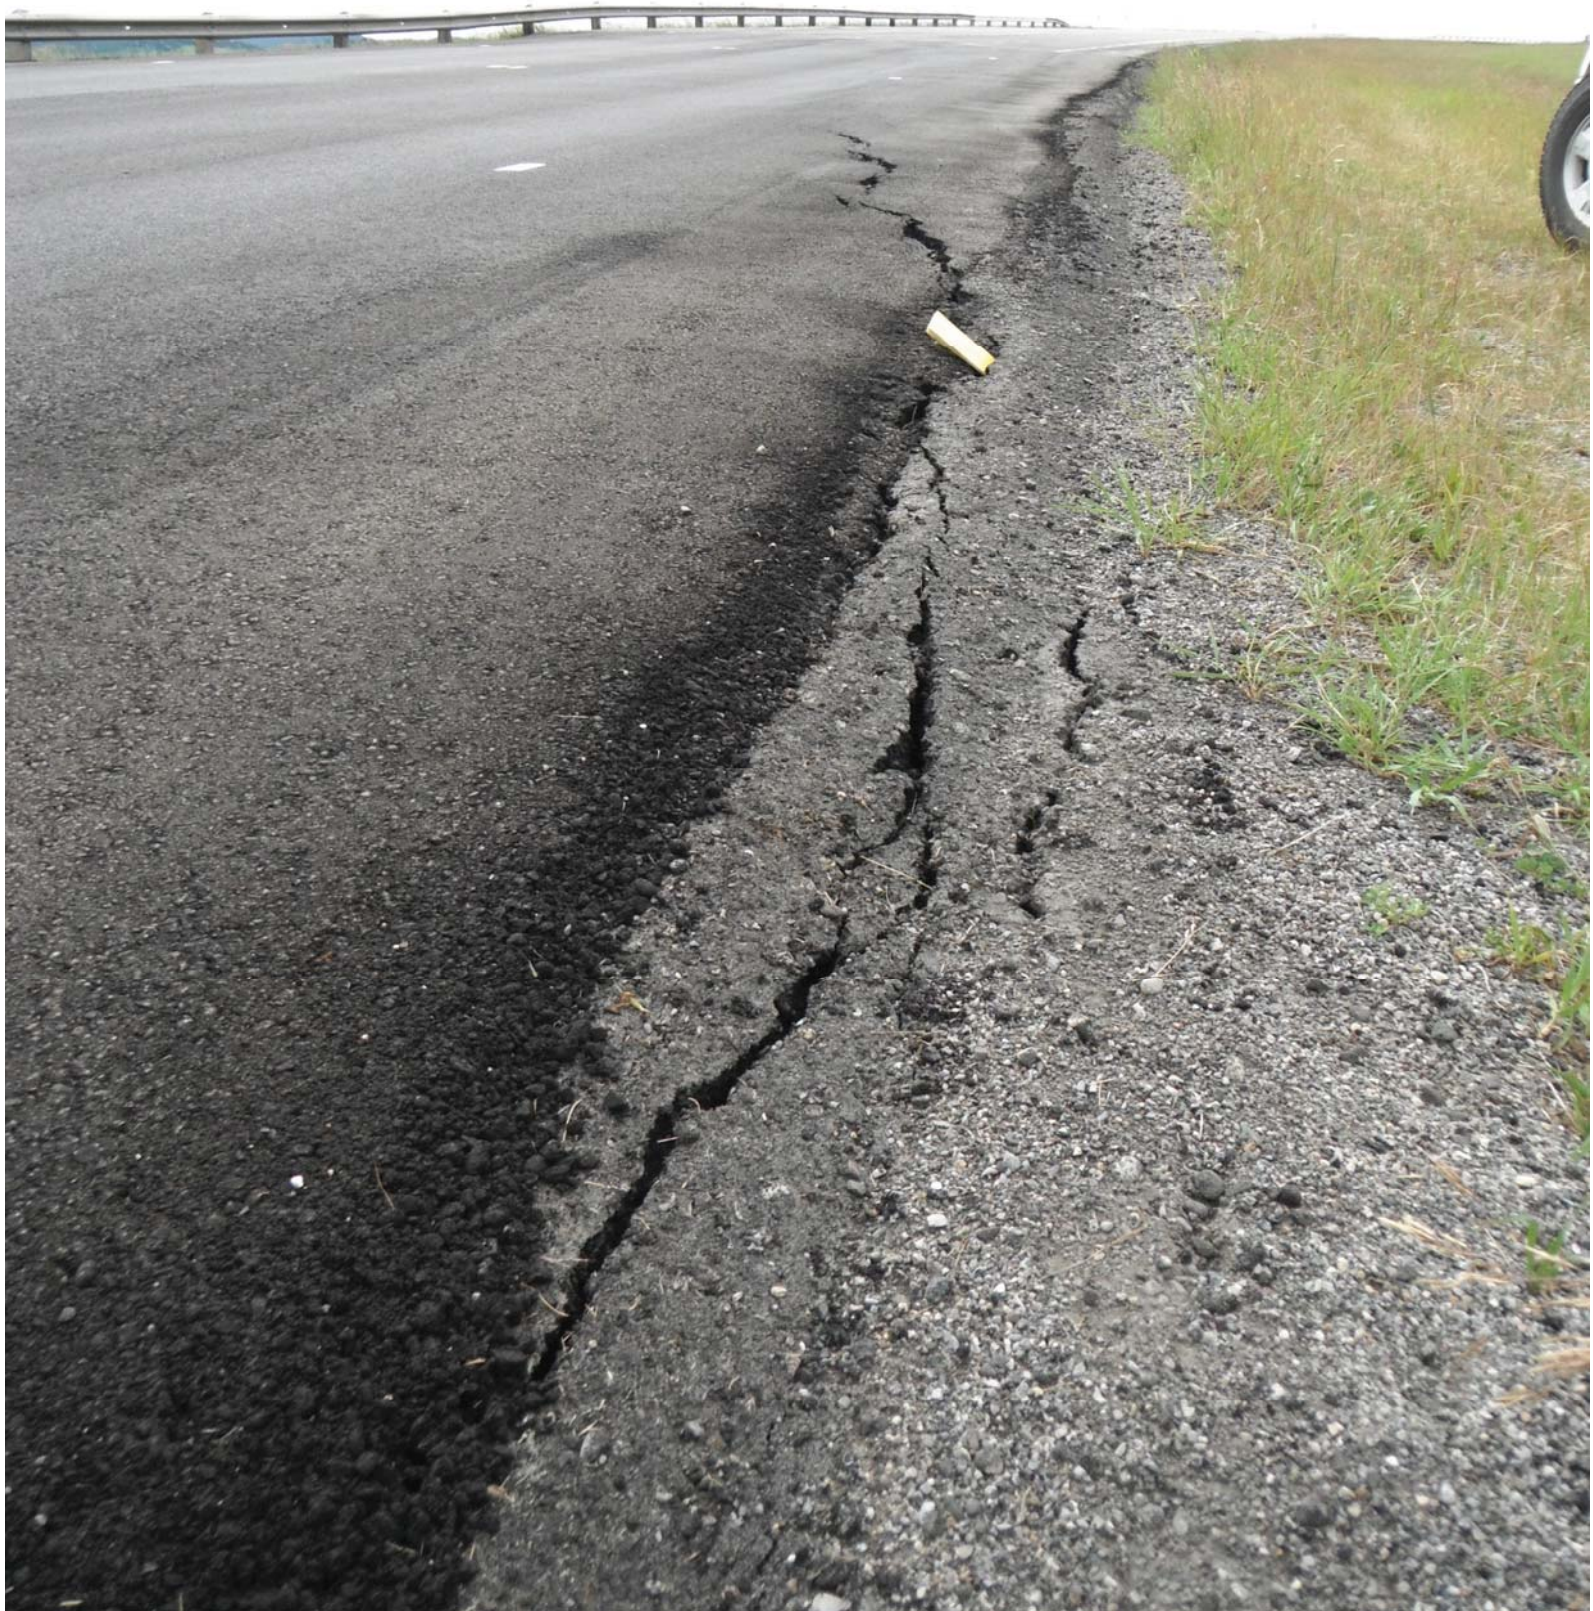
Visible edge of settlement  
through overlay
