Client	<b>Alberta Transportation</b>		<b>Figure 1</b>	
Project	<b>Southern Region Geohazard Assessment</b> <b>S38 - Hwy 22:08 - Callum Creek - Site Plan and Instrumentation Detail</b>		Date:	Revision
			<b>Sep-11</b>	
			Job No.	<b>CG25352.200</b>
			Figure 1.xls

**From:** Clay, Tyler  
**Sent:** Monday, July 18, 2011 5:31 PM  
**To:** Ross Dickson  
**Cc:** Bidwell, Andrew; Bale, Bryan  
**Subject:** S38 - Callum Creek, Hwy 22 Site Conditions (July 2011)  
**Attachments:** July2011\_CallumCk\_Figures.pdf

This email is intended to serve as a summary of the recent instrument data and observations from the July 14, 2011 visit to the S38 - Callum Creek site on Highway 22.

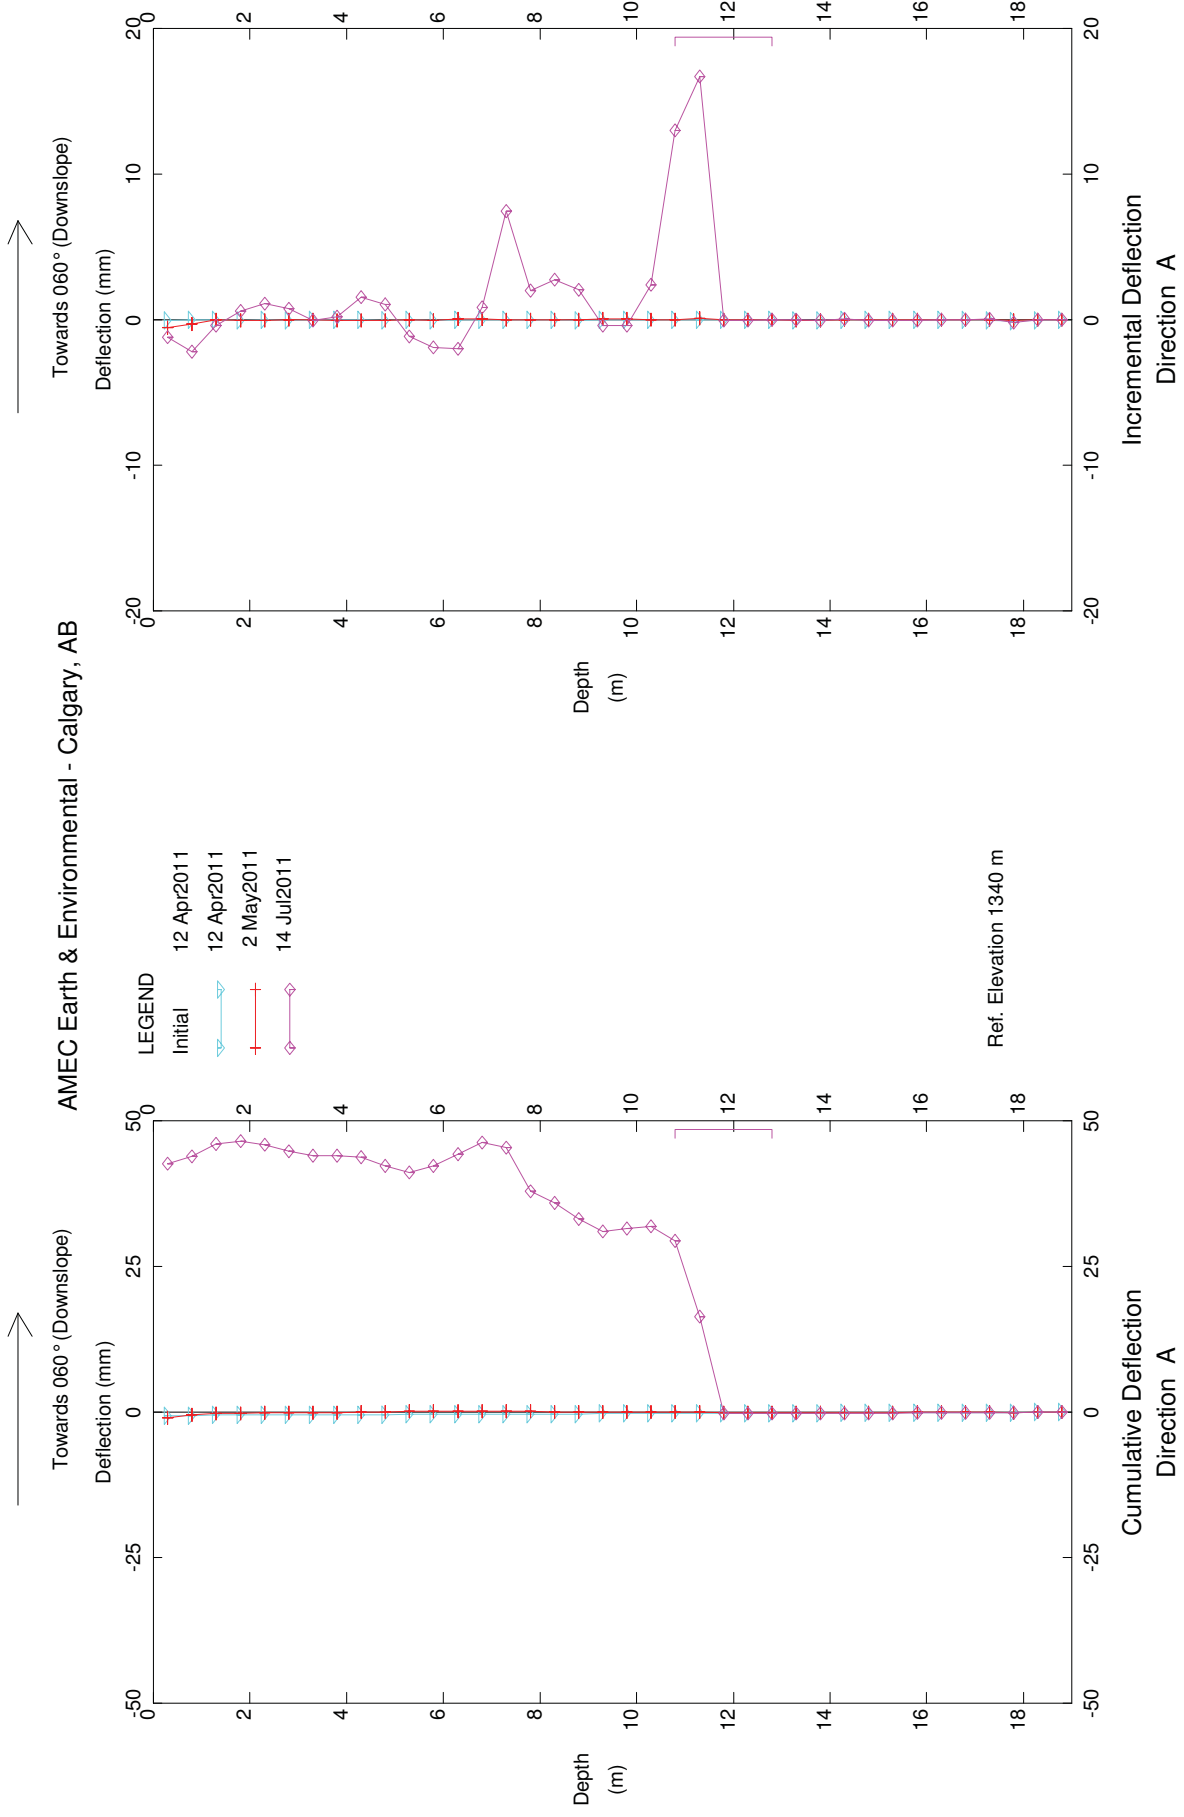
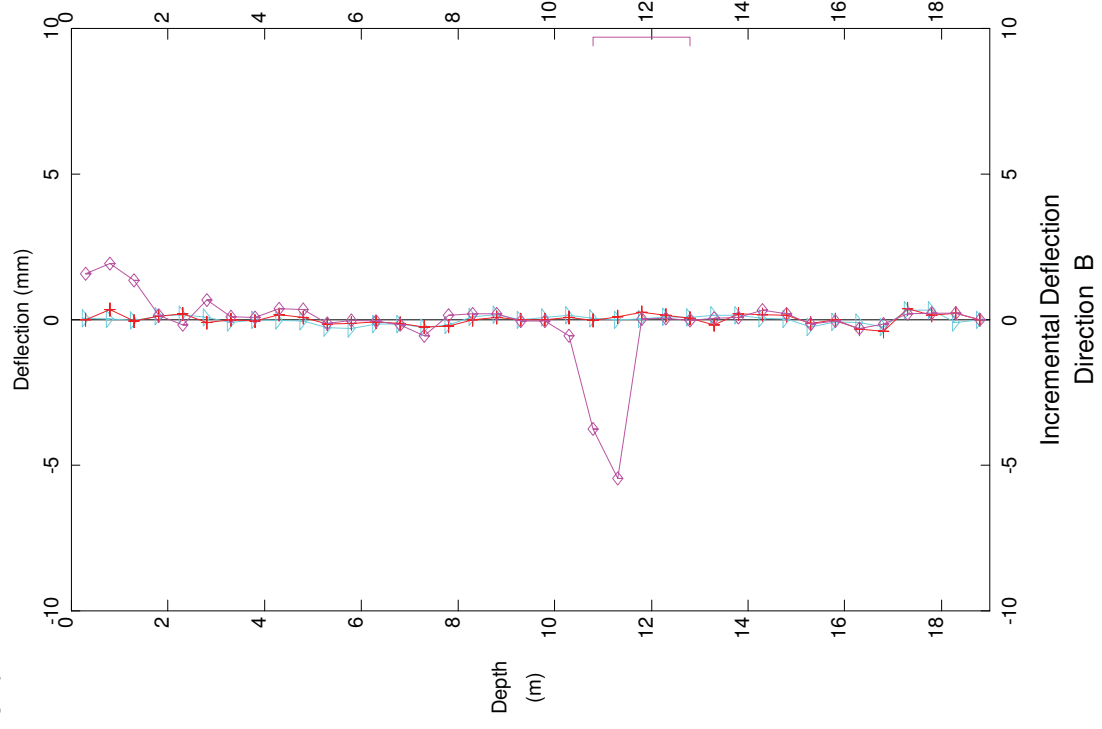
Figure S38-2

- **SI 11-01:** Since the April 12, 2011 initialization this SI has been read twice (May 2<sup>nd</sup>, July 14<sup>th</sup>). Prior to the July 14<sup>th</sup> readings there were no confirmed movement zones. The July 14<sup>th</sup> data shows a confirmed downslope movement zone at approximately 12 m depth with 31 mm displacement at 43° bearing.

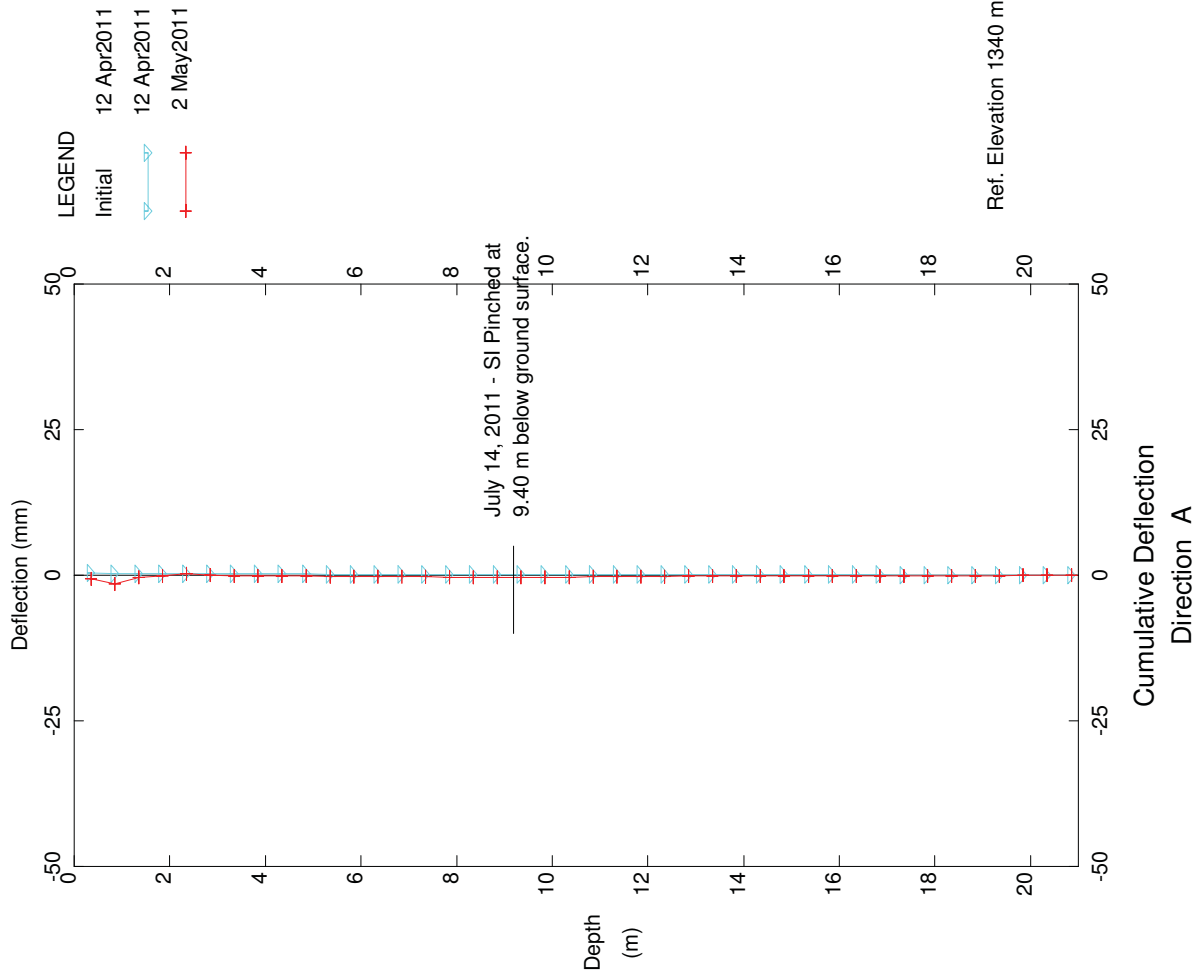
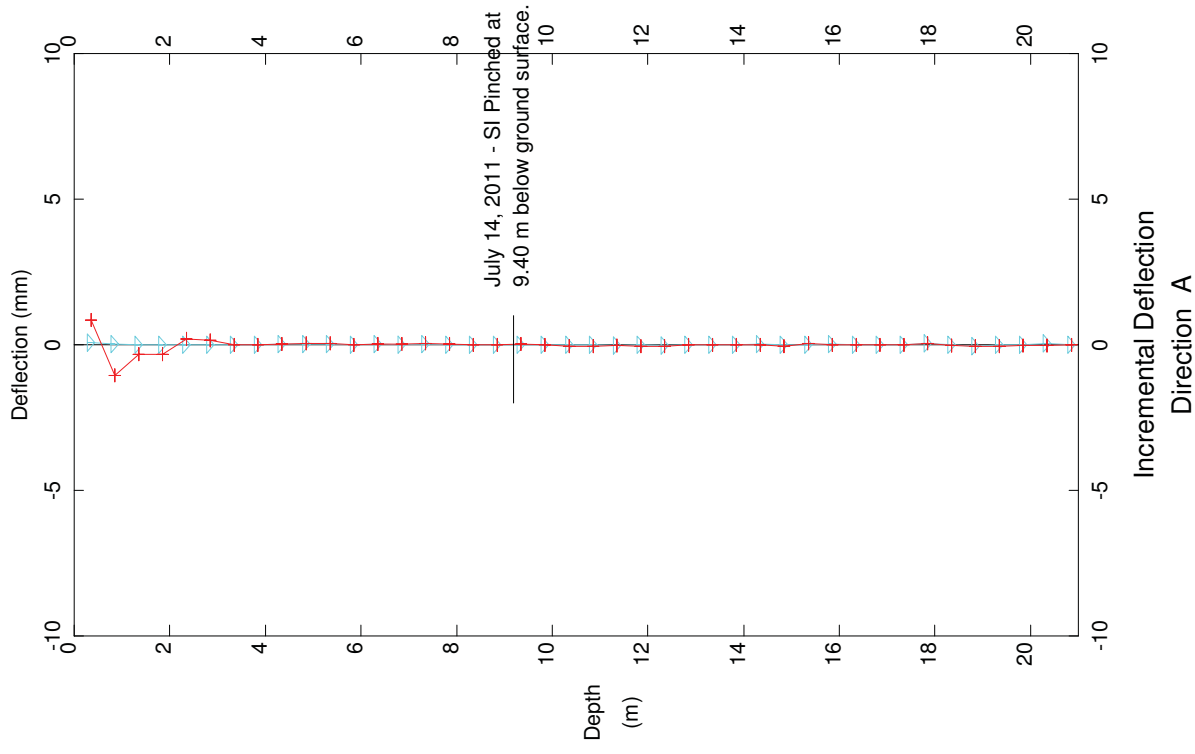
Figure S38-4

- **SI 11-02:** Since the April 12, 2011 initialization this SI has been twice (May 2<sup>nd</sup>, July 14<sup>th</sup>). Prior to the July 14<sup>th</sup> readings there were no confirmed movement zones. On July 14<sup>th</sup>, this SI was found to be pinched off at approximately 9.40 m below ground surface.

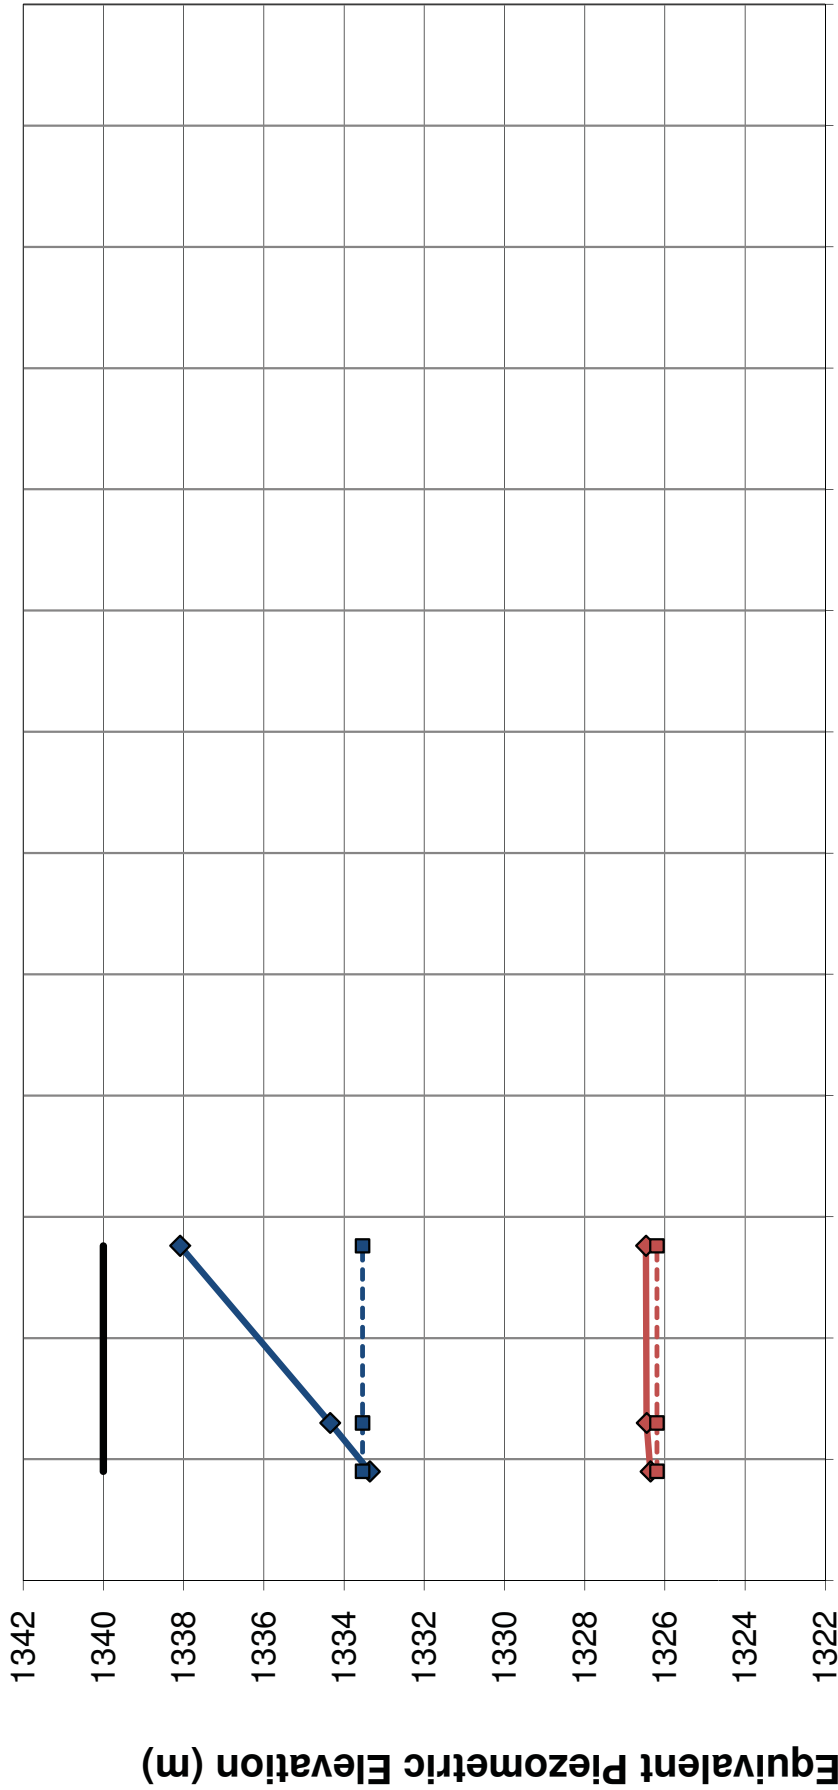
- **VW 10-6697:** This piezometer tip is installed approximately 14 m BGS (below ground surface). This instrument has recorded small pressures since it was installed, i.e. the equivalent groundwater table would be only slightly above the piezometer tip.

- **VW 10-6710:** This piezometer tip is installed approximately 6 m BGS. This instrument has recorded a pressure approximately 37 kPa higher than the previous reading in May 2011. This current pressure corresponds to an equivalent piezometric elevation 4.55 m above the tip elevation, i.e. roughly 1.5 m BGS.
