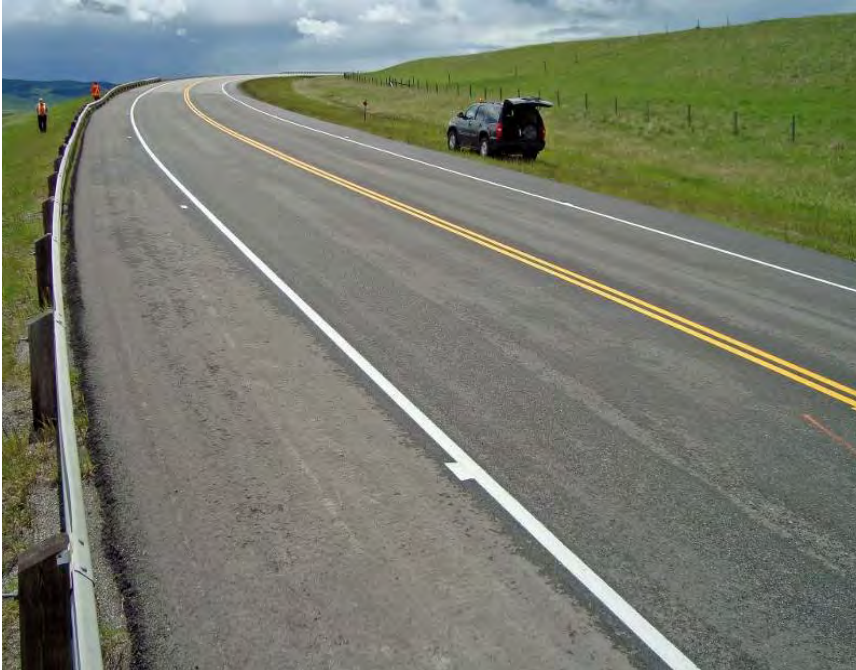
**Photo S38-1 (June 2012)**

Facing south from the east side of the highway. The site had undergone recent patch / overlay work. Very minor cracking was coming through the new pavement in previously noted areas.

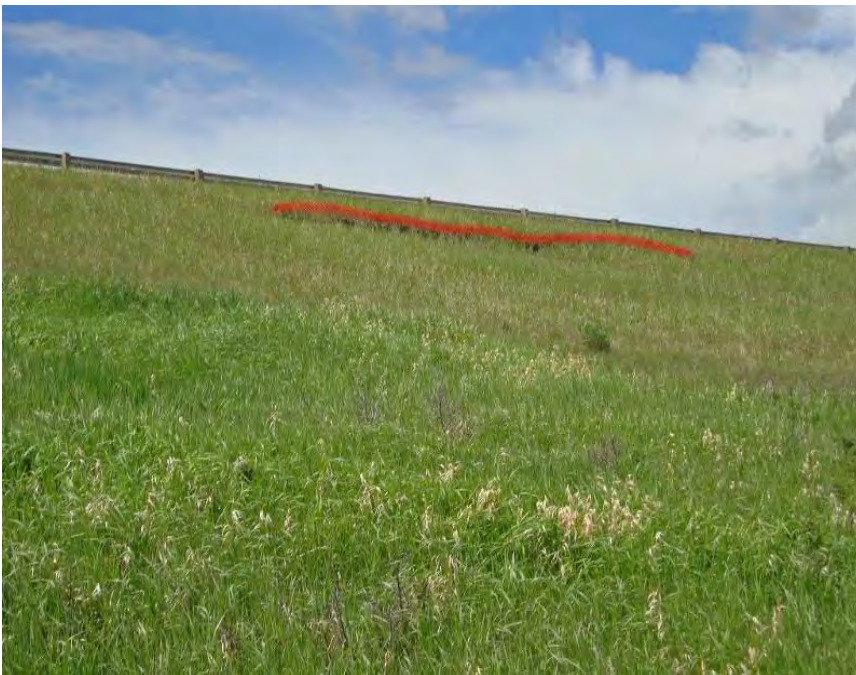
**Photo S38-2 (June 2012)**

Facing west upslope from the fenceline on the east side of the highway. Shallow sliding was noted in this area of the slope near the north end of the site and a fresh scarp is marked in red on the photo. The scarp had 200 mm aperture and 100 mm of down-drop.

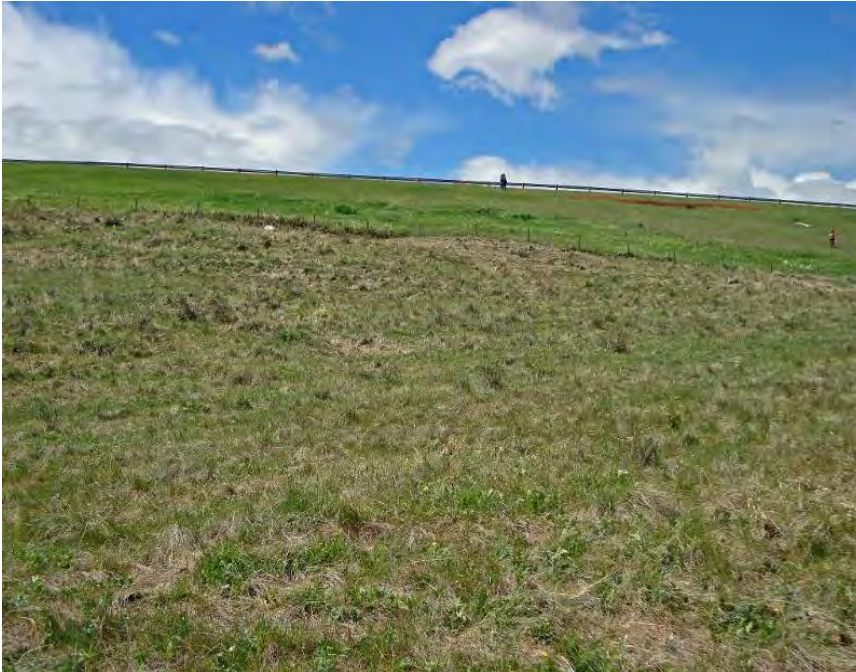
**Photo S38-3 (June 2012)**

Facing west upslope from below the fenceline on the east side of the highway.

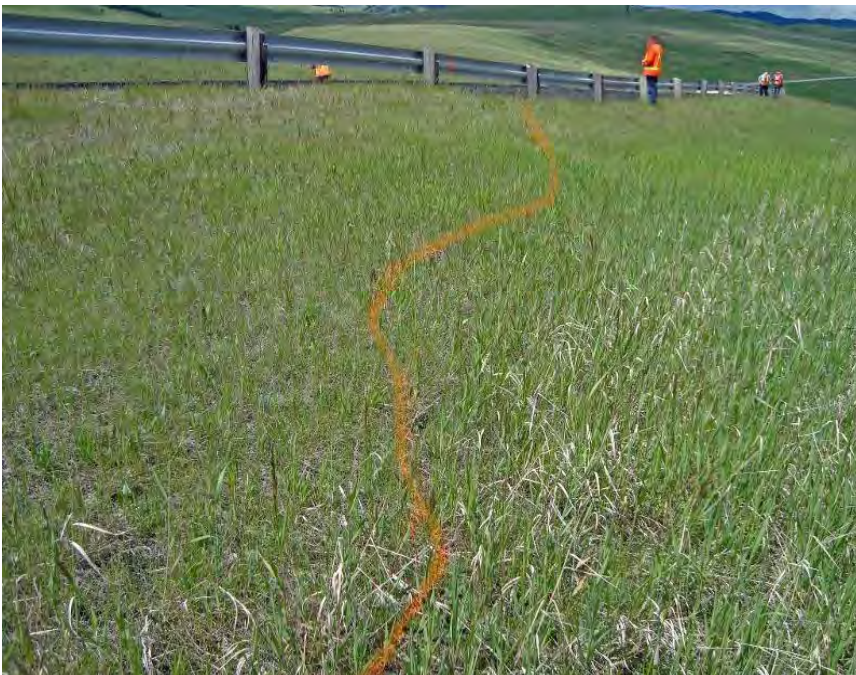
**Photo S38-4 (June 2012)**

View of a subtle scarp (marked in orange), which was observed near the downslope (east) highway shoulder at the south end of the site.
