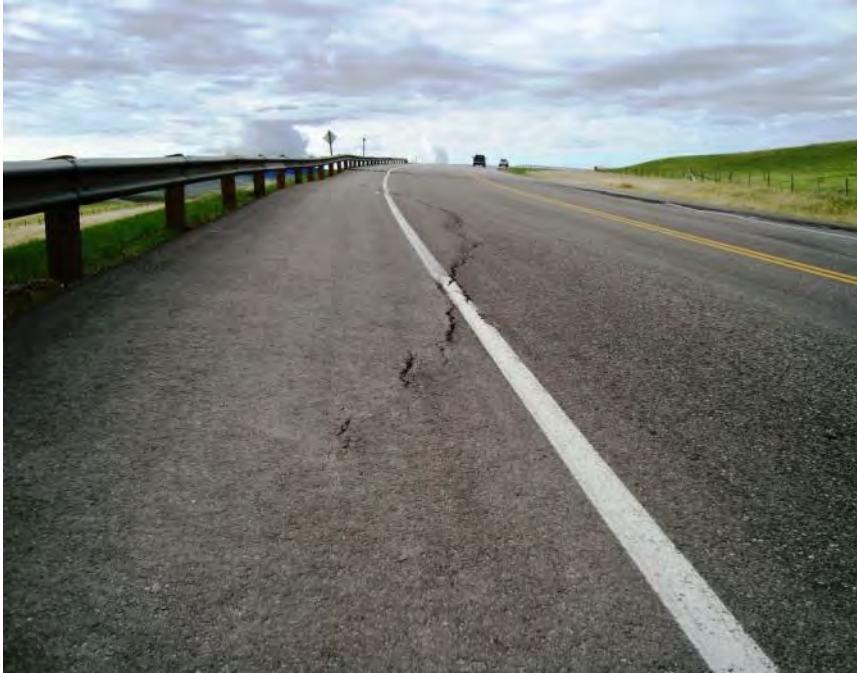
Photo S38-1 (May 2013)
Facing south from the east side of the highway. Minor cracking and settlement was visible through the previous overlay.

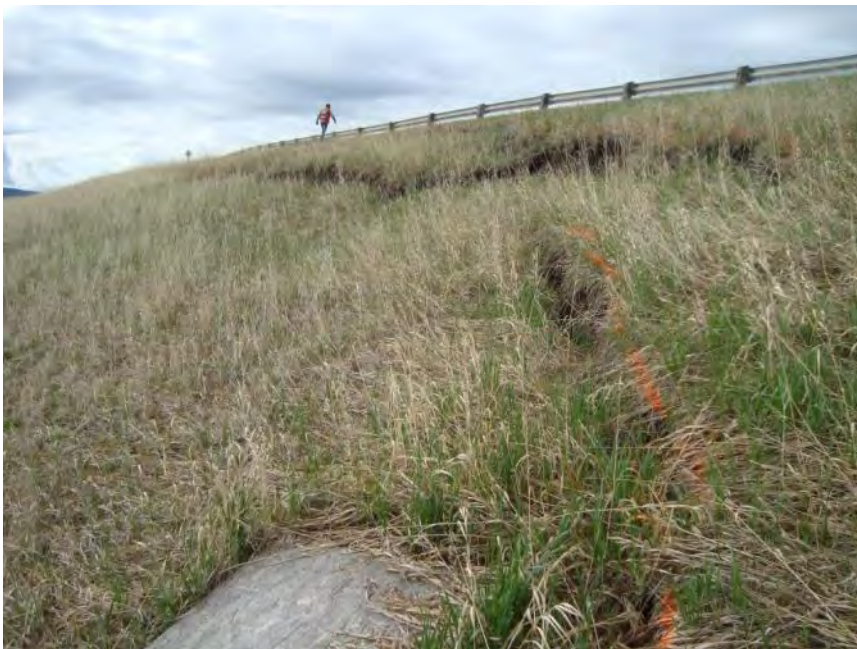
Photo S38-2 (May 2013)
Sliding near the north end of the site. The main scarp is marked in orange on the photo.
