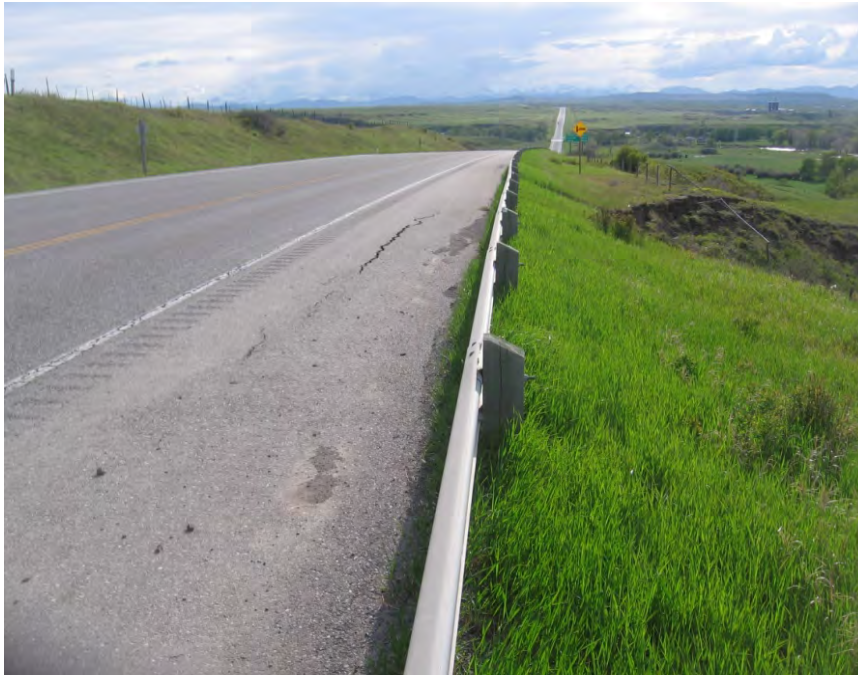
**Photo S39-1 - (June 1, 2011)**

Facing westbound towards the cracks on the road surface. The landsliding in the valley slope is visible on the right hand side of the photo, just downslope of the highway.

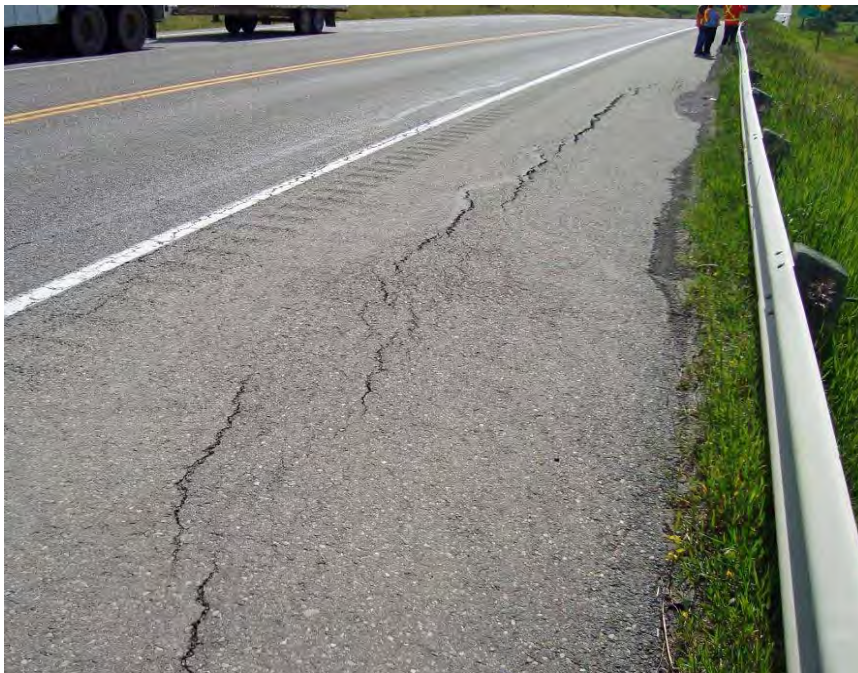
**Photo S39-2 - (June 20, 2012)**

Facing westbound towards the cracks on the road surface. The extent of the cracking has slightly increased towards the east since 2011.

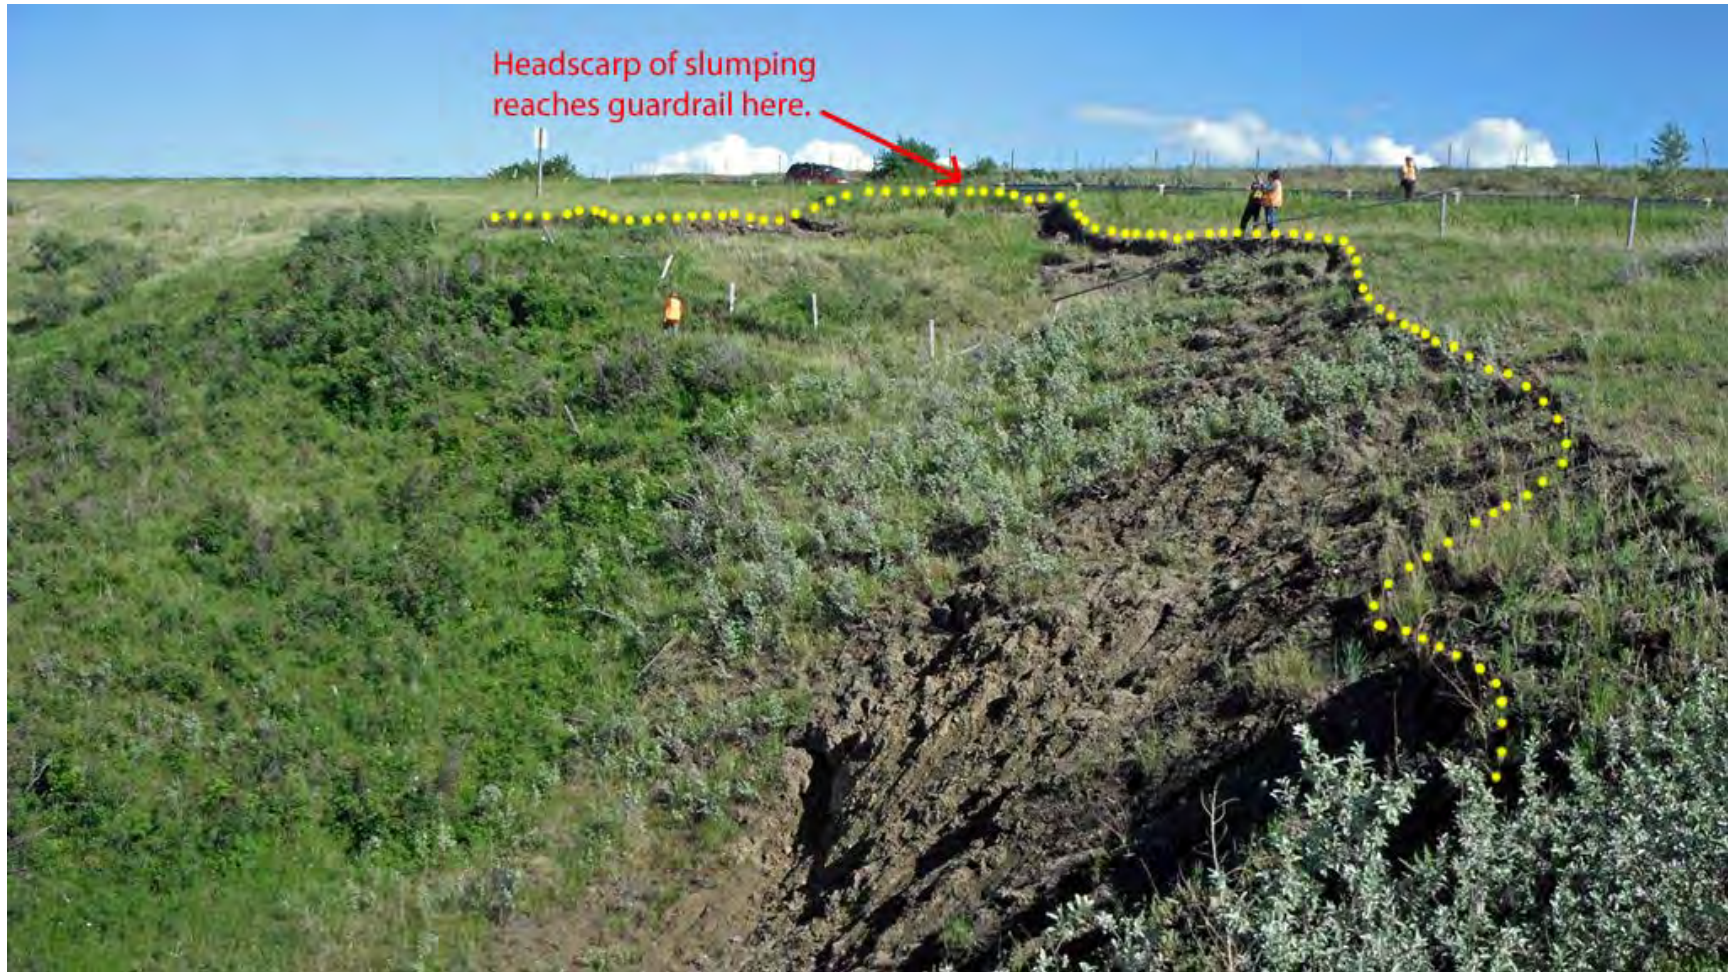
**Photo S39-3 (June 20, 2012)**

Facing upslope towards the upper portion of the landslide mass on the valley slope below the highway. The approximate location of the overall landslide headscarp is marked, as well as the point where the headscarp and gully erosion has reached the guardrail as of June 2012.

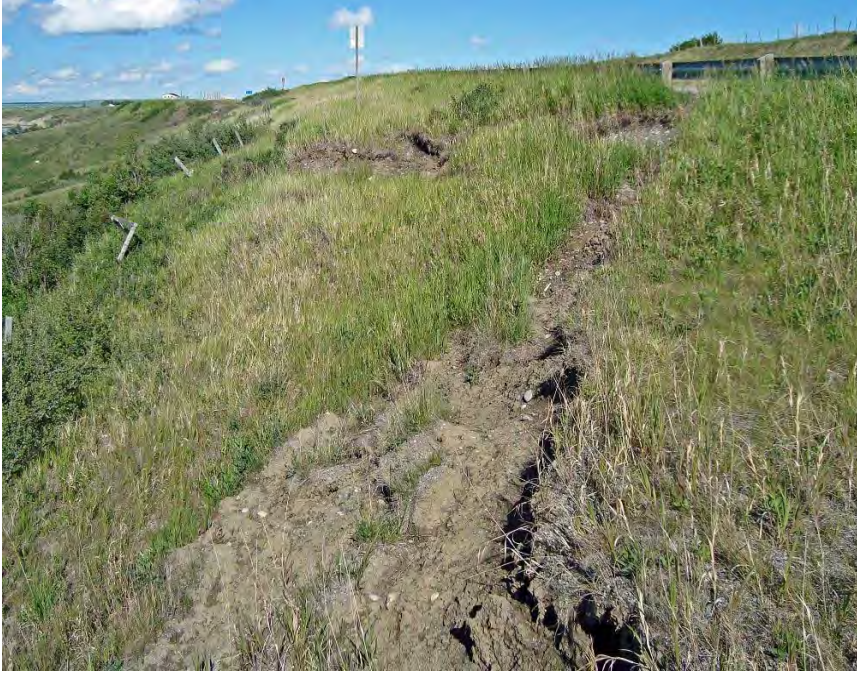
**Photo S39-4 (June 20, 2012)**

Facing southeast from the west flank of the landslide at the main headscarp area. This area appeared mostly unchanged since the 2011 inspection.
