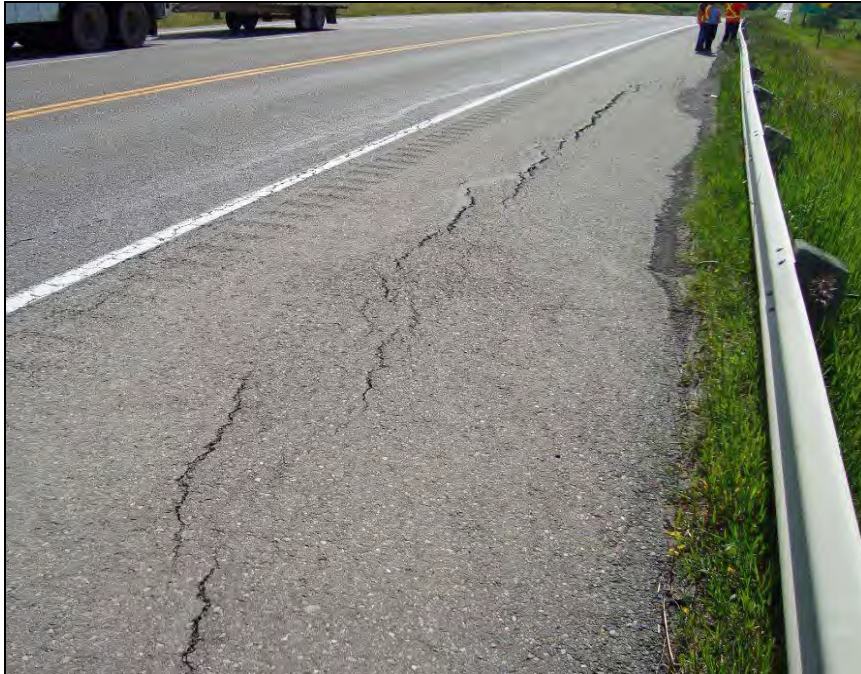
**Photo S39-1 - (June 1, 2011)**

Facing westbound towards the cracks on the road surface.

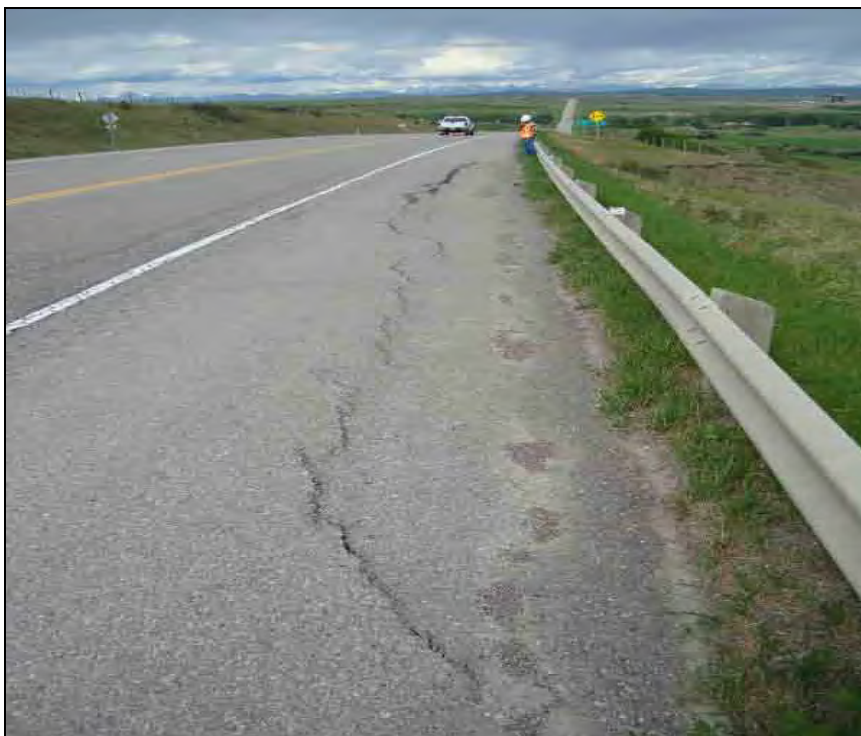
**Photo S39-2 - (May 28, 2013)**

Facing westbound towards the cracks on the road surface. The extent of the cracking had remained similar to 2012. The repaired cracks at the western end of the site have also re-opened.

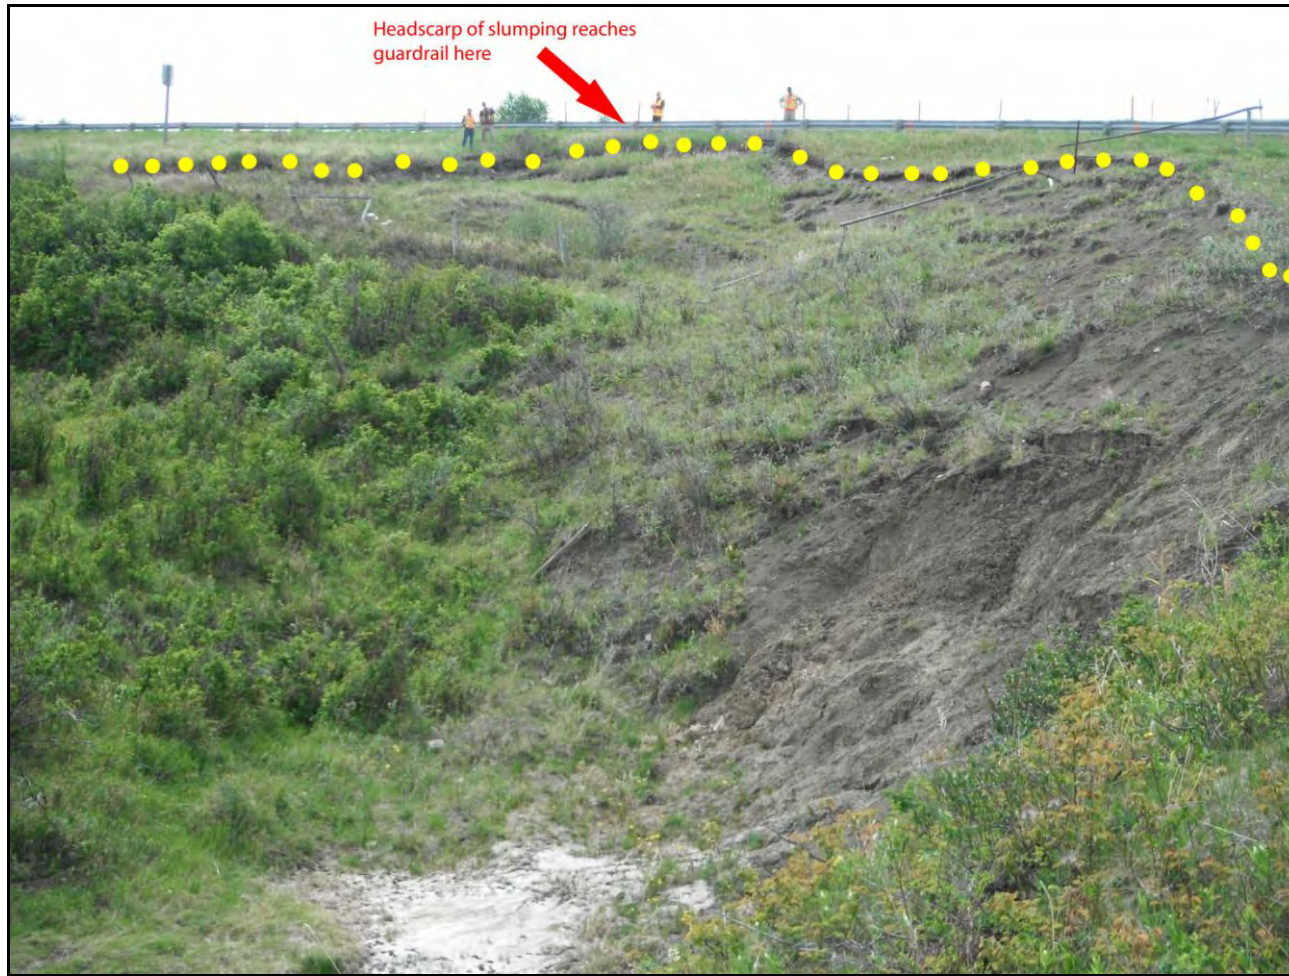
**Photo S39-3 (May 28, 2013)**

Facing upslope towards the upper portion of the landslide mass on the valley slope below the highway. The approximate location of the overall landslide headscarp is marked, as well as the point where the headscarp and gully erosion has reached the guardrail as of May 2013.

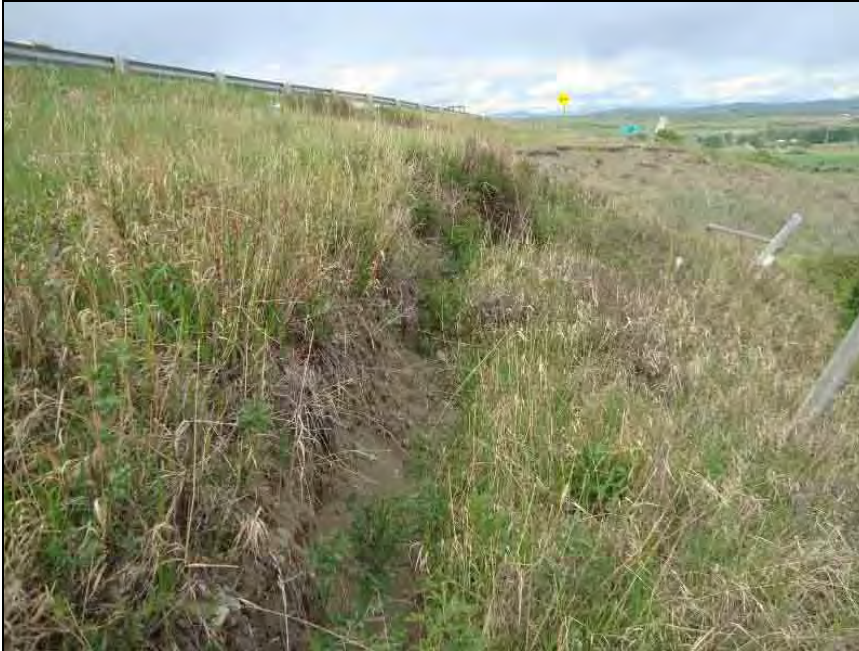
**Photo S39-4 (May 28, 2013)**

Facing west from the east flank of the landslide at the main headscarp area. This area appeared mostly unchanged since the 2012 inspection.
