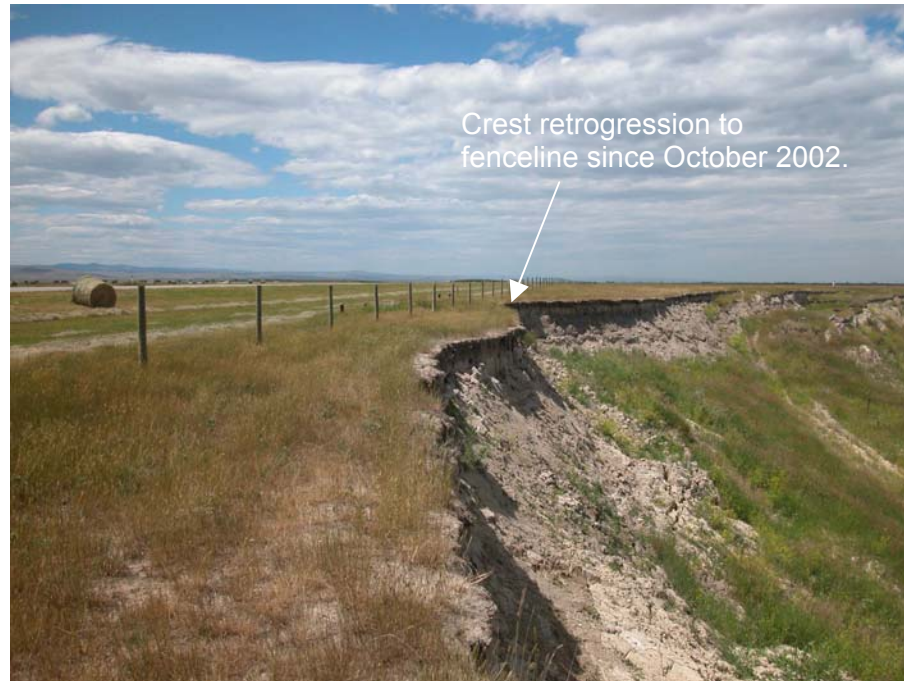
Photo 1 (upper left) – July 2003
Facing north across the slide scarp, central portion, as seen during the July 2003 inspection. The point marked with the arrow is the portion of the crest that is closest to the fenceline. This portion of the scarp has retrogressed approximately 1 m since the Fall 2002 instrument readings and is now in contact with the fenceline. Please refer to Photo 5 for a closer view of this area.

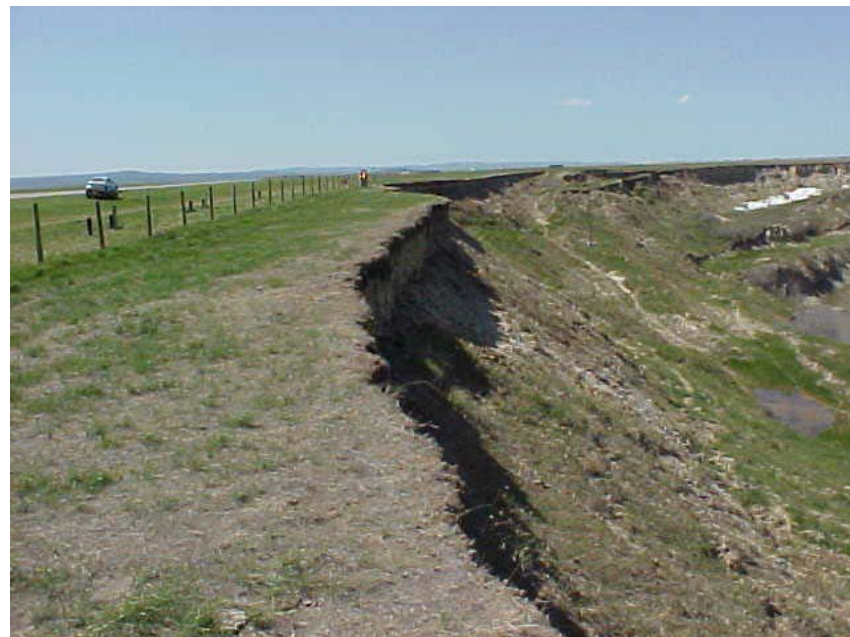
Photo 2 (lower left) – May 2002
Facing north across the slide scarp, central portion, as seen during the May 2002 inspection.

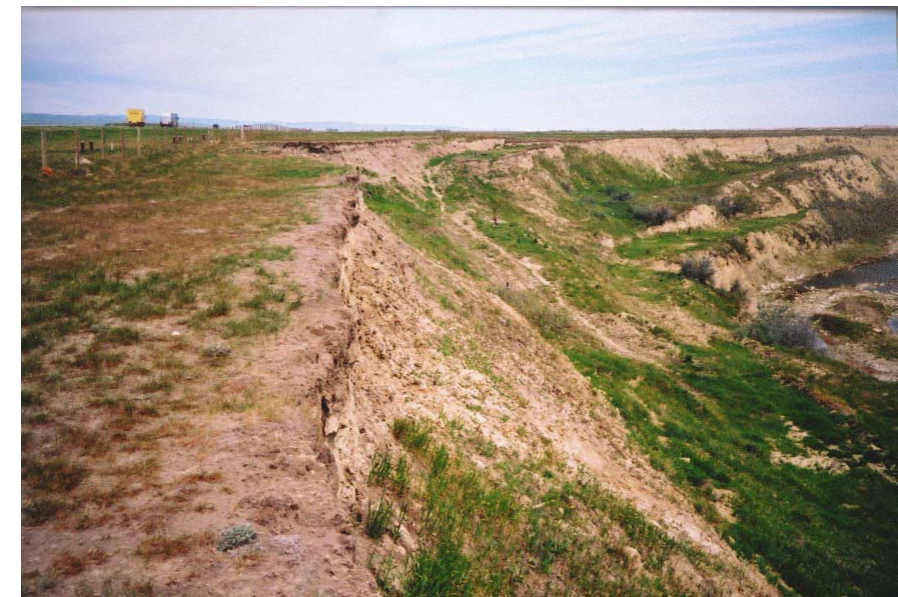
Photo 3 (lower right) – May 2001
Facing north across the slide scarp, central portion, as seen during the May 2001 inspection.

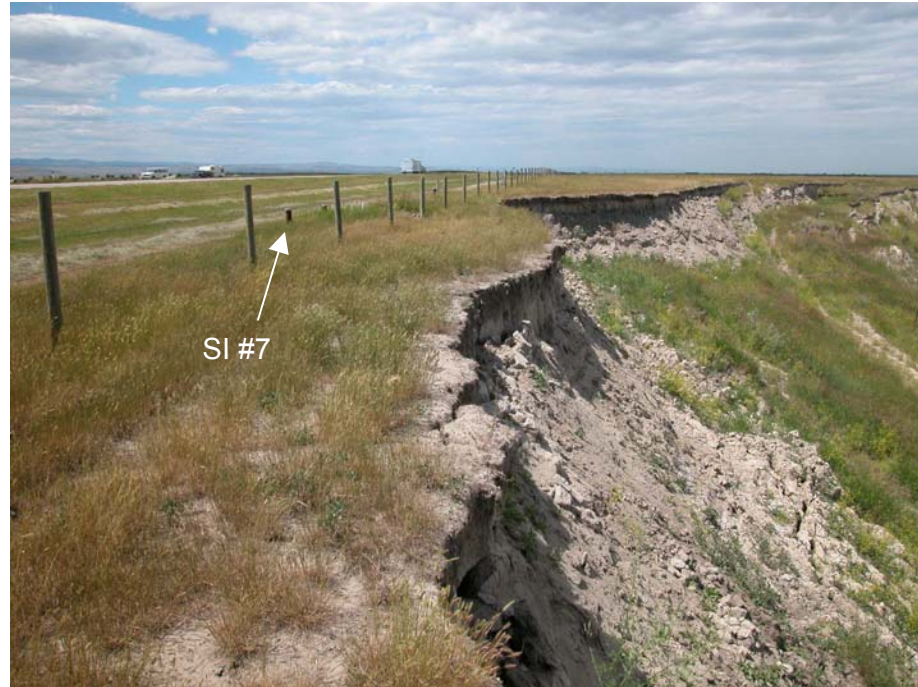
Photo 4 (upper left) – July 2003
Closer view, facing north across the recent retrogression area near SI #7 and SI #8.

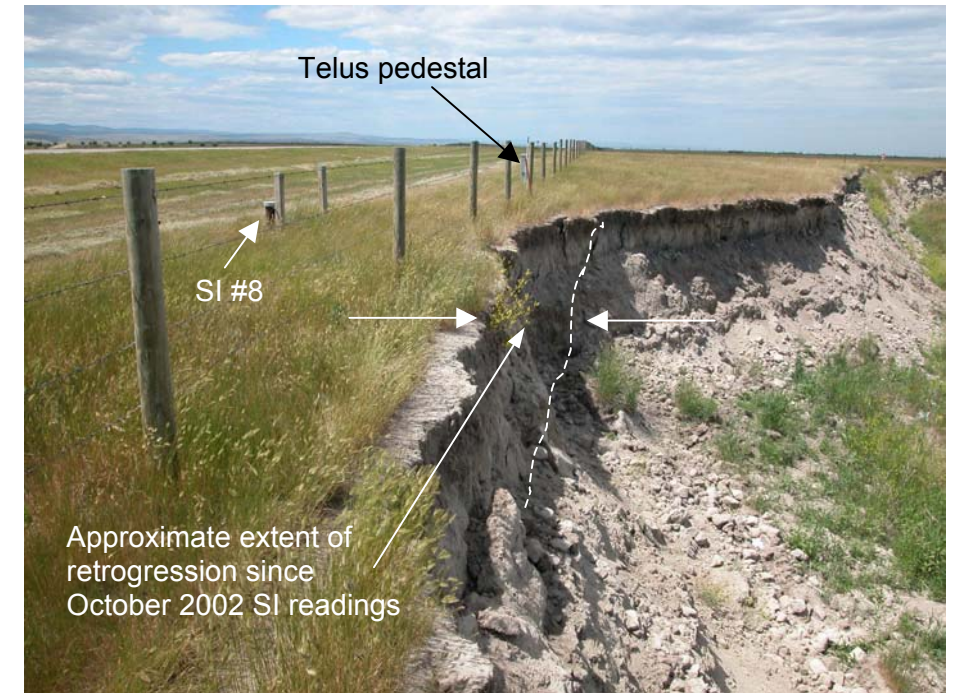
Photo 5 (upper right) – July 2003
Close-up view of retrogression area at fenceline adjacent to SI #8. The scarp in this area has retrogressed approximately 1 m since the October 2002 instrument readings. Due to the nature of landslide movement at this site – crest retrogression caused by the toppling of near-vertical blocks of soil from the scarp of the landslide – the SI's are not able to provide advance warning of landslide movement.

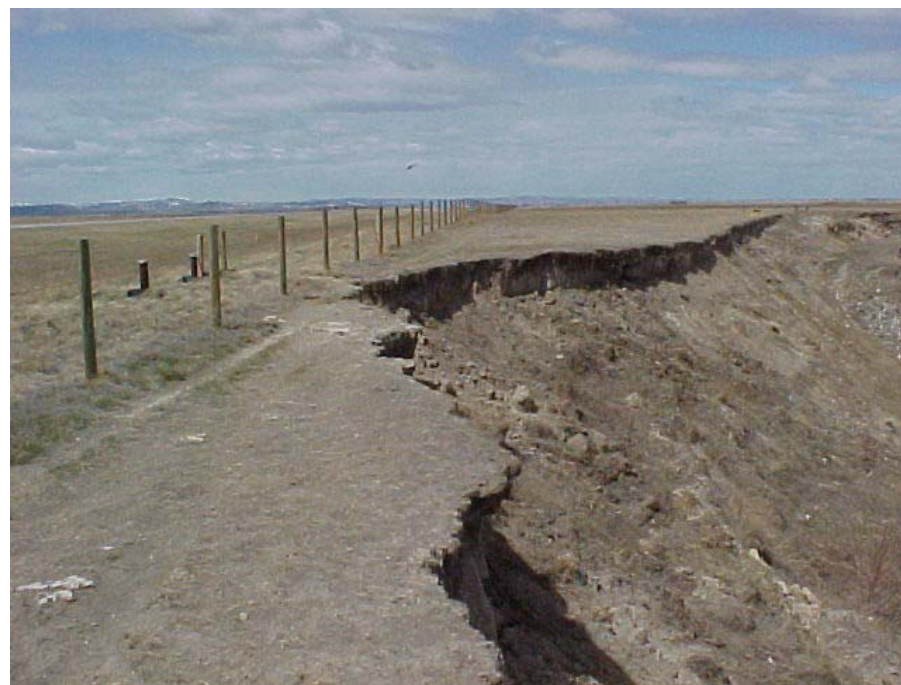
Photo 6 (lower left) – May 2002
Same area as Photo 4, as seen during the May 2002 inspection.

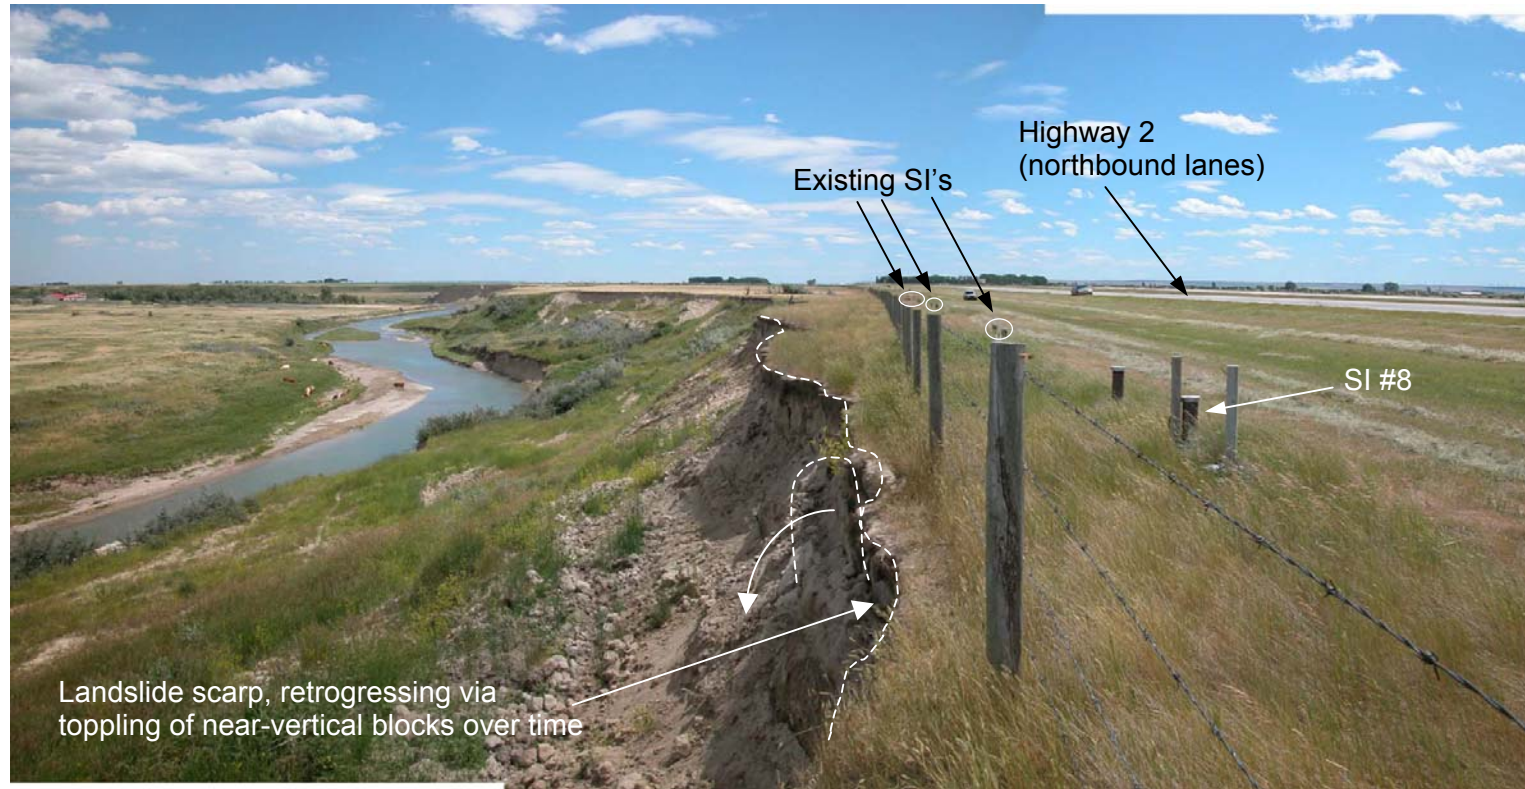
Photo 7 (top) – July 2003

Facing south across retrogression area shown in Photos 4 and 5. This view shows the area that has retrogressed approximately 1 m since the October 2002 instrument readings and is now in contact with the fenceline adjacent to SI #8.

This view also gives an indication of the relative positions of Willow Creek, the landslide complex, the landslide scarp/fenceline and the northbound lanes of Highway 2. As noted in the previous assessment reports, the SI's will not give advance warning of the toppling of near-vertical blocks from the landslide scarp as the landslide continues to retrogress to the west in the future

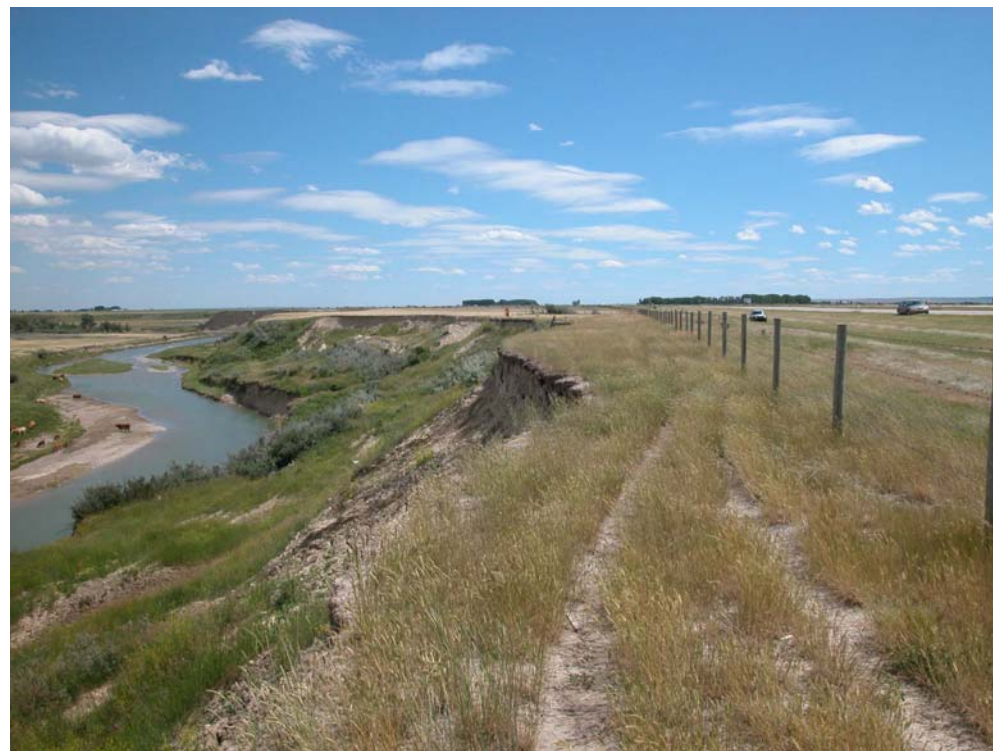
Photo 8 (lower left) – July 2003

General view of landslide scarp, facing south, as seen in July 2003.

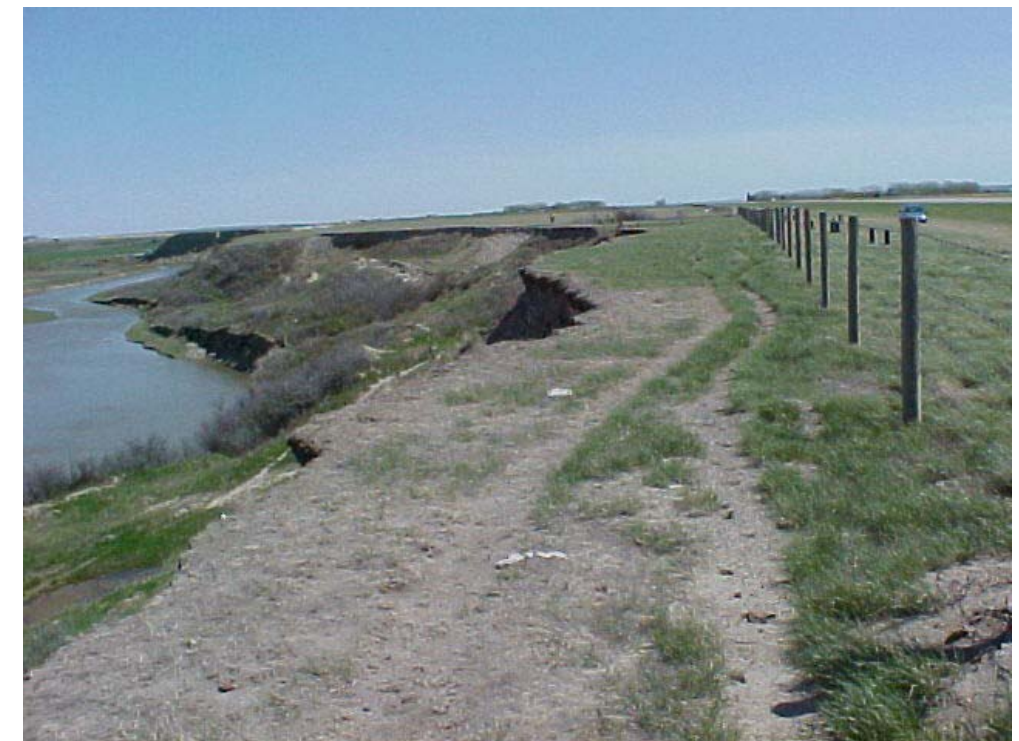
Photo 9 (lower right) – May 2002

Same area as shown in Photo 8, from May 2002 inspection.

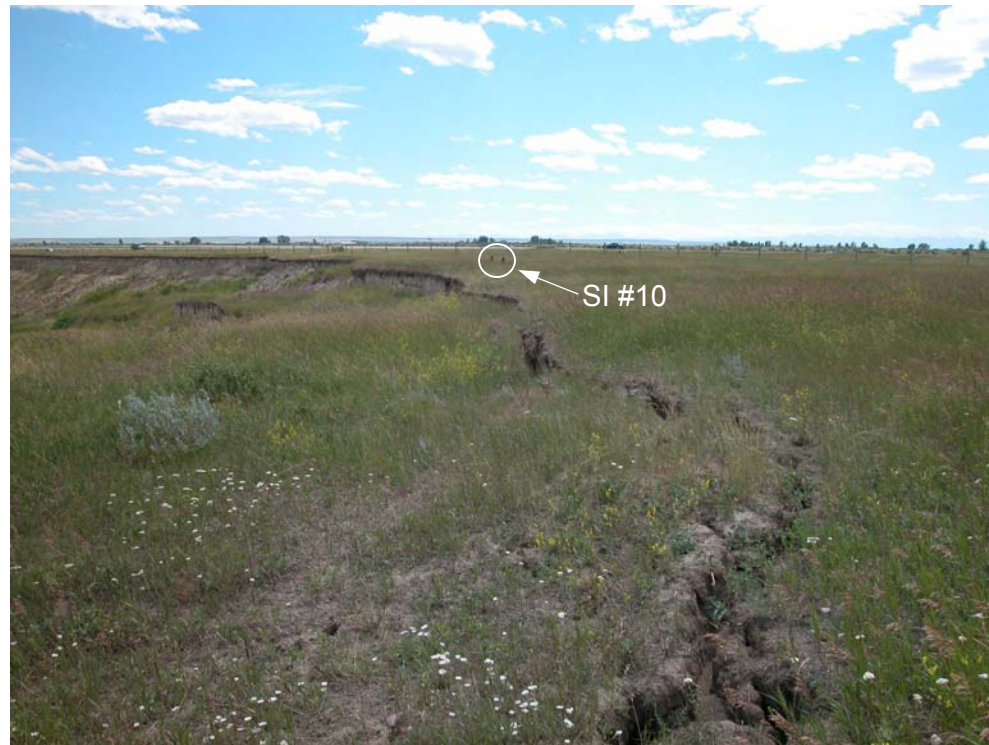
Photo 10 (upper left) – July 2003
Facing southwest across the new landslide block forming northeast of SI #10.

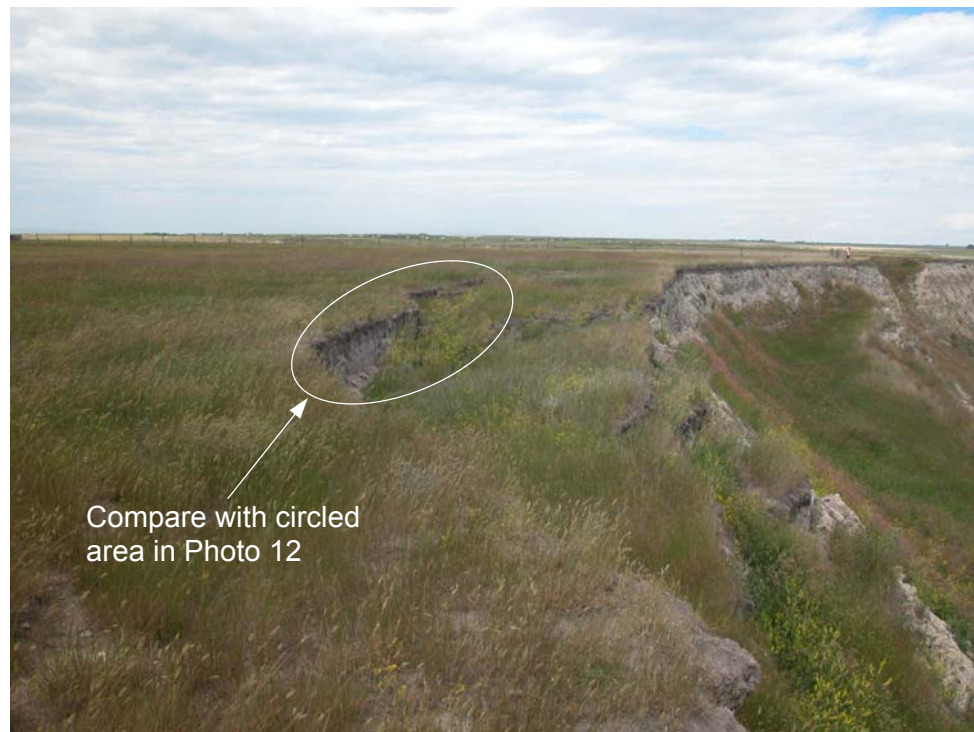
Photo 11 (lower left) – July 2003
Facing northeast across new landslide block forming near SI #10, as seen during the July 2003 inspection. Compare with Photo 12 of the same area, from the May 2002 inspection, and note the increased displacement and downdropping of the landslide block over the past year.

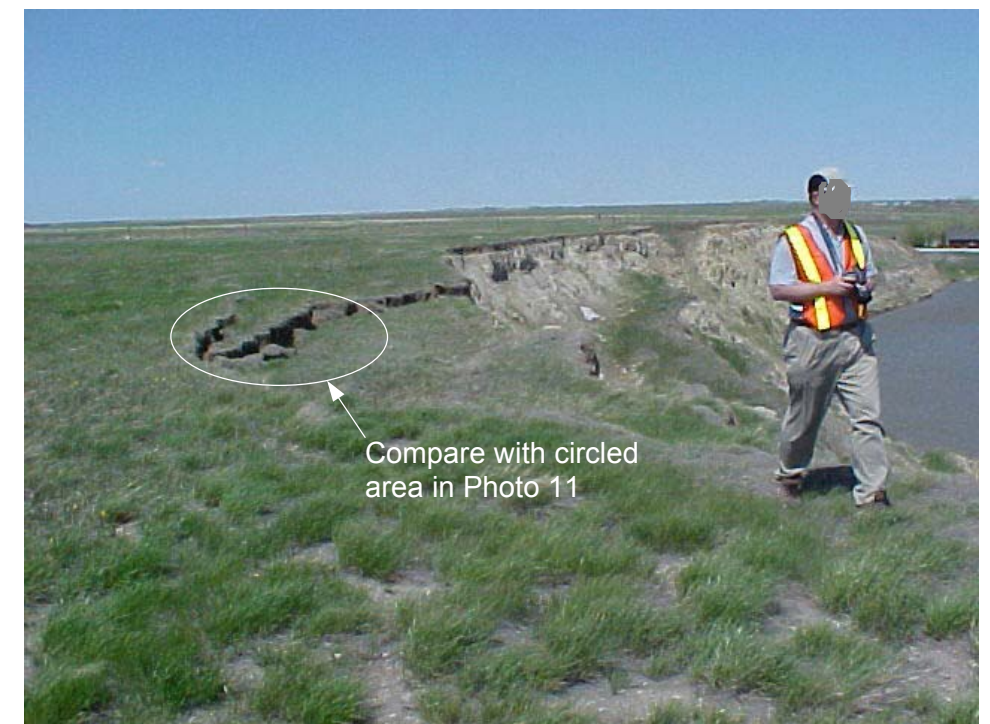
Photo 12 (lower right) – May 2002
Same area as shown in Photo 11, but from the May 2002 inspection.

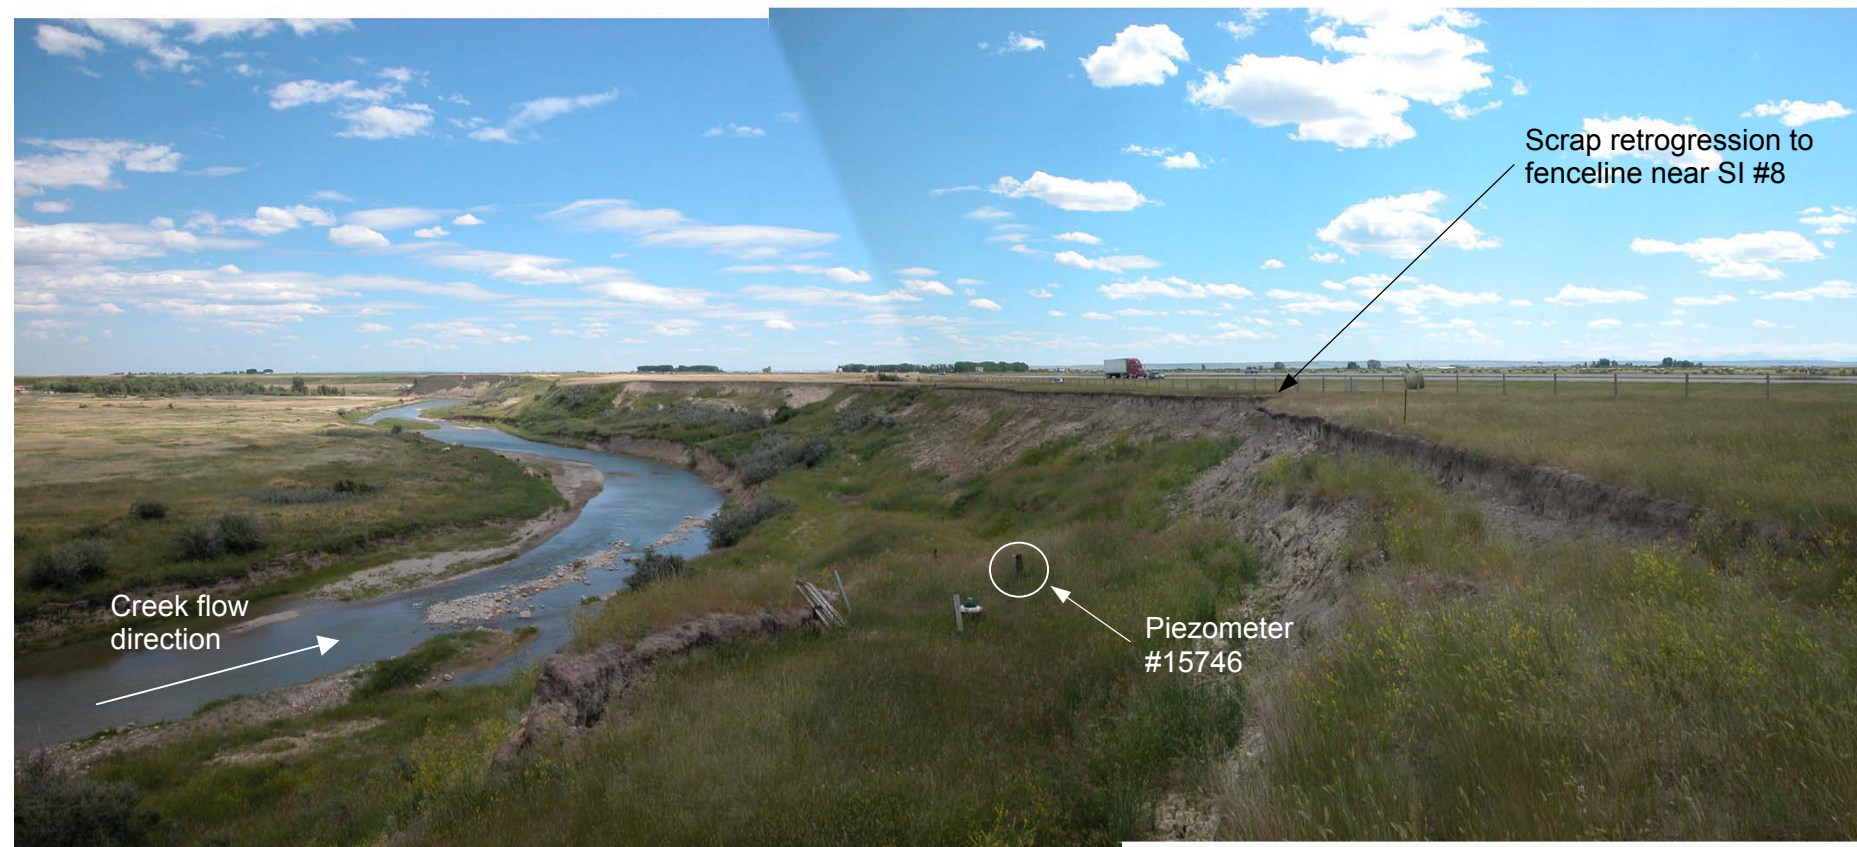
Photo 13 – July 2003

General view of the overall landslide area, facing south from near SI #10. The most active landslide block is around SI #10, from where this picture was taken and as shown in Photos 10, 11 and 12. The central area of the landslide has shown recent scarp retrogression to the fenceline, as shown in Photos 4, 5 and 7.

As noted in the previous assessments and in the instrument monitoring reports, the flow of Willow Creek is eroding material from the toe of this landslide complex, allowing the colluvium on the slope above the creek channel to gradually move further downslope. This movement in turn further removes support for the near-vertical scarp adjacent to the fenceline, allowing subsequent blocks to topple down and causing the scarp to retrogress further west, towards the fenceline and highway.

This process will continue in the future until the overall creek valley slope has reached a stable angle that will not be undermined by channel erosion. During this process, it is likely that the landslide crest will eventually reach the highway. The rate of crest retrogression is relatively slow at present, and the recommended survey monitoring of the crest position (initiated with the July 2003 site survey), will help to gauge the rate of retrogression. The existing SI's are not well-suited to provide advance warning of crest retrogression, as the mode of movement is vertical toppling of material away from the existing scarp.

Possible mitigative measures to prevent the eventual retrogression of the landslide to the highway would be significant river training measures to prevent further erosion of the toe of the landslide complex (possibly in combination with earthworks to regrade the oversteepened upper portion of the slope) or relocation of the highway to the west. The latter option is likely more practical and would avoid environmental regulatory aspects of work in the creek channel.

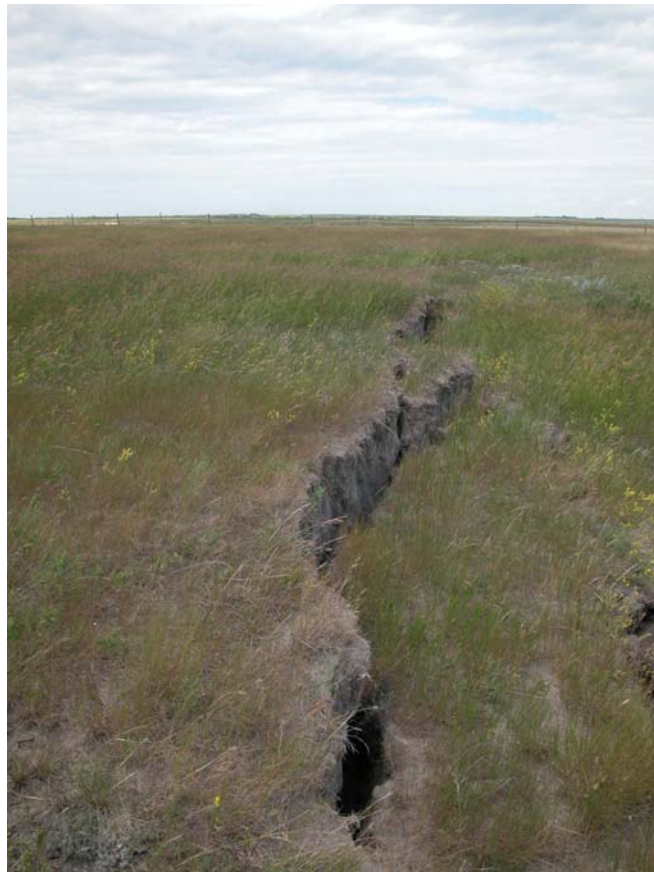
Photo 14 (left) – July 2003

A closer view of the scarp of the new landslide block developing northeast of SI #10. When this landslide block was first noted in the spring of 2002, this scarp was little more than a crack in the ground surface with negligible vertical and horizontal displacement.

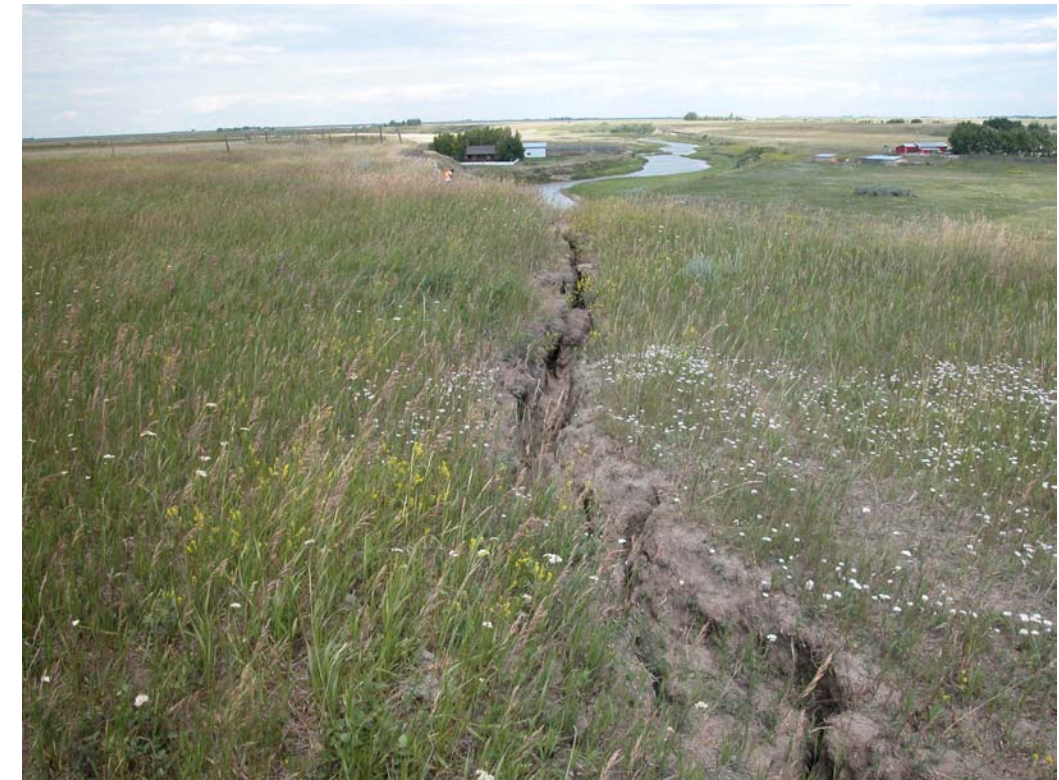
Photo 15 (right) – July 2003

Closer view of the east flank of the new landslide block forming northeast of SI #10. This landslide block illustrates the overall mode of movement of the landslide complex at this site – oversteepening of the upper portion of the creek valley slope after toe erosion by creek flow, followed by outwards toppling of blocks of material away from the top of the valley slope. It is similar to what is occurring at the point where the crest has retrogressed to the fenceline adjacent to SI #8 (Photos 4, 5 and 7), but on a larger scale at this location.
