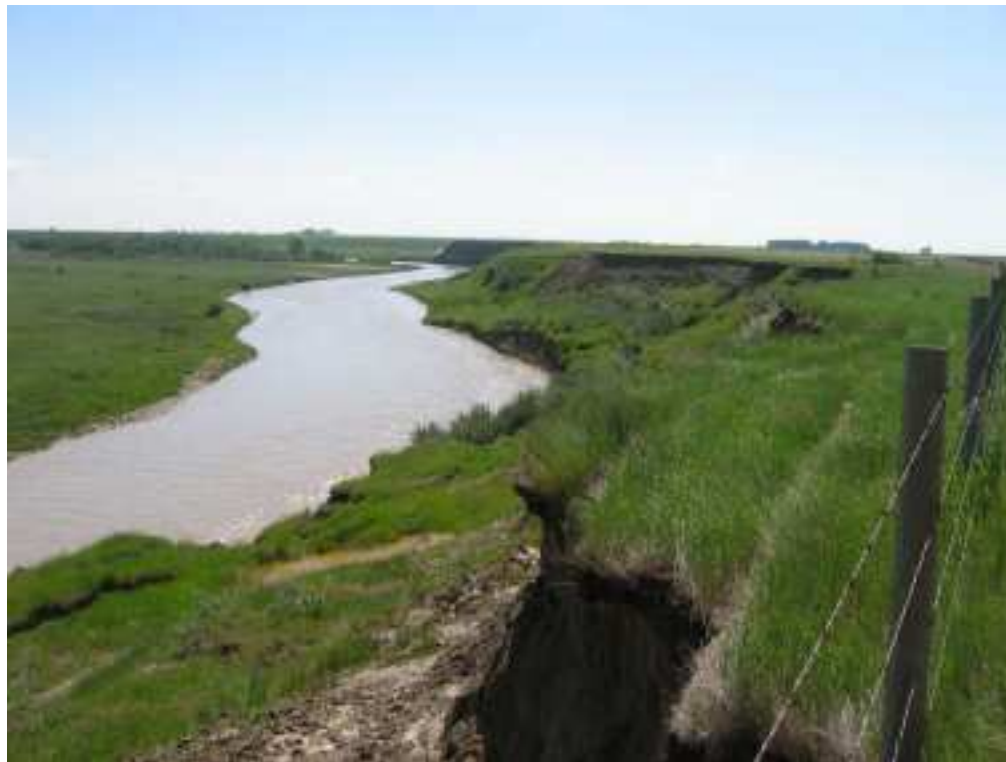
Photo S4-1 (upper left) – June 2005 – facing south across the landslide area from near SI#8.

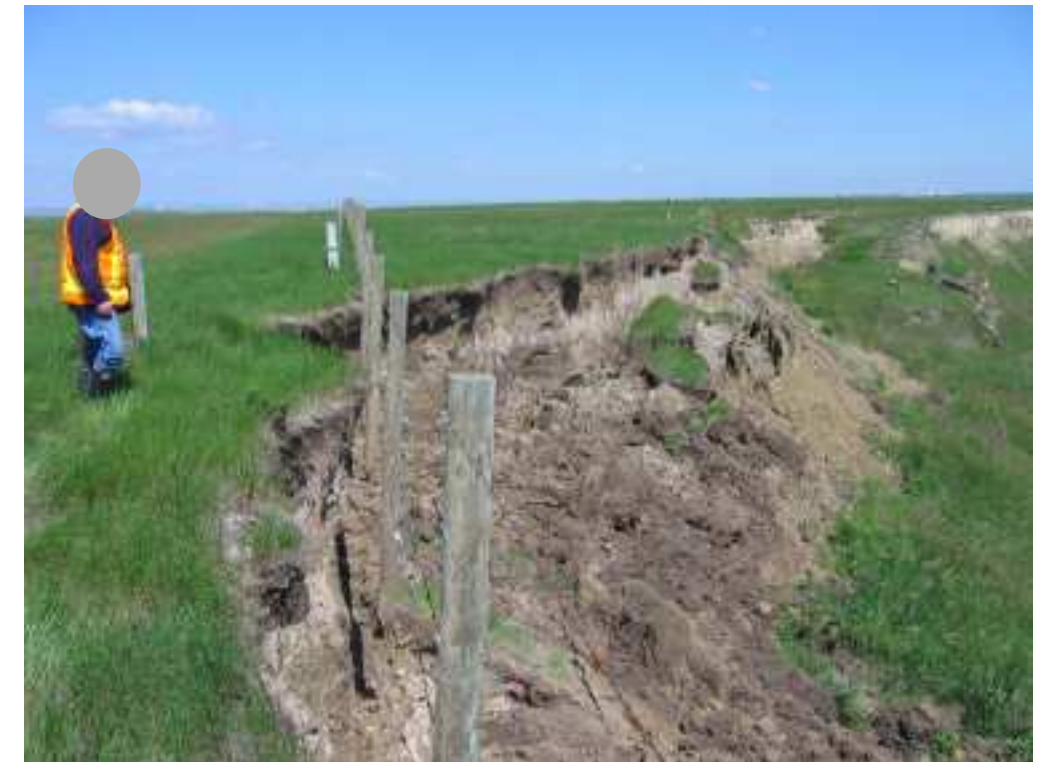
Photo S4-2 (upper right) – June 2005 – facing across the area where the landslide scarp has retrogressed across the fenceline since the 2004 inspection.

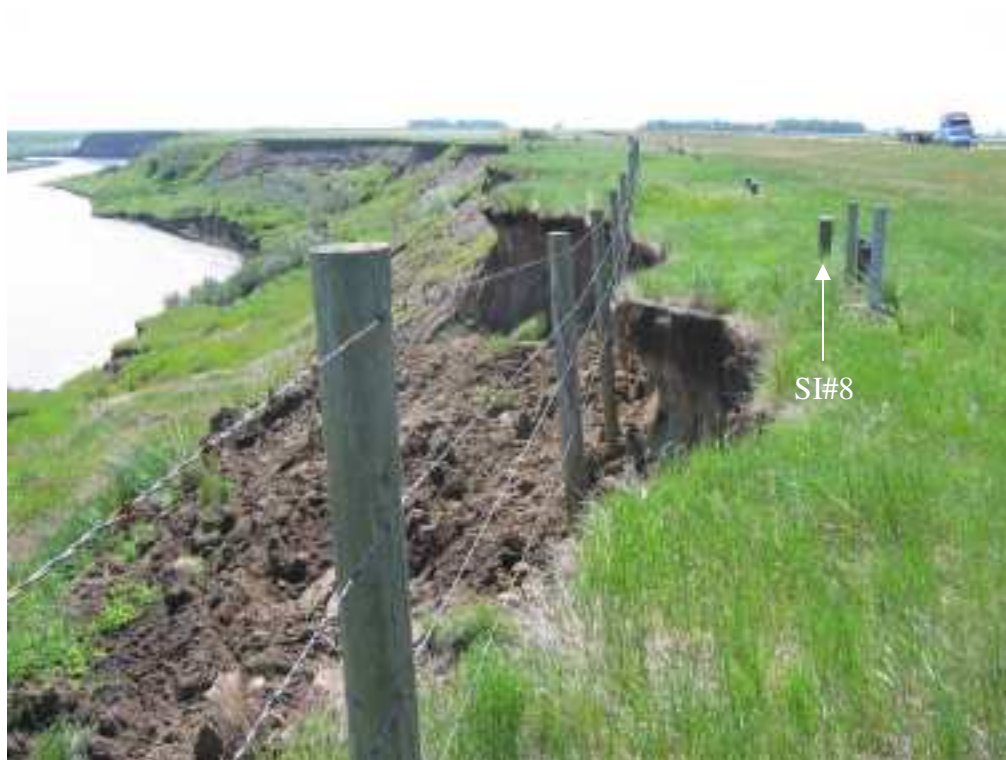
Photo S4-3 (lower left) – June 2005 – facing south across the area where the landslide scarp has retrogressed across the fenceline since the 2004 inspection.

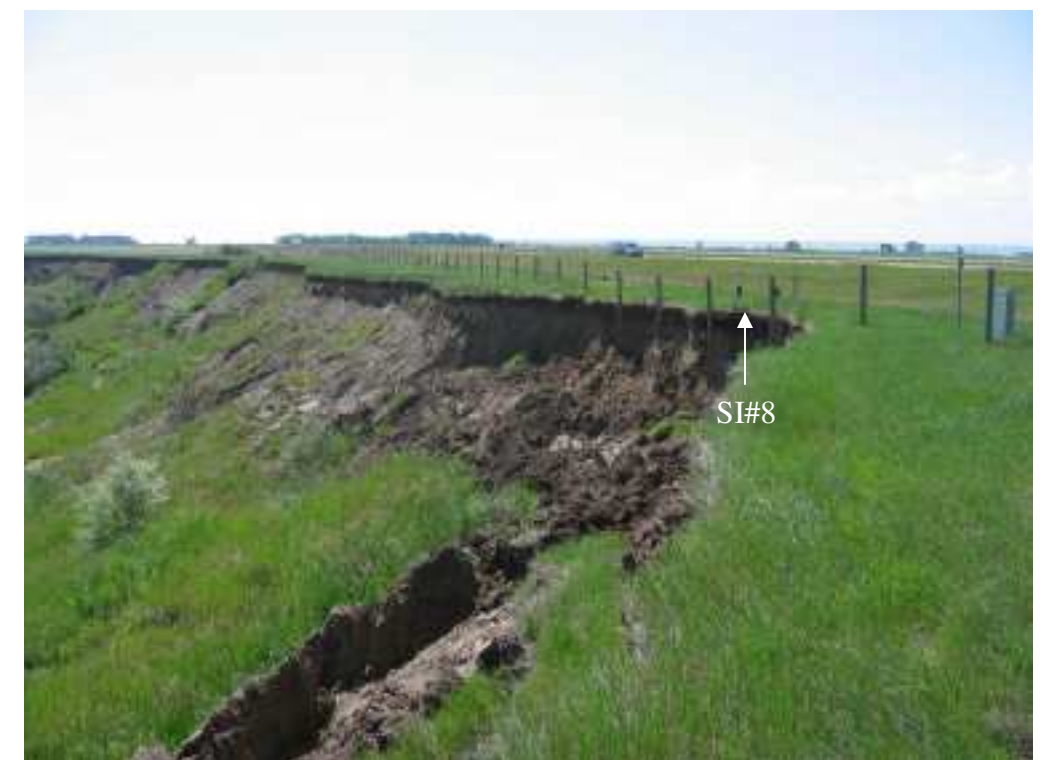
Photo S4-4 (lower right) – June 2005 – wider view of recent scarp retrogression shown in Photos S4-2 and S4-3. The fresh appearance of the exposed soil in the scarp indicates that the retrogression occurred in mid to late June 2005, likely due to heavy rains.

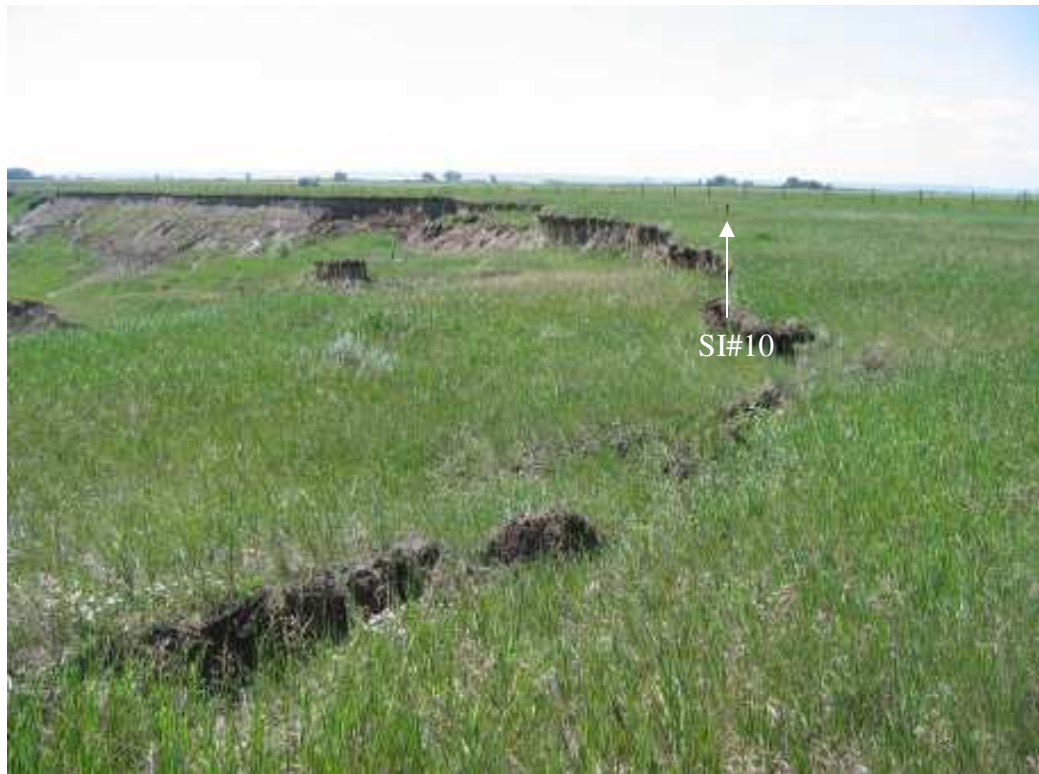
Photo S4-5 (upper left) – June 2005 – recent downdrop of landslide block along the northern flank of the landslide area.

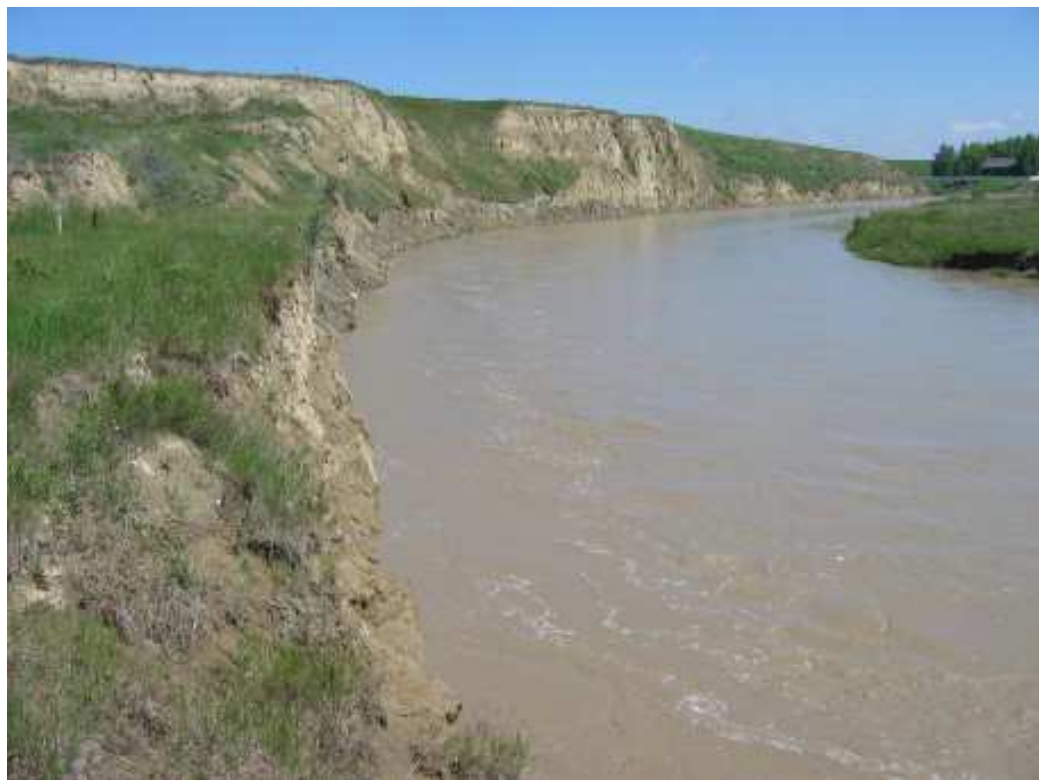
Photo S4-6 (lower left) – June 2005 – looking upstream at scarp that has formed above creek level. Recent toe erosion in central portion of landslide area due to high creek levels following heavy rains in June 2005.
