### S5 Chin Coulee

Alberta Transportation/S. Region Landslide Monitoring Program

Site S5 - Chin Coulee

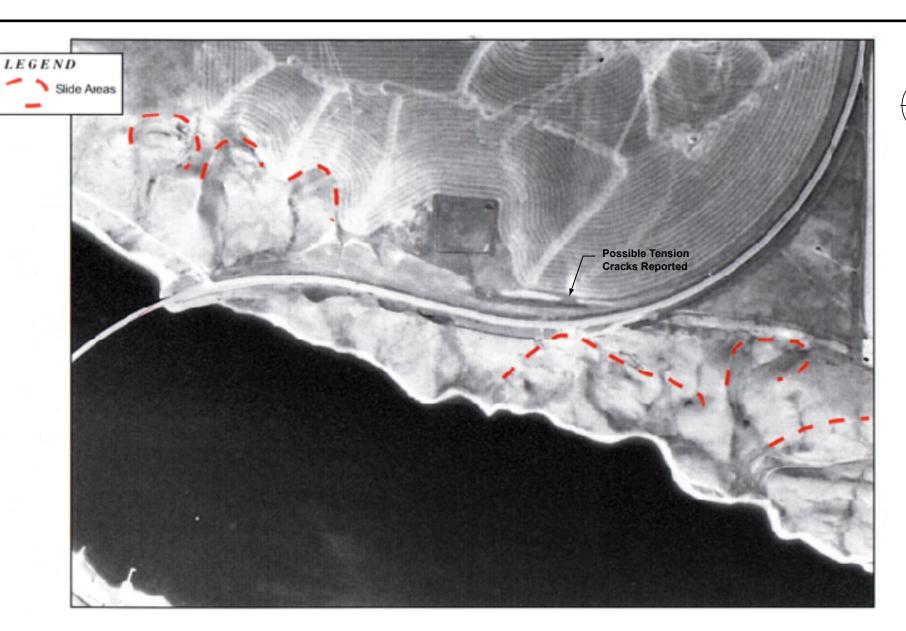
Figure S5-1

Enlarged View from Airphoto
