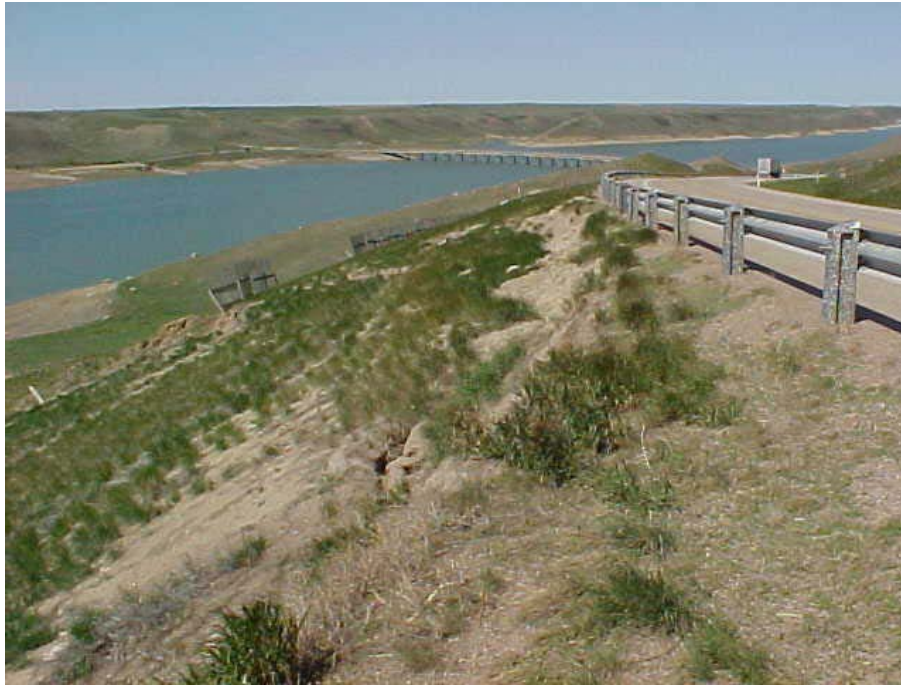
Photo 1 – View of downslope edge of the road showing the proximity of the landslide scarp to the guardrail (May 2002).

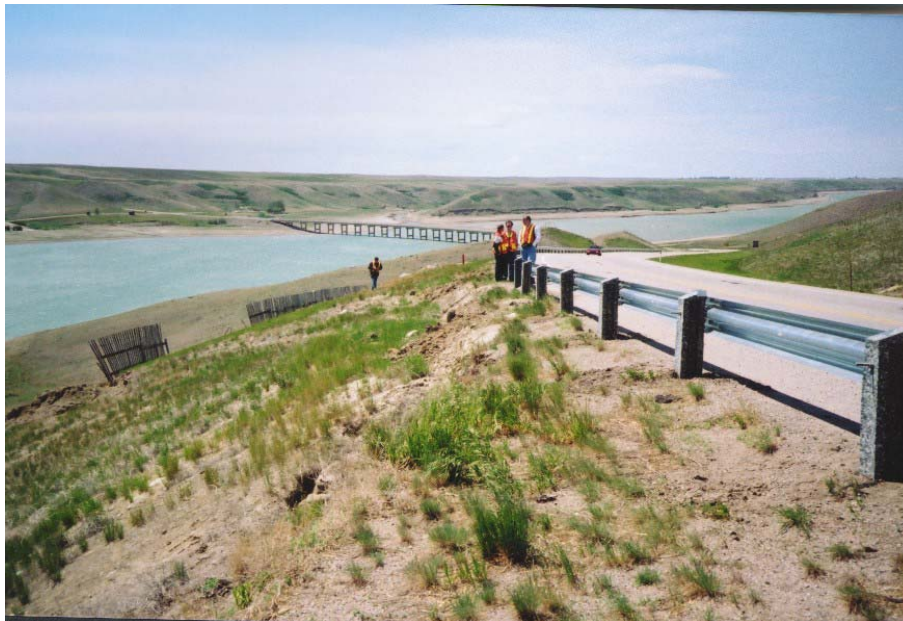
Photo 2 – Downslope edge of road as seen during the May 2001 inspection.

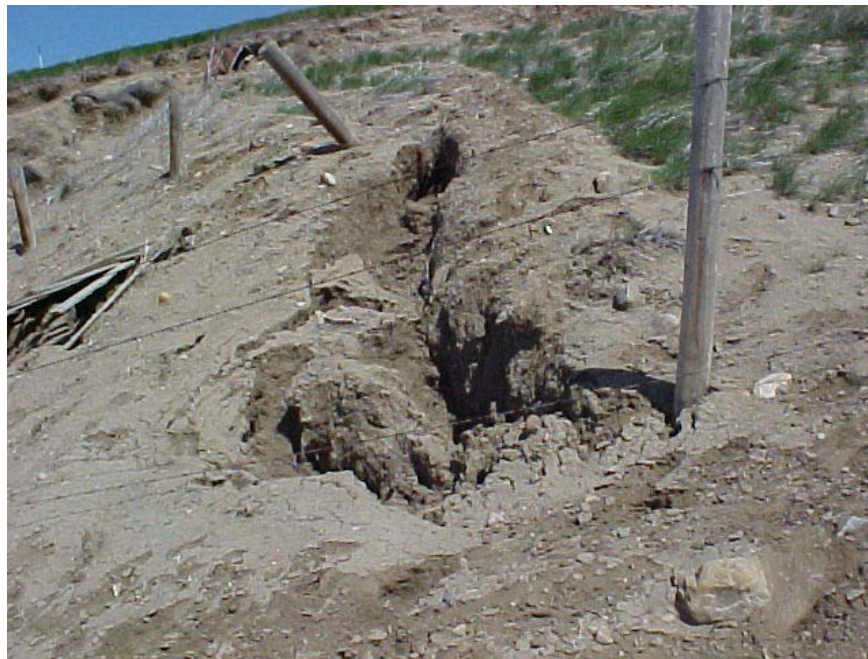
(May 2002)

Photo 3 – Recent gullying and piping in the exposed soils on the landslide blocks immediately downslope of the road.

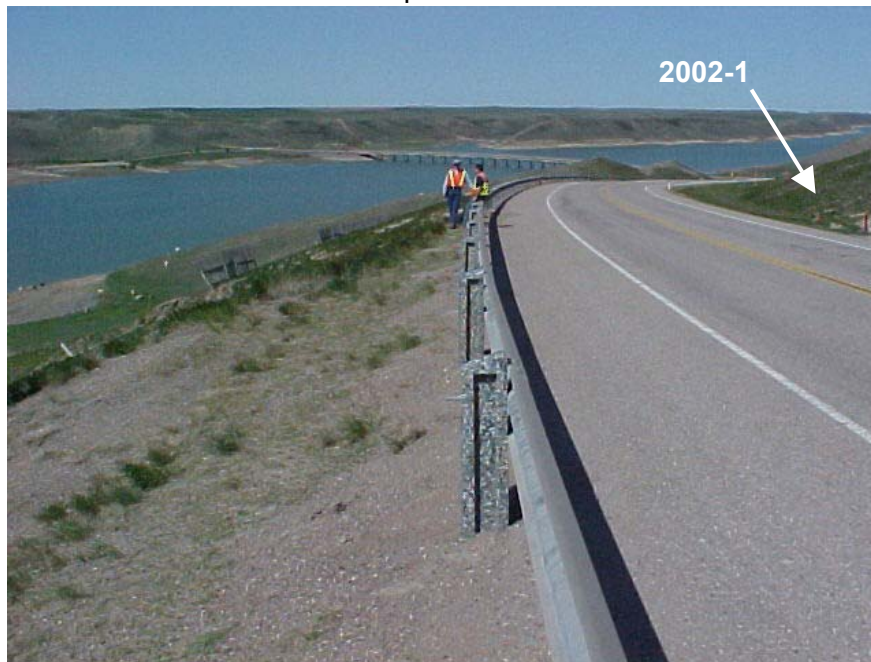
(May 2002)

Photo 4 – Facing southwest across the landslide area. Note the new SI 2002-1 installed in the upslope road ditch in order to monitor for additional/deep-seated movements retrogressing above the road.
