APPENDIX S5
Chin Coulee

Alberta Transportation
Southern Region Landslide Monitoring Program
Spring 2001 Assessment Report

Site S5 – Chin Coulee

PROJECT: SOUTHERN REGION LANDSLIDE MONITORING
TITLE: INSTRUMENTATION SITE PLAN
HWY 36:02
CHIN COULEE, NEAR TABER

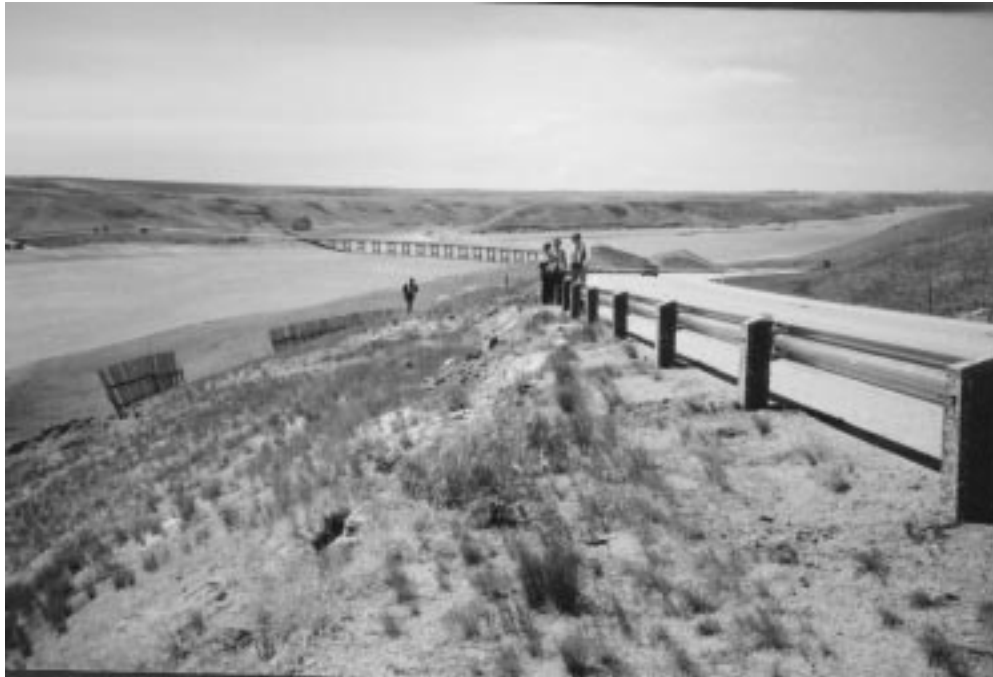
- The scarp area of the slide was directly adjacent to the north shoulder of the road. Photo 1 shows this feature.
- It was reported by maintenance personnel that the guardrail had been previously repaired, and fill had been placed on the downslope side of the guardrail. It was evident that at least portions of this fill had been lost downslope. There was some distortion to the guardrail, but it was not possible to determine if this was due to slope movement or was how the rail had been installed during realignment. See Photos 1 and 2, comparing the 2000 and 2001 assessments.

Photo 1 – View of downslope edge of the road above slide area (2001). Note newly-installed guardrail and slide scarp visible downslope of road.

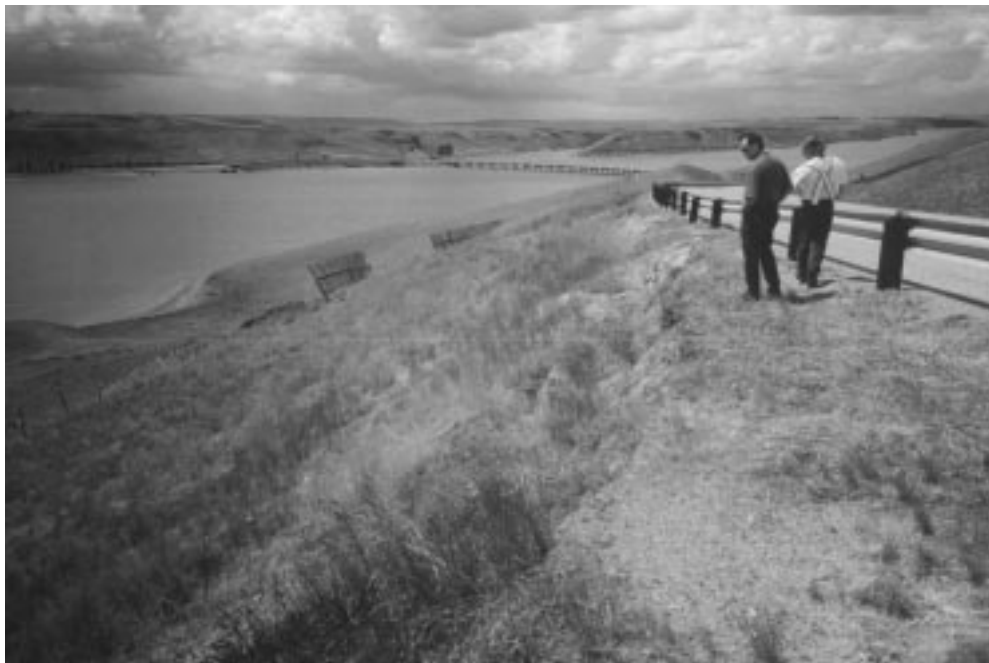
Photo 2 – Downslope edge of road as seen during the June 2000 assessment.

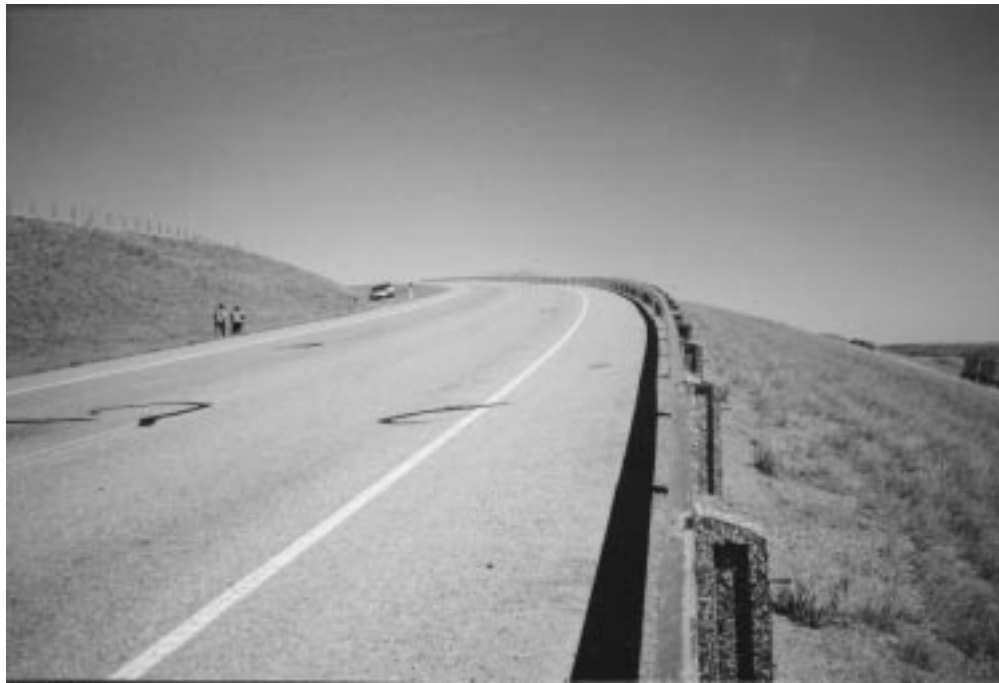
- One major longitudinal crack had been sealed in the eastbound lane adjacent to the slide. Horizontal displacements and distortion of the road surface were minimal. Refer to Photos 3 and 4.

Photo 3 – Facing northeast along road through slide area. Note newly-installed guardrail.

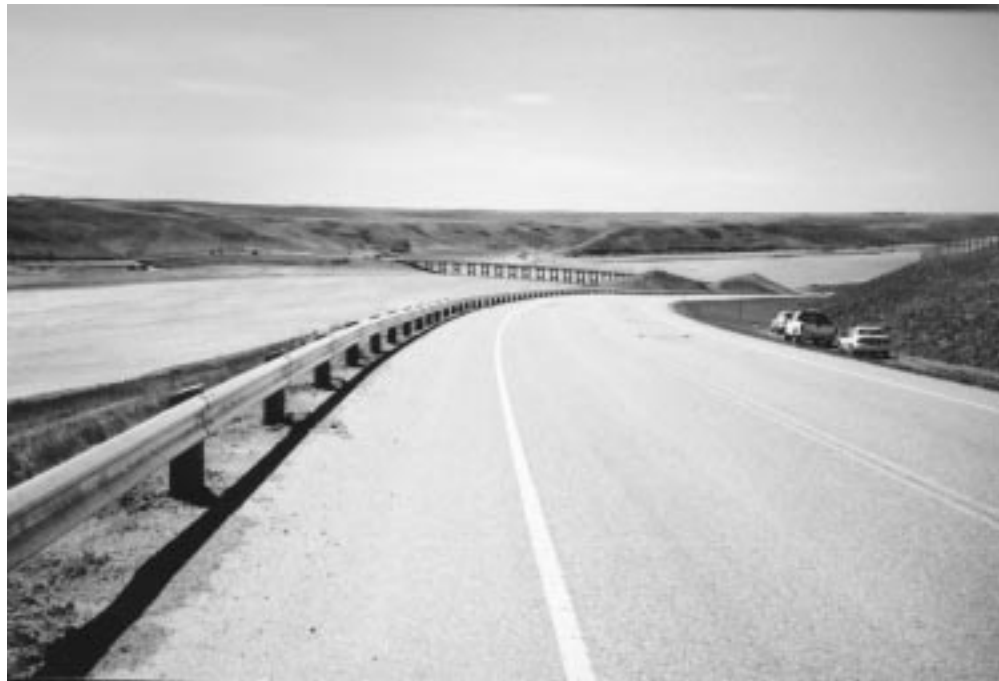
Photo 4 – Facing southwest along road through slide area. Note newly-installed guardrail.

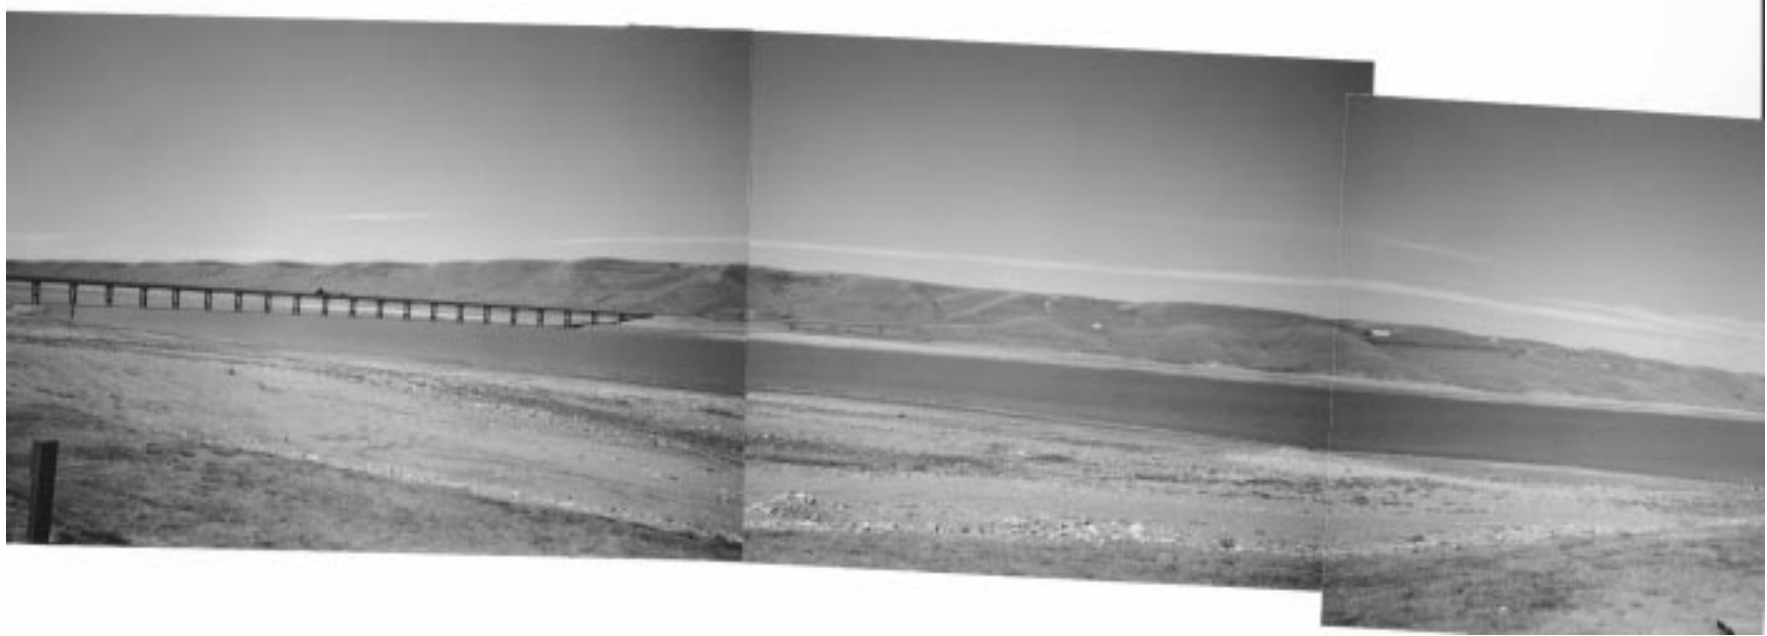
Photo 5 – View of Highway 36 on the north side of the Chin Coulee reservoir. The monitoring/assessment site is near the crest of the hill.
Note landslide throughout the north valley wall.
